Water Lane Hall Bishops Stortford

Condition Reports

East Herts District Council

60739177
WLH-ACM-XX-XX-RP-SE-001

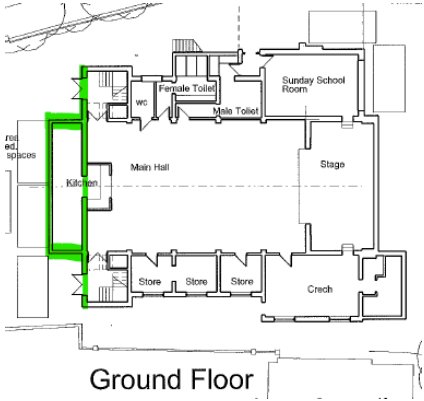
<p>Ground Floor</p>					
(2a) Photos EX-1, 2 & 3	<p><u>Front entrance and (northwest) stair lobby</u></p> <p>i) External cracking to the brickwork at high level over the front entrance doors. The cracking propagates vertically and diagonally above the bullseye window at first floor, with a vertical crack at the base of the window (the cracking continues through the wall and pronounced cracks can be seen internally).</p> <p>ii) Despite widespread cracking internally within the stair lobby walls, there doesn't appear to be any consequent adverse structural distress to the external (white painted) decorative timber (Baroque-style) doorcase including pilasters, the half round window (fanlight) and masonry surroundings located above and each side of the entrance door.</p> <p>No apparent related structural damage <u>externally</u> to the adjoining (west) triangular gable end wall to the hall. However</p>	<p>i) Possible ground subsidence due to faulty drains and / or action from nearby trees. There is an evident problem with the below ground drainage in the adjoining hardstanding. The nearby gulley became flooded during heavy rainfall in March 2025 whilst AECOM were surveying the building. Other evidence includes the settlement of the Tarmacadam hardstanding where it abuts the walls to the building entrance.</p>	<p>i) Investigate drains by conducting a below ground drainage CCTV survey. This is being coordinated by AECOM between February-April 2025.</p> <p>ii) Carry out trial pitting of the foundations to the wall on the west frontage and the north return wall. Expose the existing foundations for structural inspection. Pending the results, a more <u>comprehensive specialist site ground investigation is recommended</u>, including a desktop geotechnical study, and a minimum of 2No boreholes (window samples), and associated laboratory soil sampling and testing for soil type, tree root identification and analysis and soil engineering properties. Ground water</p>	<p>i) If subsidence is the cause of the movement the foundations in the location of the subsidence will likely require underpinning for the extent shown below, including transition underpinning into the hall gable wall (all as highlighted in blue).</p> <p>ii) Repair of the masonry cracks based on an underpinning scheme would comprise of brick stitching using stainless steel bars inserted into the bed joints (such as Helifix), specified by the structural engineer.</p>	<p>Subsidence is likely to be the cause. If it is active subsidence, it will continue causing further cracks, water ingress and loss of stability affecting the safety of the building.</p>	B

<p>iii) Allow provisional sum for repairs to the external entablature to south elevation frontage, including its fixity to the external wall.</p>

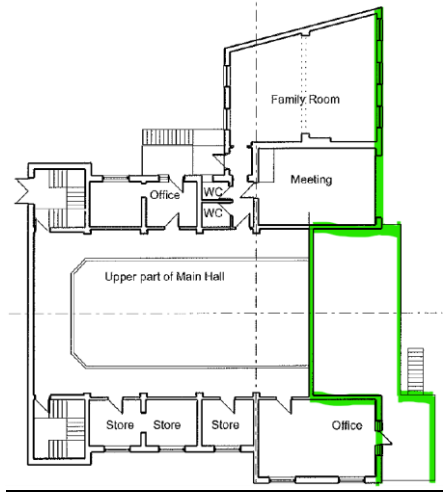
(3a) Photo EX-6	<u>Family room (modern extension over car park entrance) on east elevation</u> i) General water related damage to brickwork, including around windows	i) Blocked roof guttering and downpipes (refer to accompanying building surveying report for further advice).	Refer to accompanying building surveying report for any further advice.	Refer to accompanying building surveying report for any further advice.	Progressive ongoing water ingress and damage to the internal structure and fabric leading to further deterioration / decay compromising the structural safety through loss of fabric.	B/C
(3b) Photo EX-6	<u>Ground floor (Sunday school / meeting room)</u> i) General cracking and spalling to painted rendered wall below and around window, with severe water saturation and staining at junction with the ground.	i) Blocked roof guttering and downpipes (refer to accompanying building surveying report for further advice). ii) There are evident problems with the below ground drainage in the car park area. Reports of bad smells from foul drainage has been reported in the warmer months in this area. It understood that the hardstanding at the rear elevation once housed an external toilet building (since removed and covered with a raised paved hardstanding). The height of the raised paving	Allow for permanent removal of the raised paved hardstandings, and inspection of the downpipe. Locally remove the render coverings to promote drying. Inspect the render material which may be a hard cementitious mix.	Cement renders are known to promote dampness within solid masonry as rainwater which passes the render becomes trapped within the wall structure. This usually leads to the decay of the masonry itself along with the mortar, the internal finishes and leads to decay of the timbers bearing into or, in close contact with the walls. It is recommended that when a major	Progressive ongoing water ingress and damage to the internal structure and fabric leading to further deterioration / decay compromising the structural safety through loss of fabric.	B/C

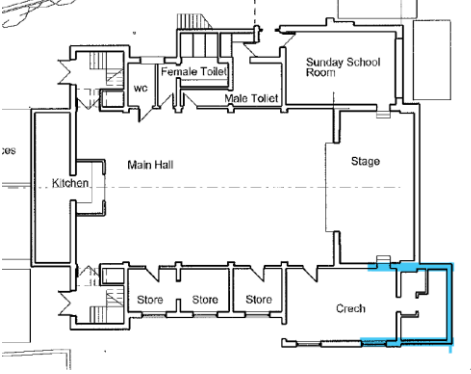
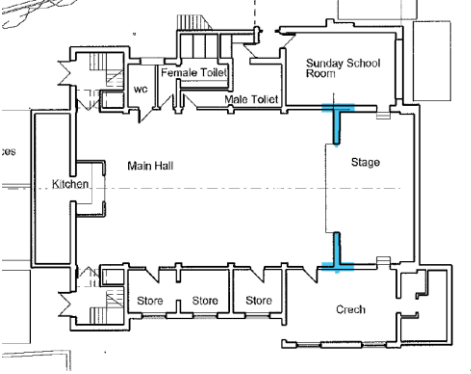
(3e) Photos EX-6 & 7	<u>Rear gable elevation of hall</u> Evident brickwork cracking to the left-hand side of a former window opening (now infilled) to the left of the main hall fanlight window. Refer to the corresponding cracks internally within the hall, to the east gable wall.	i) Possible building subsidence due to faulty drains, tree roots and / or the backfilled waterway (River Stort) at the rear of the building.	i) Investigate drains (see above for details) ii) Establish movement monitoring to check for progressive subsidence (see above for details) iii) Carry out trial pitting of the foundations. Expose the existing foundations for structural inspection. iv) Refer to table section relating to defects to the internal face of the wall. v) Check the junction between the flat roof to the hall stage and the hall east gable wall for signs of detachment due to building movement.	i) If subsidence is the cause of the movement the foundations in the location of the subsidence will likely require underpinning for the extent shown below including transition underpinning into the hall return walls (all as highlighted in blue).

ii) Repair of the masonry cracks based on an underpinning scheme would comprise of brick stitching using stainless steel bars inserted into the bed joints (such as Helifix), specified by the structural engineer.	Subsidence-based movement of the hall gable may be ongoing. Inaction may result in further deterioration of the structure and ultimately failure of the supporting walls and partial collapse. Progressive ongoing water ingress and damage to the internal structure and fabric and the external render leading to further structural decay compromising the structural safety and loss of historic fabric.	B/C

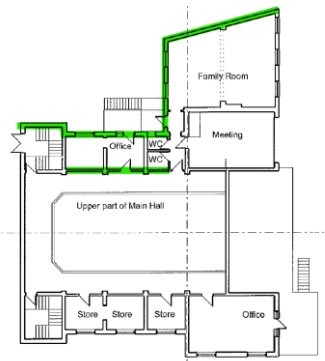
(4a) Photos EX-2 & 3	<u>Side (north) elevation of entrance / stair lobby at ground floor</u> No signs of adverse structural defects in the external fabric. However, internally there are numerous cracks in the walls to the lobby/staircase. Green staining to the brickwork. Furthermore the external ground hardstanding (Tarmacadam) appears to have dropped relative to the building. Refer to the accompanying building fabric and building services reports for other observations in this area.	i) Possible building subsidence due to faulty drains and /or tree roots. ii) Water penetration into the façade, possibly through a combination of causes such as faulty rainwater goods, roof leaks, water splashing, latent defects i.e. missing DPC, and deficiencies in the brickwork have likely caused the historic defects on this elevation. Active water overtopping from the guttering is evident, as seen during heavy rainfall during the survey.	i) Investigate drains (see above for details) ii) Establish ground movement monitoring to check for progressive subsidence. iii) Carry out trial pitting of the foundations. Expose the existing foundations for structural inspection. iv) Refer to table section relating to defects to the internal face of the wall. v) Investigate for damp penetration and retained moisture in the masonry. Determine the quantity of moisture in the masonry masses and its source(s).	Once the source(s) of the damp penetration have been established, the affected areas will require remediation and re-decoration. The roof guttering in this area is defective and will need to be replaced. The water penetration may be remedied once the below ground drainage repairs have been made. The results of the CCTV drainage survey and recommendations are awaited. Refer to the External front elevation (west) for underpinning recommendations.	Subsidence-based movement may be ongoing. Inaction may result in further deterioration of the structure. Progressive ongoing water ingress and damage to the internal structure and fabric and the external brickwork leading to further structural decay compromising the structural safety and loss of historic fabric.	B/C

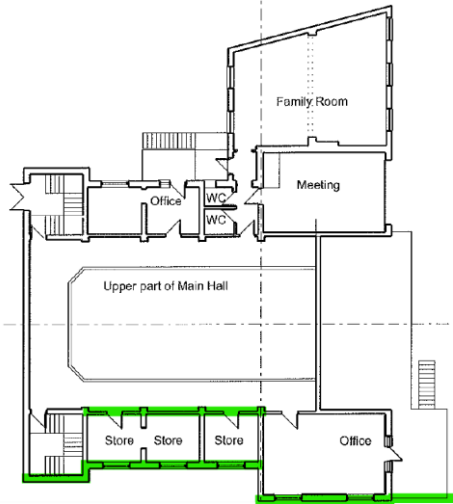
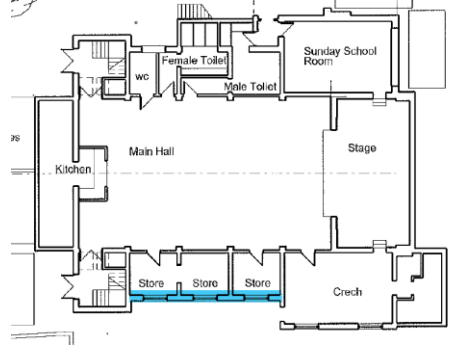
(5a) Photos EX-13, 14 & 15	<p><u>Side (south) elevation (central region)</u></p> <p>Staggered diagonal and vertical cracking in the brickwork walls generally between the lower and upper level windows. At least two (centre and left of centre) of the three segmental brick arches have dropped causing loss of support to the brick spandrels between the windows which have cracked in a classic arched-shaped manner to remain stable.</p> <p>The brickwork below DPC level along the length of the three hall windows appear to be saturated, weathered, stained with salts and bed joints and perpend joints missing.</p>	<p>i) The symptoms of distress suggest that the cause is ground related, which may be subsidence due to faulty drains and / or the action of tree roots. The dropping of the brick arches is activated by dropping of the supporting wall/piers.</p> <p>ii) Open cracks in the façade allow water to penetrate into the wall core which exacerbates further deterioration due to damp and mechanical actions such as freeze/thaw. Other agents of decay include faulty rainwater goods, roof leaks, water splashing, latent defects i.e. missing DPC, and deficiencies in the brickwork/mortar which need to be investigated further to enable appropriate repairs to be specified.</p> <p>The external ground is built up too high against the brick courses below DPC level, causing accelerated decay.</p>	<p>i) Investigate below ground drainage (see above for details)</p> <p>ii) Establish ground movement monitoring to check for progressive subsidence.</p> <p>iii) Carry out trial pitting of the foundations. Expose the existing foundations for structural inspection.</p> <p>iv) Refer to table section relating to defects to the internal face of the wall.</p> <p>v) Investigate for damp penetration and retained moisture in the masonry. Determine the quantity of moisture in the masonry masses and its source(s).</p>	<p>i) If subsidence is the cause of the movement the foundations in the location of the subsidence will likely require underpinning for the extent shown (all as highlighted in blue).</p>

<p>ii) Repair of the vertical masonry cracks based on an underpinning scheme would comprise of brick stitching using stainless steel bars inserted into the bed joints (such as Helifix), specified by the structural engineer. Additional reinforcement to repair the brick arch lintels can adopt the Helifix HeliBars which are installed in parallel lengths bonded into cut slots directly above the existing lintel. Angled CemTies or DryFix ties are installed up through the lintel and into the masonry above the lower HeliBars; specified by the structure in accordance with Helifix installation requirements.</p> <p>iii) The ground level adjoining the brick façade needs to be lowered to at least 150mm below DPC level.</p> <p>The brickwork bed and perpend joints need to be re-pointed using an appropriate lime-based</p>	<p>Subsidence-based movement may be ongoing. Inaction may result in further deterioration of the structure.</p> <p>Durability is essential for the continued structural health of the building and fabric. Openings in the external envelope allow water to penetrate and initiate decay.</p>	B/C

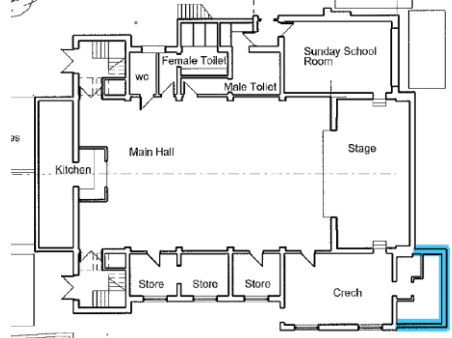
(5c) Photos EX-9, 10 & 11	<p><u>Side (south) elevation of single-storey workshop at ground floor</u></p> <p>Two parallel rows of severe (fine to circa 10mm thickness) staggered diagonal cracking in the brickwork walls extending half-height between the underside of the small window and the ground; and probably extending to the foundations. A third finer crack extends from the flat roof verge to the level of the window sill, indicating a general tilting of the building towards the rear car park (to the east). The flat arch brick lintel to the small side window has a large tapered vertical crack to its left-hand side.</p> <p>The concrete gulley below the location of wall cracking is cracked. The gulley is also blocked, as evidenced during the survey during heavy rainfall.</p>	<p>i) The symptoms of distress suggest that the cause is ground related, which may be subsidence due to faulty drains and / or the action of tree roots.</p> <p>ii) Open cracks in the façade allow water to penetrate into the wall core which exacerbates further deterioration due to damp and mechanical actions such as freeze/thaw. Other agents of decay include faulty rainwater goods, roof leaks, water splashing, latent defects i.e. missing DPC, and deficiencies in the brickwork/mortar which need to be investigated further to enable appropriate repairs to be specified.</p>	<p>i) Investigate below ground drainage (see above for details)</p> <p>ii) Establish ground movement monitoring to check for progressive subsidence.</p> <p>iii) Carry out trial pitting of the foundations. Expose the existing foundations for structural inspection.</p> <p>iv) Refer to table section relating to defects to the internal face of the wall.</p> <p>As a temporary measure locally prop the head of the small window to the cill with short lengths of treated hardwood timber to prevent local collapse of the brickwork in this area.</p>	<p>i) If subsidence is the cause of the movement the foundations in the location of the subsidence will likely require underpinning for the extent shown (all as highlighted in blue).</p>

<p>ii) Repair of the vertical masonry cracks based on an underpinning scheme would comprise of brick stitching using stainless steel bars inserted into the bed joints (such as Helifix), specified by the structural engineer.</p>	<p>Subsidence-based movement may be ongoing. Inaction may result in further deterioration of the structure.</p> <p>Durability is essential for the continued structural health of the building and fabric. Openings in the external envelope allow water to penetrate and initiate decay.</p>	B/C

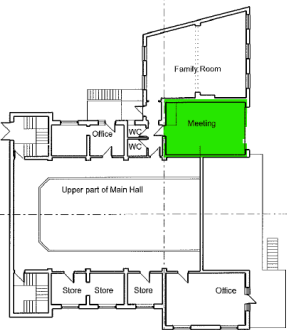
<p>The ceiling above the church parlour room has a raised collar roof arrangement. There are visible signs of water penetration due to water staining, spalling and cracking on the ceiling and walls. There are also signs of roof spread and possible distortion of the roof/ceiling towards the rear wall facing the car park. This is evidenced by stretch mark patterns of cracking in the ceiling.</p> <p>The parlour room floor is live and bouncy under the heel-drop test, and the vibration causes the internal door to rattle. The floor is also noticeably rolling towards the rear wall.</p>	<p>Given there are evident ground movement related defects around parts of the Water Lane Hall building(s), particularly at the east (car park) side, damage from subsidence cannot be discounted until appropriate factual site data is obtained through various investigations.</p> <p>Other likely causes for the cracking and movement of the roof is water penetration, condensation and thermal effects.</p>	<p>i) Investigate drains (see external observations for further details)</p> <p>ii) Physical checks to check if the plaster cracks continue through into the wall structure.</p> <p>iii) Establish movement monitoring to check for progressive subsidence (see external observations for further details).</p> <p>iv) Carry out trial pitting of the foundations. Expose the existing foundations for structural inspection.</p> <p>v) Refer to table section relating to defects to the external face of the walls.</p>	<p>i) If subsidence is the cause of the movement the foundations in the location of the subsidence will likely require underpinning for the extent shown below highlighted in blue, with transition underpinning along the flanking walls as shown.</p>

<p>ii) Repair of the masonry cracks based on an underpinning scheme would comprise of brick stitching using stainless steel bars inserted into the bed joints (such as Helifix), specified by the structural engineer. Repairing the internal cracking to the plaster would benefit</p>	<p>If it is active subsidence, it will continue causing further cracks, water ingress and loss of stability affecting the safety of the building.</p> <p>Durability is essential for the continued structural health of the building and fabric. Openings in the external envelope allow water to penetrate and initiate decay.</p>	B/C

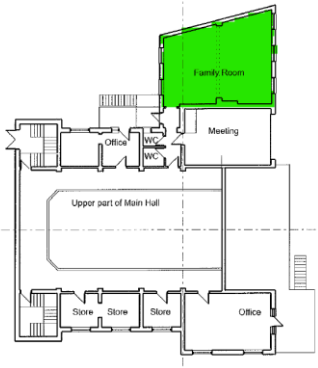
</div> <p>According to earlier reports, the new room was built in 1969. The New Room is situated above the private car park undercroft, and it is constructed in a steel frame encased in concrete with a concrete first floor slab with 'wood wool' permanent formwork left visible insitu on its underside. The frame is built on pad foundations, and the external walls are built in cavity wall construction.</p> <p>i) There are signs of structural movement at the north end of the room (facing Waitrose carpark), evidence by various cracks to the brickwork and concrete encasement. Reports of movement were recorded in the 2008 report by Swarder & Sons.</p> <p>ii) Roof water penetration at northeast corner of the room. The ceiling finishes have perished and collapsed locally. There is active water on the surface of the timber flat roof joists, white and green mould on the underside of the ply roof deck and black mould on the plasterboard ceiling. The approximate affected area is 10m2.</p>	Given there are evident ground movement related defects around parts of the Water Lane Hall building(s), particularly at the east (car park) side, damage from subsidence cannot be discounted until appropriate factual site data is obtained through various investigations.	Other likely causes for the water ingress is water penetration, and condensation.	i) Investigate drains (see external observations for further details). ii) Carry out trial pitting of the foundations. Expose the existing foundations for structural inspection. Check for active tree roots. iii) Refer to table section relating to defects to the external face of the walls.[DP2] iv) Refer to investigations in table section ref: 4 regarding the first-floor slab with wood wool formwork material.	i) If subsidence is the cause of the movement the pad foundations in the location of the subsidence will need to be assessed to see if they need to be modified. This is subject to the results of the investigations. ii) Repair flat roof coverings entirely, replace damaged sections of ply decking and ceiling plasterboard. Building surveyor / architect to advise on thermal insulation requirements to meet the current Building Regulations. iii) Redecorate room	If it is active subsidence, it will continue causing further cracks, water ingress and loss of stability affecting the safety of the building. Durability is essential for the continued structural health of the building and fabric. Openings in the external envelope allow water to penetrate and initiate decay.	A

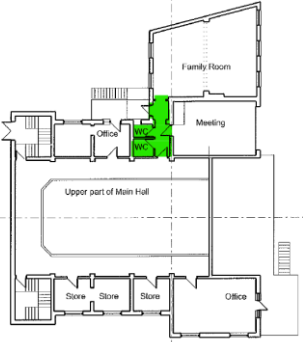
</div> <p>i) Cracked and water stained ceiling in WC adjoining fire exit door.</p> <p>ii) Cracked and water stained ceiling and walls above fire exit door in lobby area.</p>	Water penetration, principally from the roof.	Open up ceilings. Check condition of roof joist ends and lintels.	Repair roof structure if members are locally decayed. Repair roof coverings and ceiling / walls. Redecorate.	Durability is essential for the continued structural health of the building and fabric. Openings in the external envelope allow water to penetrate and initiate decay. [DP3]	B

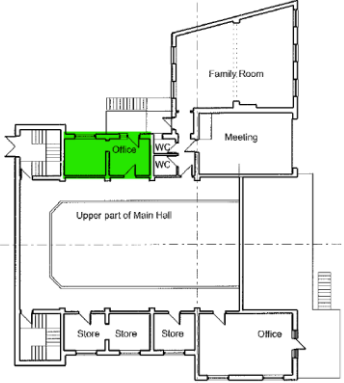
</div> <p>i) Cracked and water stained ceiling in office room adjoining fire exit door. Flat roof above. Floor coverings are dark stained. Condition of floor structure unknown. Floors are fairly live.</p> <p>ii) Partially collapsed lath and plaster ceiling in adjoining office room. Rotten timber joists. Signs of dry rot spores on</p>	Water penetration, principally from the roof.	Open up ceilings. Check condition of roof joist ends and lintels.	Repair roof structure if members are locally decayed. Repair roof coverings and ceiling / walls. Allow for local structural repairs to the first-floor joists, including splicing new timber joists to ends of joists and supporting them off masonry hangers. Redecorate.	Durability is essential for the continued structural health of the building and fabric. Openings in the external envelope allow water to penetrate and initiate decay. If dry rot is present, it will spread rapidly to other parts of the building via the masonry walls. Repair costs will rise if dry rot is not treated early.	A

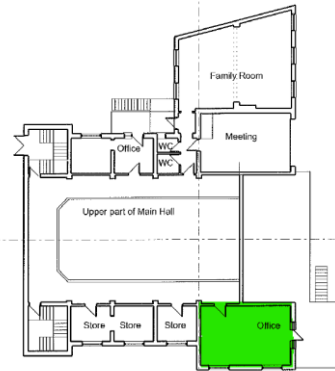
<p>i) The ceiling above the creche area has a raised collar roof arrangement. Whilst there are no visible signs of water penetration, there are cracks to the ceiling and walls, and a black stain above the entrance door to the hall gallery. Based on the external observations noted above in the table, there are signs of building movement at the southeast corner.</p> <p>ii) The floor is live and bouncy under the heel-drop test.</p>	<p>Given there are evident ground movement related defects around parts of the Water Lane Hall building(s), particularly at the east (car park) side, damage from subsidence cannot be discounted until appropriate factual site data is obtained through various investigations.</p> <p>Other likely causes for the cracking and movement of the roof is water penetration, condensation and thermal effects.</p>	<p>i) Investigate drains (see external observations for further details)</p> <p>ii) Physical checks to check if the plaster cracks continue through into the wall structure.</p> <p>iii) Establish movement monitoring to check for progressive subsidence (see external observations for further details).</p> <p>iv) Carry out trial pitting of the foundations. Expose the existing foundations for structural inspection.</p> <p>v) Refer to table section relating to defects to the external face of the walls.</p>	<p>i) If subsidence is the cause of the movement the foundations in the location of the subsidence will likely require underpinning for the extent shown (see table section 5b).</p> <p>ii) Repair of the vertical masonry cracks based on an underpinning scheme would comprise of brick stitching using stainless steel bars inserted into the bed joints (such as Helifix), specified by the structural engineer.</p>	Refer to the above comments relating to the Parlour Room.	B

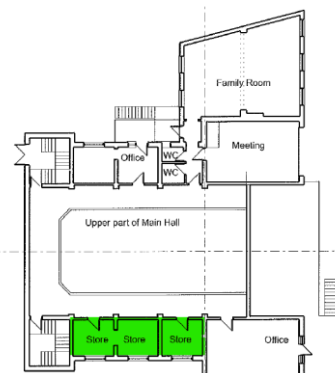
<p>i) Cracking in ceiling</p> <p>ii) Live floors under the heel-drop test</p> <p>iii) Water damage to wall/ceiling adjoining TRUSS 1 and south stair lobby.</p>	<p>Given there are evident ground movement related defects around parts of the Water Lane Hall building(s), damage from subsidence cannot be discounted until appropriate factual site data is obtained through various investigations.</p> <p>Other likely causes for the cracking and movement of the roof is water penetration, condensation and thermal effects.</p>	<p>Open up ceilings.</p> <p>Check condition of roof joist ends and lintels.</p>	<p>Repair roof structure if members are locally decayed.</p> <p>Repair roof coverings and ceiling / walls.</p> <p>Allow for local structural repairs to the first-floor joists, including splicing new timber joists to ends of joists and supporting them off masonry hangers.</p> <p>Redecorate.</p>	<p>Repair roof structure if members are locally decayed.</p> <p>Repair roof coverings and ceiling / walls.</p> <p>Allow for local structural repairs to the first-floor joists, including splicing new timber joists to ends of joists and supporting them off masonry hangers.</p> <p>Redecorate.</p>	B

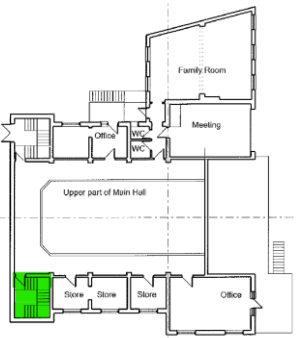
<p>i) Water damage to wall/ceiling adjoining TRUSS 1 / office room at first floor</p> <p>ii) Wall paint peeling and spalling</p> <p>iii) Multiple cracks to the ceiling and walls generally, notably above south window and above and around west bullseye window/fanlight window.</p>	Refer to table section (2c) comments (stair lobby)	Refer to table section (2c) comments (stair lobby)	<p>Refer to table section (2c) comments (stair lobby)</p> <p>i) Repair of the masonry cracks based on an underpinning scheme would comprise of brick stitching using stainless steel bars inserted into the bed joints (such as Helifix), specified by the structural engineer. Repairing the internal cracking to the plaster would benefit reinforcement of the new plaster interface with existing.</p> <p>ii) Repair roof structure if adverse distortion has pulled member connections apart. Repair roof coverings and vaulted ceiling.</p>	<p>If it is active subsidence, it will continue causing further cracks, water ingress and loss of stability affecting the safety of the building.</p> <p>Durability is essential for the continued structural health of the building and fabric. Openings in the external envelope allow water to penetrate and initiate decay.</p>	B

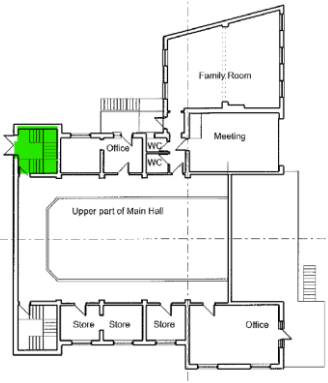
<p>i) Multiple cracks to the ceiling and walls generally, notably above and around the north window and the west bullseye window/fanlight window. The cracking on the ceiling is a type of a parallel stretching pattern suggesting ground movement at the northwest corner of the stair lobby building. The cracking in this room is <u>severe</u>.</p> <p>ii) At the first floor landing the junction between the rebated stone tread stair and the landing slab has separated. This is evidenced by spalling paint along the line of the stone joint, and a physical vertical gap between the top of the tread and the underside of the landing.</p>	<p>Refer to table section (2a) comments (stair lobby)</p> <p>Staircase defect – The most likely cause of the opening up of the joint between the stone landing and the upper stair flight is ground movement and consequent dropping of the building on the NW corner.</p> <p>CAUTION: With this type of staircase construction (stone cantilevered staircase), the stair flight is supporting the first-floor landing slab, and the metal balustrading is preventing the staircase from twisting under load. Therefore, the apparent dropping of the upper flight could affect the structural support of the landing which would become <u>a health and safety hazard</u>.</p>	<p>Refer to table section (2a) comments (stair lobby)</p> <p>Staircase defect – Movement monitoring of the staircase and the wall and ceiling cracking to determine if movement is progressive.</p>	<p>Refer to table section (2a) comments (stair lobby)</p> <p>i) Repair of the masonry cracks based on an underpinning scheme would comprise of brick stitching using stainless steel bars inserted into the bed joints (such as Helifix), specified by the structural engineer. Repairing the internal cracking to the plaster would benefit reinforcement of the new plaster interface with existing.</p> <p>Repair roof structure if adverse distortion has pulled member connections apart. Repair roof coverings and vaulted ceiling.</p> <p>ii) Allow for temporary support of the upper landing and stair flight with designed temporary works that still enables the entrance lobby and staircase to be used. Permanent repairs are subject to the results of the ground investigations. Allow for remedial works pinning of the stone staircase using multiple thin steel shim plates packed into the gaps between the stone elements injected with a suitable grout, all to the structural engineers design.</p>	<p>If it is active subsidence, it will continue causing further cracks, water ingress and loss of stability affecting the safety of the building.</p> <p>Durability is essential for the continued structural health of the building and fabric. Openings in the external envelope allow water to penetrate and initiate decay.</p> <p>The dropped staircase could become a health and safety hazard if the cause of the movement is not investigated.</p>	B A (staircase)

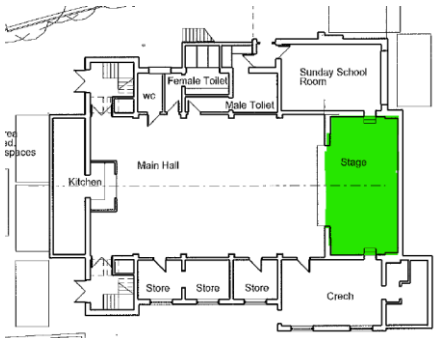
<p>i) Heavy (dark) water staining on ceiling boarding to monopitch roof at rear of stage. Structure of the roof is not confirmed, but likely to be timber joisted supported from the hall gable east wall and the east elevation wall facing the car park.</p>	Water penetration, principally from the roof.	<p>Open up ceilings.</p> <p>Check condition of roof joists and at their bearing ends and wallplates.</p> <p>Check for presence of vertical tie straps</p>	<p>Repair roof structure if members are locally decayed.</p> <p>Repair roof coverings and ceiling / walls.</p> <p>Redecorate.</p>	<p>Durability is essential for the continued structural health of the building and fabric. Openings in the external envelope allow water to penetrate and initiate decay.</p> <p>If dry rot is present, it will spread rapidly to other parts of the building via the masonry walls. Repair costs will rise if dry rot is not treated early.</p>	B

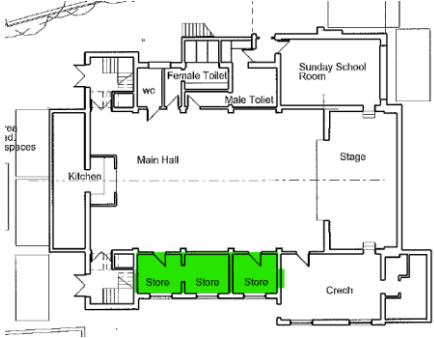
<p>i) Cracking around the side and head of the windows, spalled paint and chipped plaster.</p> <p>ii) Cracking running along the ceiling junction with the internal walls. Black mould in crack in front corner of room, and black residue on wall where water has penetrated ceiling from above.</p> <p>iii) Ceiling cracked around vertical pipework penetrating ceiling.</p>	Water penetration, principally from the roof.	<p>Open up ceilings.</p> <p>Check condition of roof joists and at their bearing ends and wallplates.</p>	<p>Repair roof coverings and ceiling / walls.</p> <p>Allow for local structural repairs to the first-floor joists, including splicing new timber joists to ends of joists and supporting them off masonry hangers.</p> <p>Redecorate.</p>	<p>Durability is essential for the continued structural health of the building and fabric. Openings in the external envelope allow water to penetrate and initiate decay.</p> <p>If dry rot is present, it will spread rapidly to other parts of the building via the masonry walls. Repair costs will rise if dry rot is not treated early.</p>	A/B

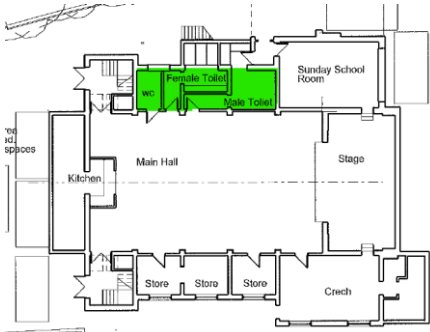
</div> <p>i) Various cracks running along the ceilings. Defects in floor above include active water penetration and potential dry rot.</p>	Water penetration, principally from the roof. Possible condensation.	Open up ceilings. Check condition of floor joists and at their bearing ends and wallplates.	Repair roof coverings and ceiling / walls. Allow for local structural repairs to the first-floor joists, including splicing new timber joists to ends of joists and supporting them off masonry hangers. Redecorate.	Durability is essential for the continued structural health of the building and fabric. Openings in the external envelope allow water to penetrate and initiate decay. If dry rot is present, it will spread rapidly to other parts of the building via the masonry walls. Repair costs will rise if dry rot is not treated early.	B

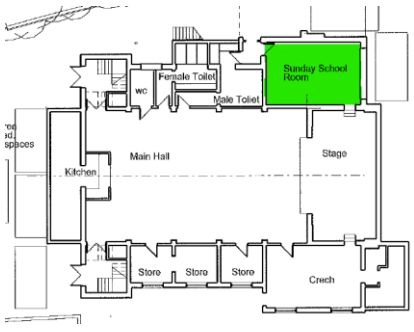
</div> <p>i) Various cracks running along the ceilings. Defects in floor above include active water penetration.</p>	Water penetration, principally from the roof. Possible condensation.	Open up ceilings. Check condition of floor joists and at their bearing ends and wallplates.	Repair roof coverings and ceiling / walls. Allow for local structural repairs to the first-floor joists, including splicing new timber joists to ends of joists and supporting them off masonry hangers. Redecorate.	Durability is essential for the continued structural health of the building and fabric. Openings in the external envelope allow water to penetrate and initiate decay. If dry rot is present, it will spread rapidly to other parts of the building via the masonry walls. Repair costs will rise if dry rot is not treated early.	B/C

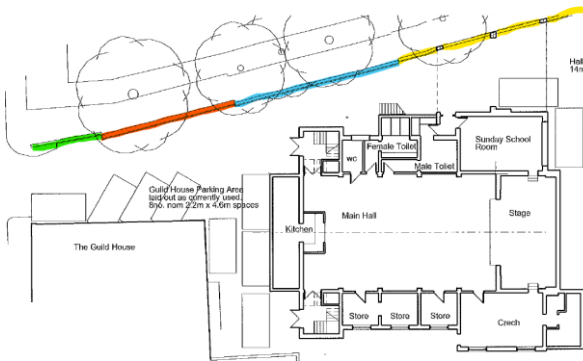
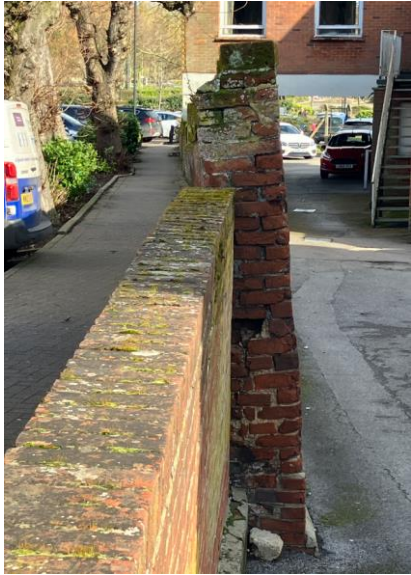
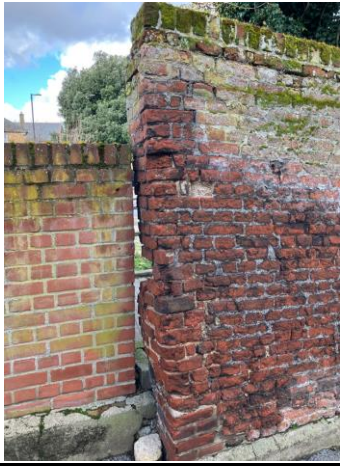
</div> <p>i) Length of wall highlighted in green Between 1.1 and 1.63m height. Modern brickwork, 215mm thick, possibly built in recent past. Wall is reasonably plumb.</p> <p>ii) Length of wall highlighted in red Between 1.85m and 2.14m height. Thickness 340mm. Older (red) brickwork, possibly original. At its western end the wall integrity is poor, with loose and missing brickwork and joints. Heavy moss growth at the head of the wall. Height of wall different each side due to Water Lane Hall side road having steeper gradient. Severe distortion of the wall which is leaning into the public pavement serving the supermarket. The wall is not in contact with the adjoining 215mm thick wall at its western end (adjoining the wall highlighted in green) where the maximum lean in the wall from the vertical is 140mm. The wall begins to straighten as it runs east (towards the wall highlighted in blue). At mid-length the wall leans 60mm from the vertical.</p> <p>iii) Length of wall highlighted in blue Between 2.14m and 2.4m in height. Thickness 215mm (upper) 440mm (lower) thickened both sides. Heavy moss growth at the head of the wall. Height of wall different each side due to Water Lane Hall side road having steeper gradient. Wall is reasonably plumb. There is a vertical diagonal crack through the wall at approximately mid-length.</p> <p>iv) Length of wall highlighted in yellow</p>	<p>Possible cause of leaning wall is ground movement due to the adjoining (horse chestnut) trees.</p> <p>Walls that are either built out-of-plumb or move out-of-plumb in service can become potentially unstable when the centre of gravity of the wall moves beyond width $t/6$ where t = the <i>structural</i> thickness of the wall.</p> <p>The freestanding wall highlighted in red with thickness 340mm is leaning 140mm out of plumb, which falls outside width $t/3$ (110mm). There is a risk that the wall is unstable due to eccentric loading. Masonry walls have little or no tensile strength, therefore walls that lean and are put into tension may have to be re-built or strengthened with masonry buttressing. The wall is also susceptible to impact from vehicles from the hall side.</p> <div>

</div>	<p>The Client is to determine the ownership of the boundary wall, and whether the wall highlighted in red is listed or locally listed. Since any permanent repairs or rebuilding parts of the wall may require consultation.</p>	<p>ii) TEMPORARY PROPPING To be designed by temporary works contractor / engineer to provide a safe means of support to the west end of the wall highlighted in red, whilst a permanent remedial works proposal is agreed for the wall.</p> <p>iii) Repair cracking in wall highlighted in blue using Helifix crack stitching to specialists details.</p>	<p>Once a wall is out of plumb, the process accelerates because of eccentric loading. The Water Lane end of the wall highlighted in red is unstable.</p>	A

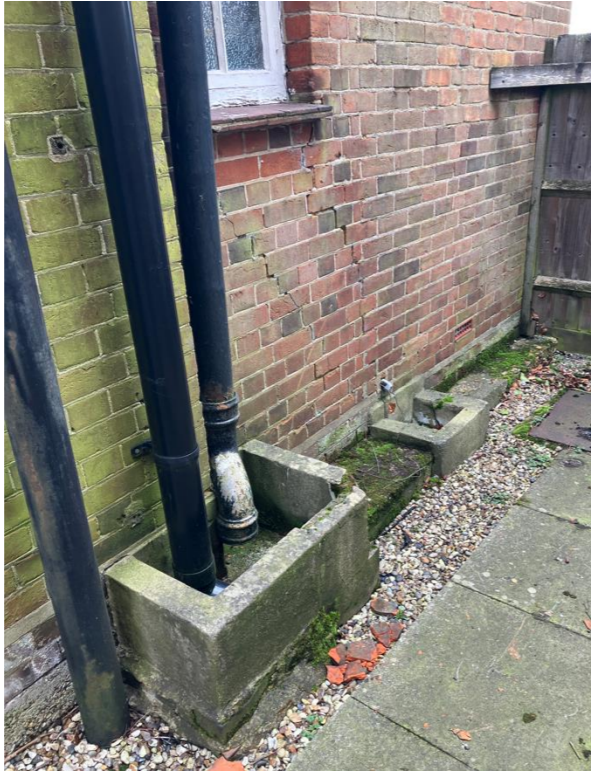
EX-11	Previous photo refers. Both gullies are cracked and broken.	EX-12	South elevation of two-storey building (office above creche), showing diagonal brickwork cracking (arrowed), and water damage to roof eaves soffit (circled)

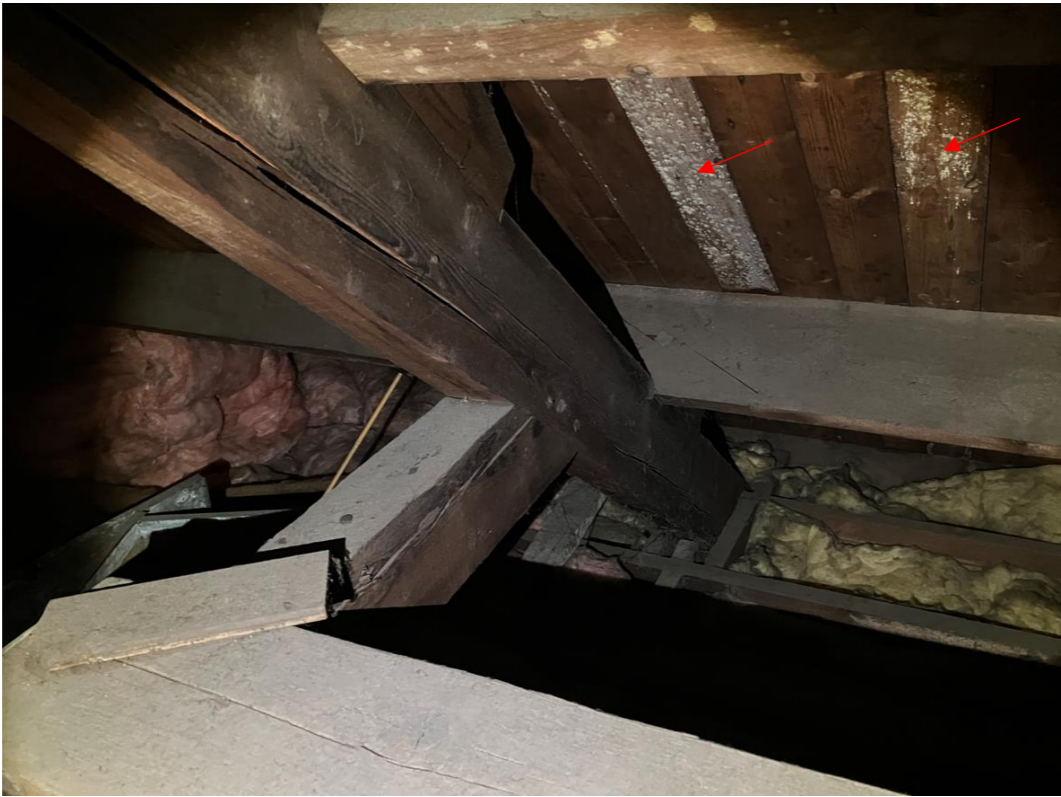
H ROOF 3	Internal view of hall roof space showing typical chord and purlin interfaces with principal truss rafter. White mould staining on underside of roof sarking (arrowed)	H ROOF 4	Internal view of hall roof space showing purlin interfaces with principal truss rafter. White mould staining on underside of roof sarking

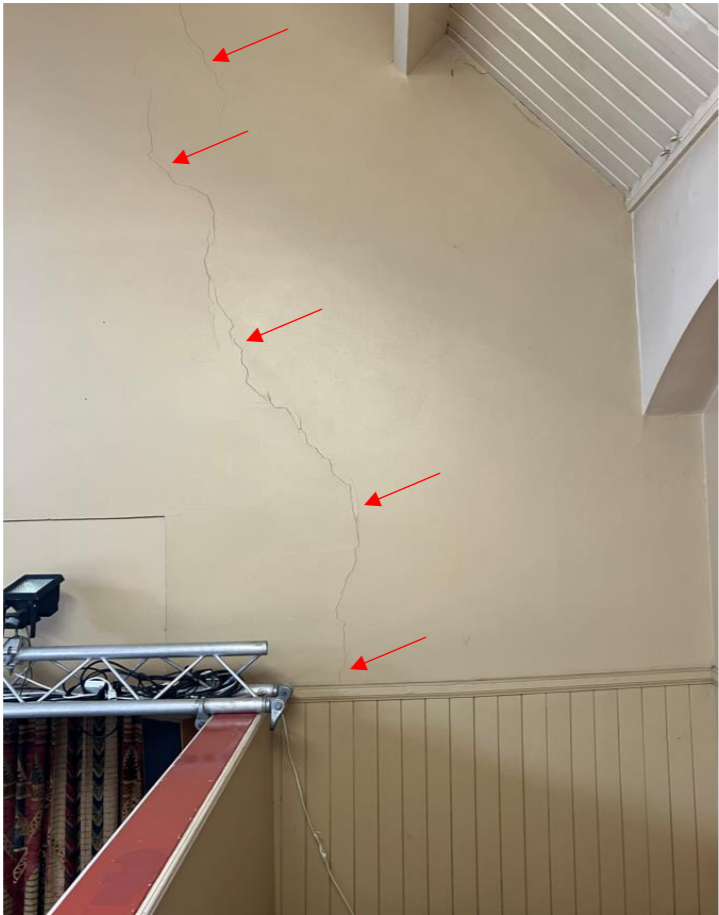
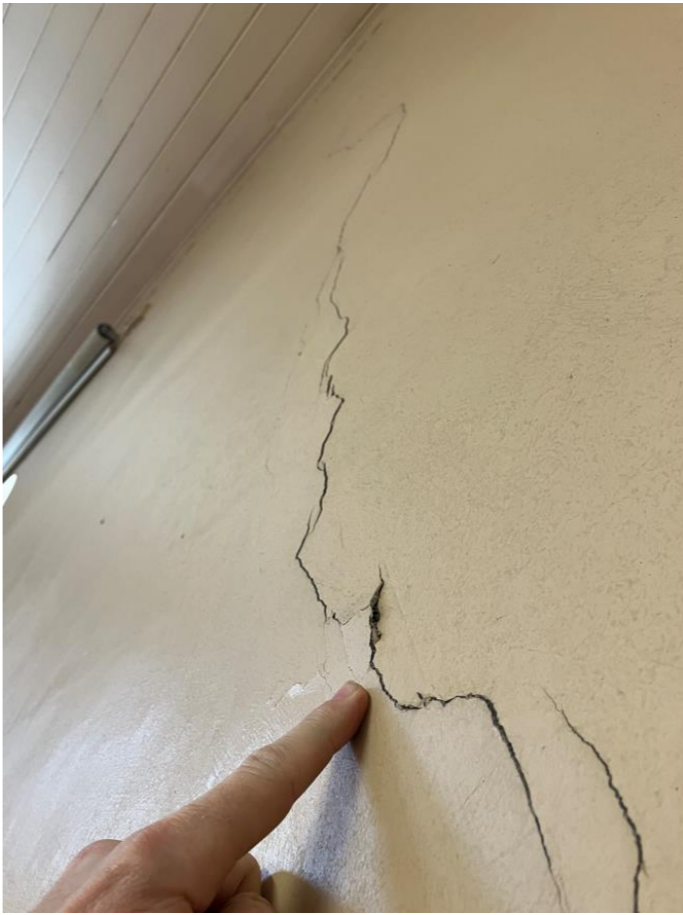
GALL-1	Hall gable wall (east) showing vertical diagonal wall cracking	GALL-2	Hall gable wall (east) showing vertical diagonal wall cracking

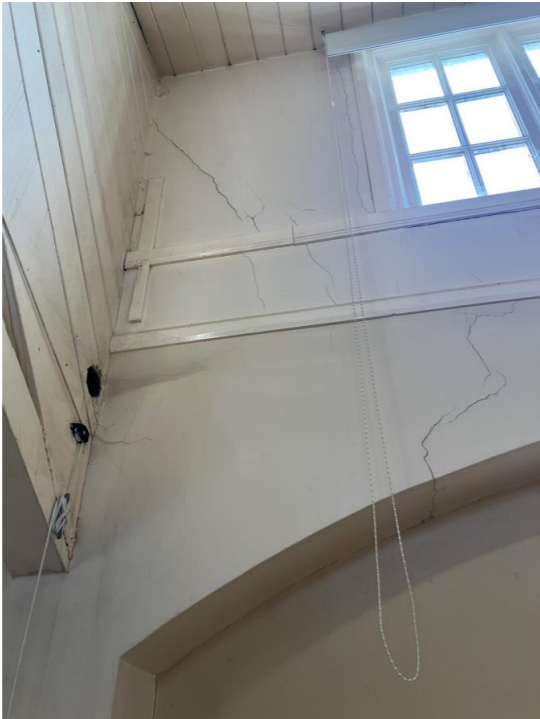
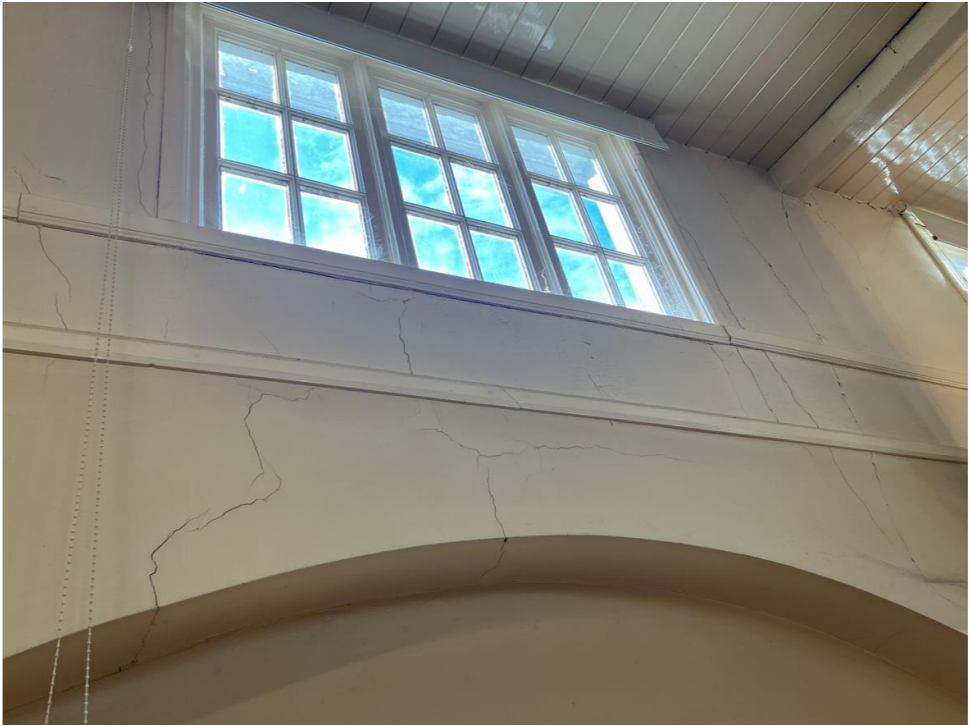
GALL-3	South elevation wall to hall at TRUSS 4 showing sporadic wall cracking	GALL-4	South elevation wall to hall between TRUSS 4 & TRUSS 3 showing sporadic wall cracking

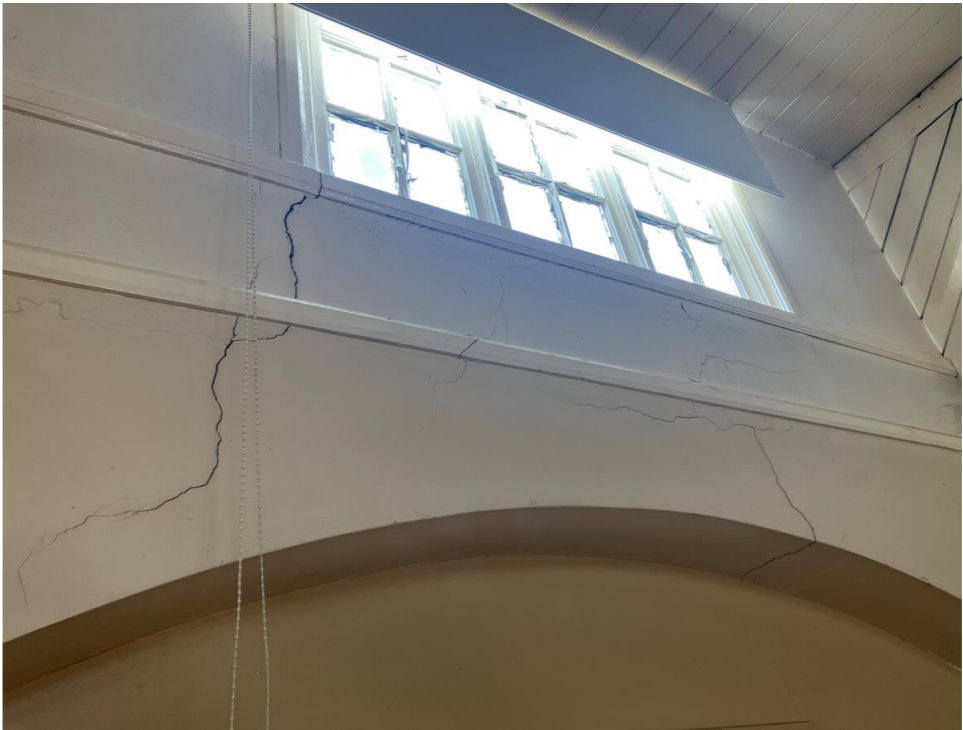
GALL-9	South elevation wall to hall at TRUSS 2 showing wall cracking	GALL-10	South elevation wall to hall between TRUSS 2 & TRUSS 1 showing wall cracking

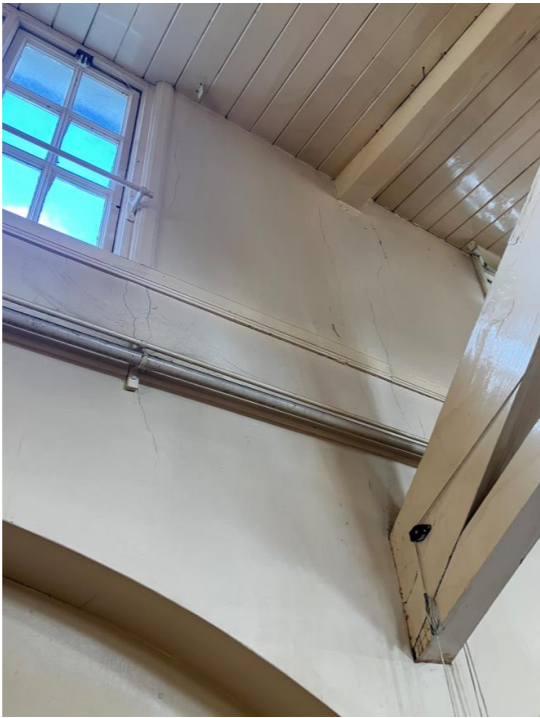
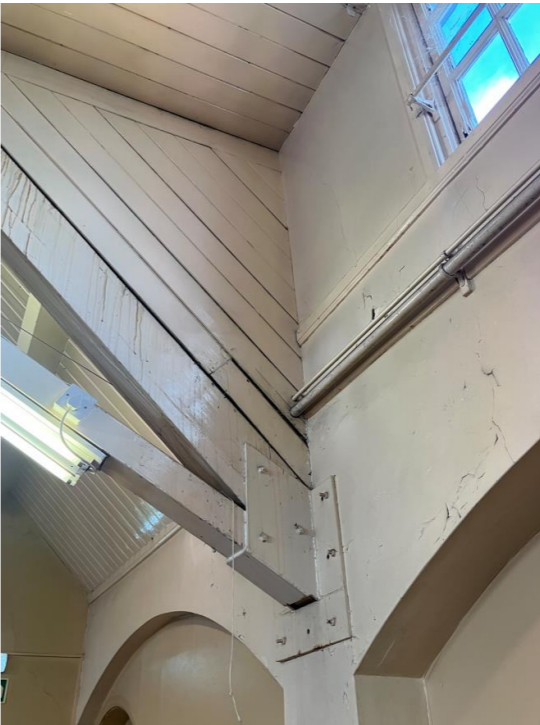
GALL-17	North elevation wall to hall at TRUSS 2 showing sporadic wall cracking	GALL-18	North elevation wall to hall at TRUSS 1 showing wall cracking

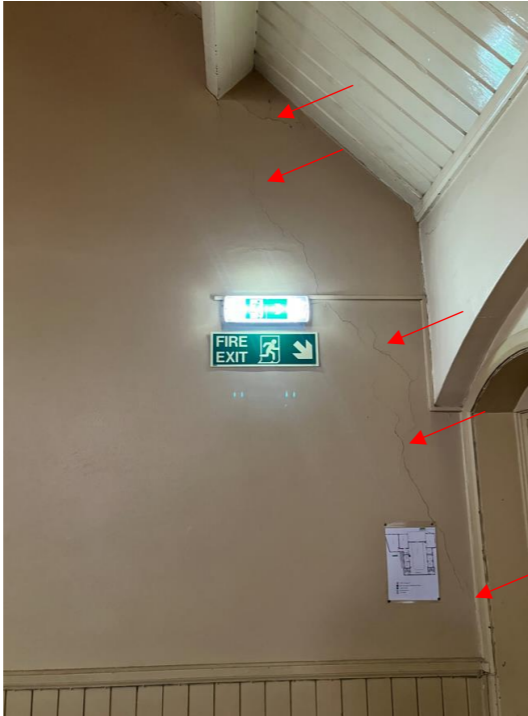
NO PHOTO	
GALL-19	Hall gable wall (west) showing vertical diagonal wall cracking adjoining NW stair lobby (which also has adverse structural cracking)

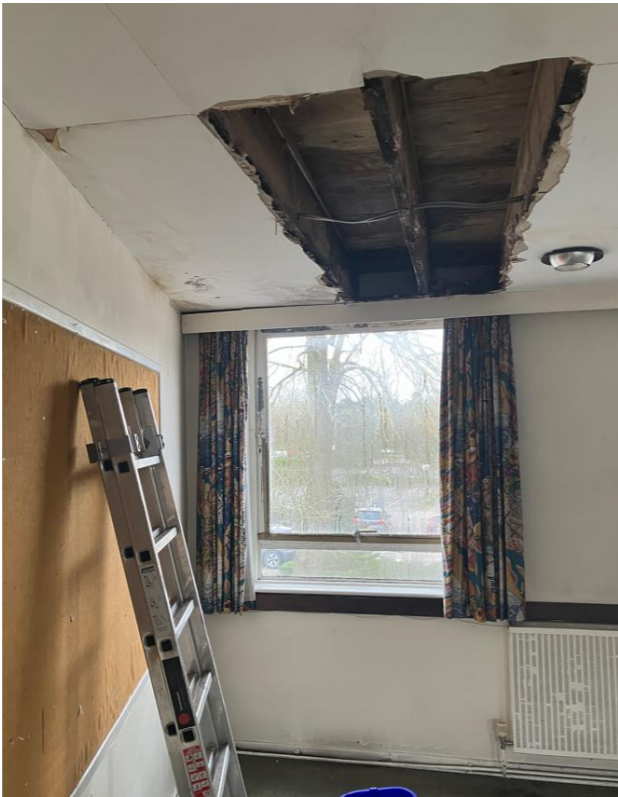
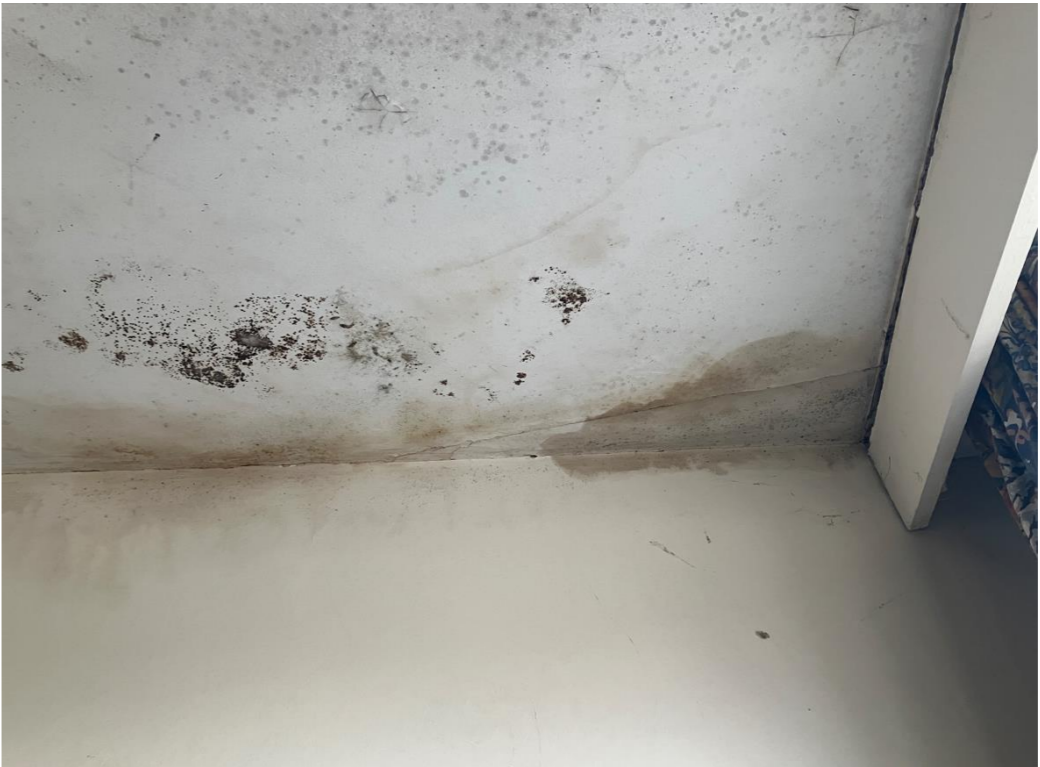
NEW-1	The 'New Room' at first floor, facing east on NE corner	NEW-2	Ceiling view in the NE corner showing mould deposits due to chronic water penetration

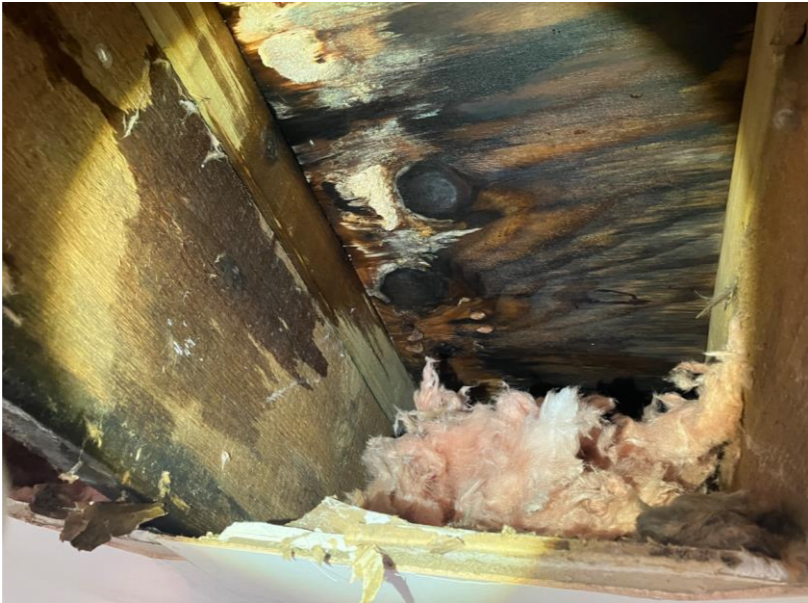
NO PHOTO	
NEW-3	Ceiling view in the NE corner showing active water penetration and mould forming on underside of flat roof ply boarding

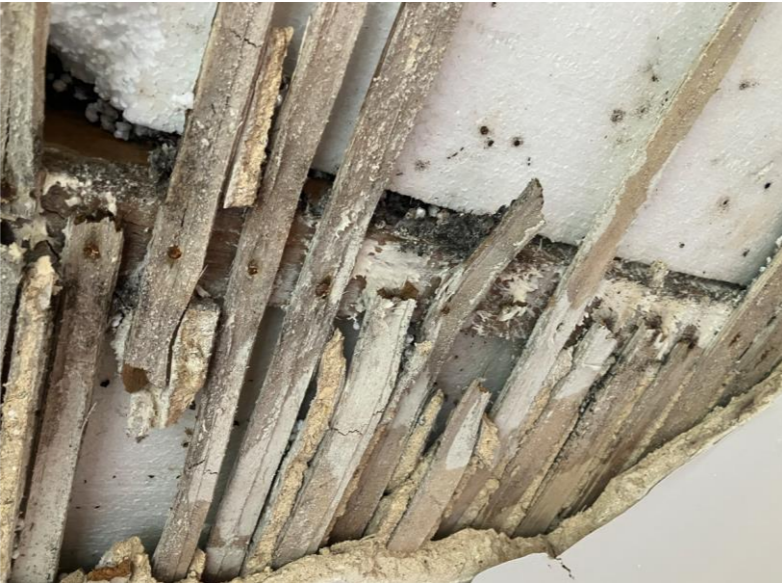
NO PHOTO	
OFF-2	View of the ceiling above the offices on the north side of the hall, showing major water damage and signs of possible dry rot spores
