Water Lane Hall Bishops Stortford

Condition Reports

East Herts District Council

60739177
WLH-ACM-XX-XX-RP-SE-001

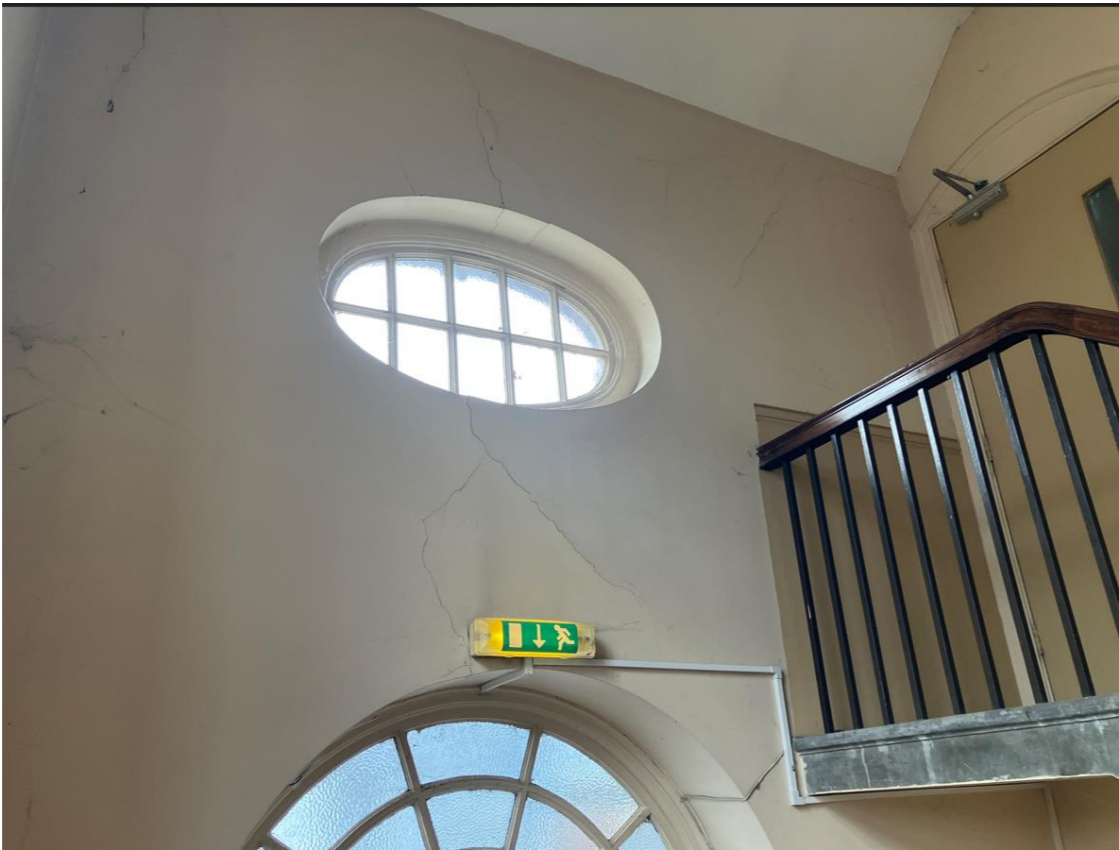
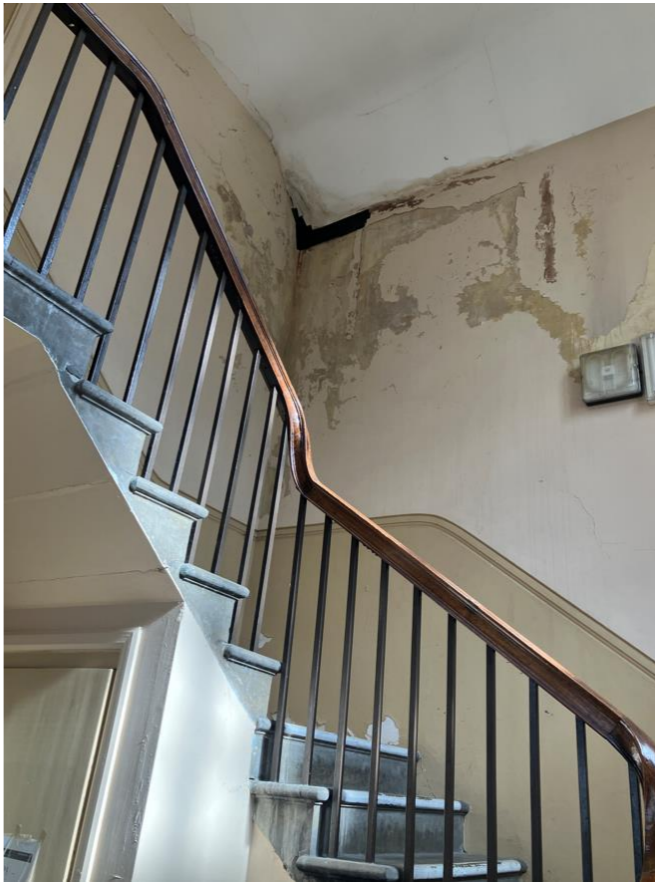
SW-1	View inside the staircase / entrance lobby on the southwest corner, showing cracking on the west facing wall	SW-2	View inside the staircase / entrance lobby on the southwest corner, showing water damage to the internal east wall

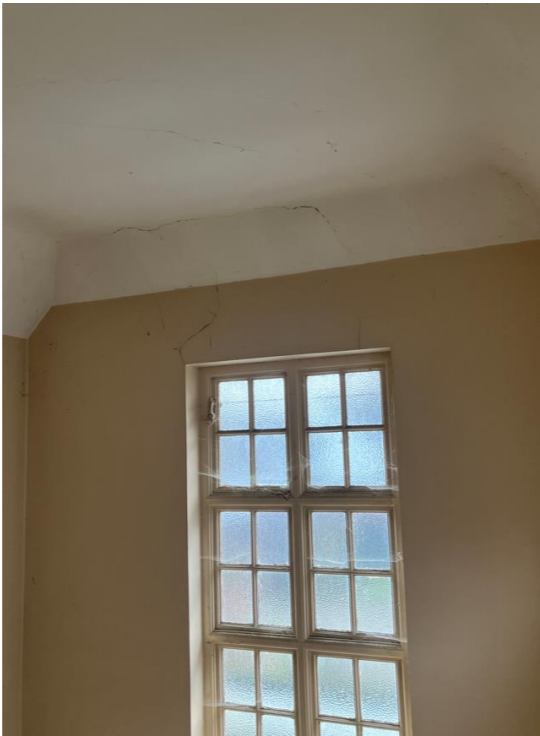
NO PHOTO	
SW-3	View inside the staircase / entrance lobby on the southwest corner, showing cracking on the south facing wall	-

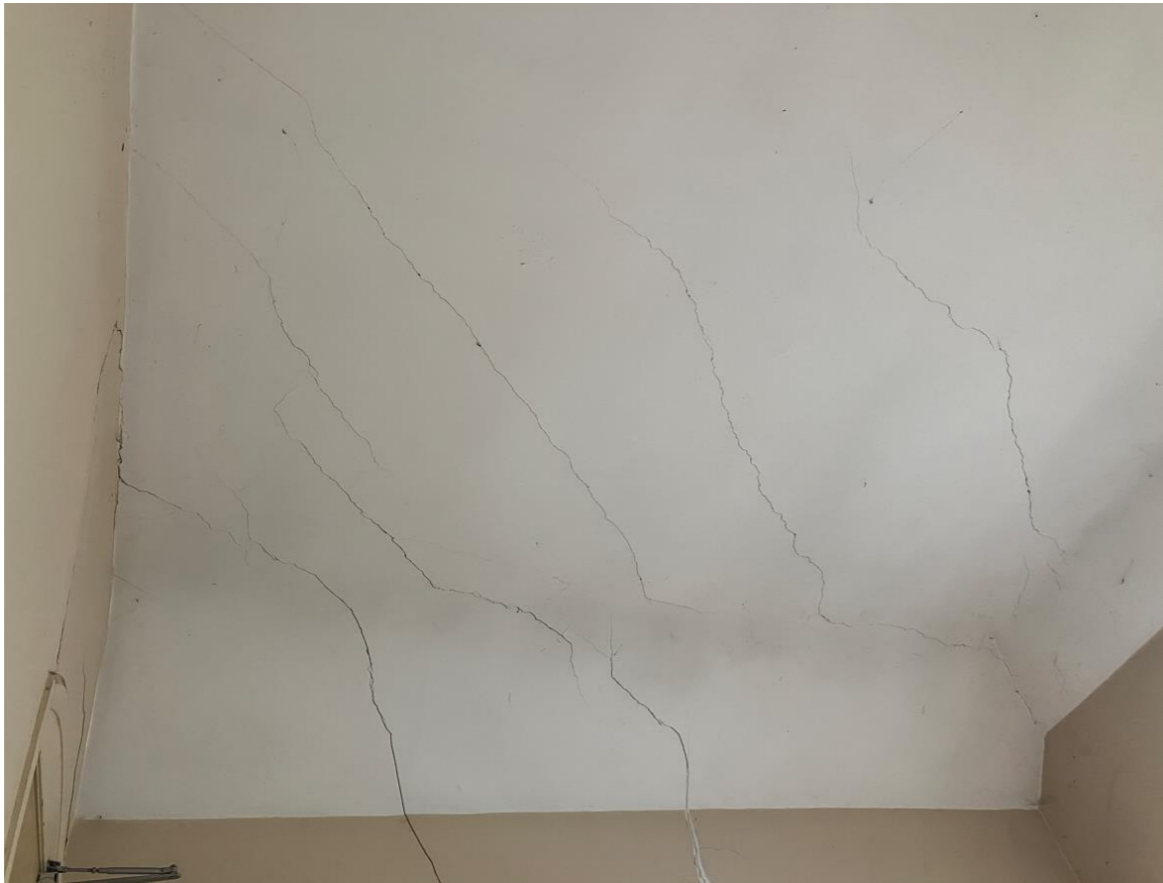
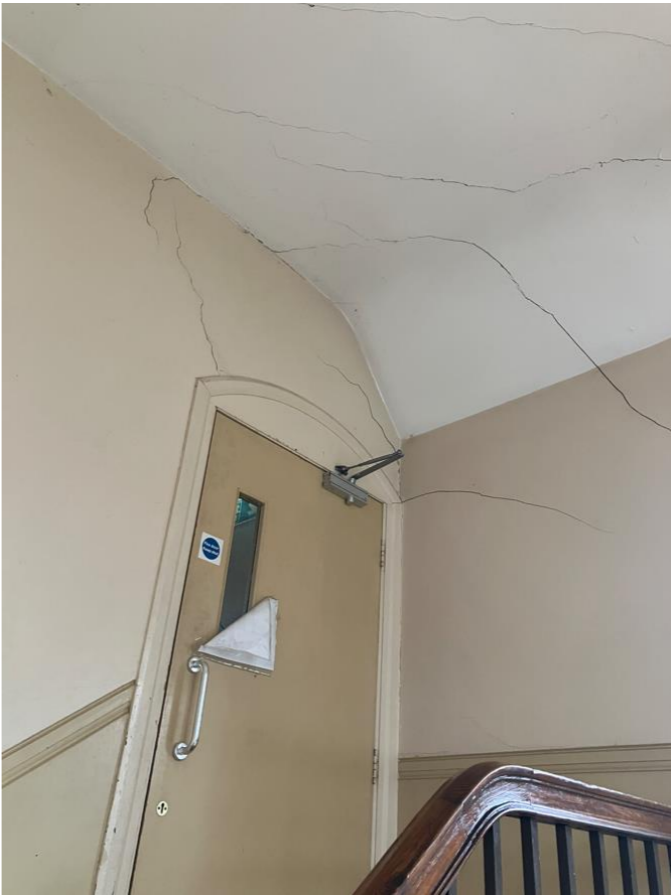
NW-3	View inside the staircase / entrance lobby on the northwest corner, showing cracking to the ceiling above the external (west) wall. The cracking forms a stretching pattern indicating possible dropping of the external wall on the NW corner	NW-4	Previous photo refers

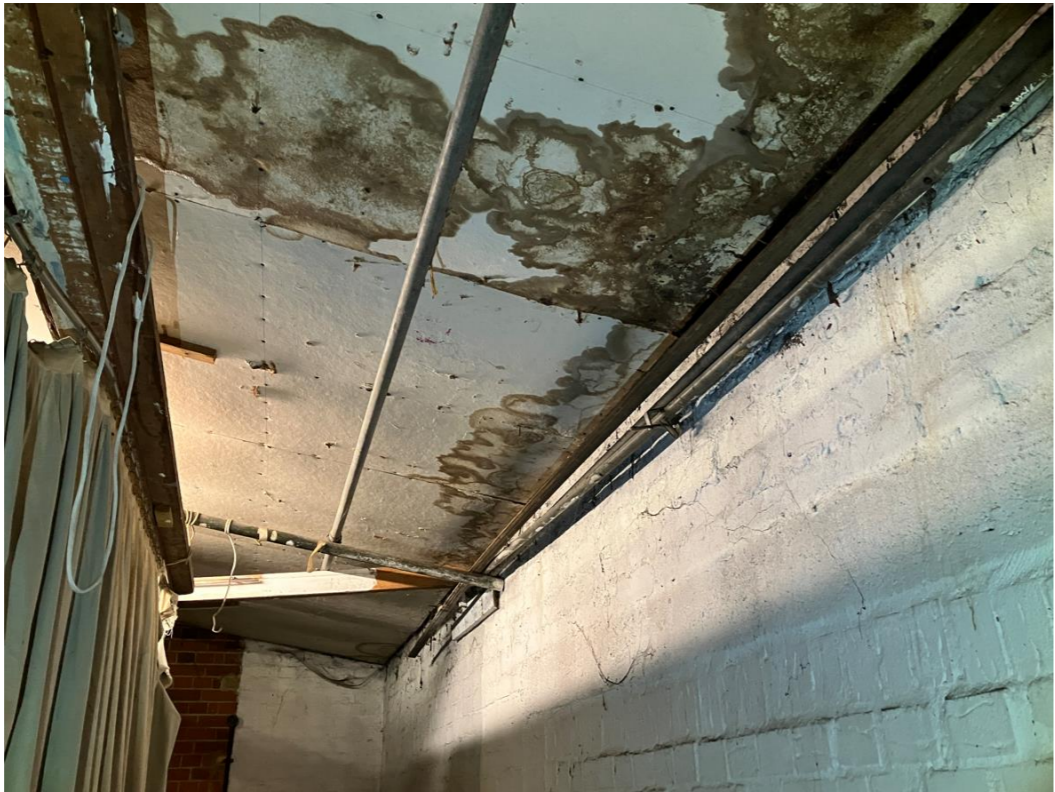
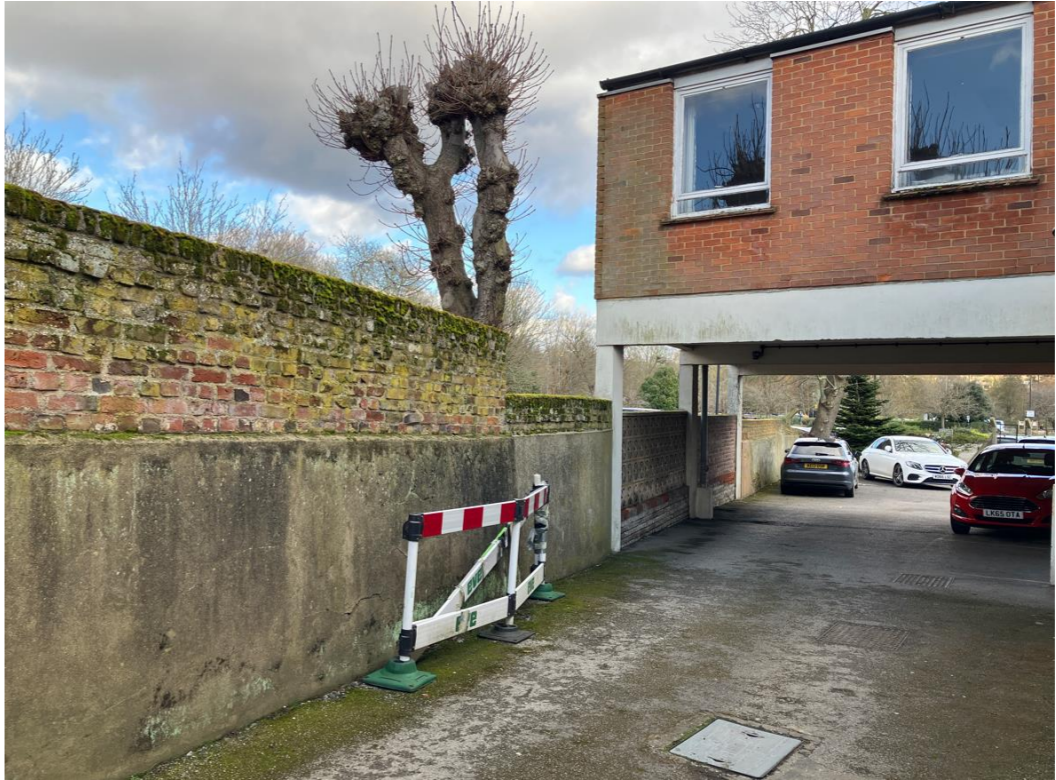
ST-1	View on rear (east) wall behind the hall stage, showing water staining from water penetration. Condition of the roof structure is not known.	EXT W1	View looking northeast on the freestanding brickwork boundary wall between Water lane Hall and the adjoining car park
