# EAST HERTS COUNCIL HERITAGE AT RISK REGISTER

Updated October 2025

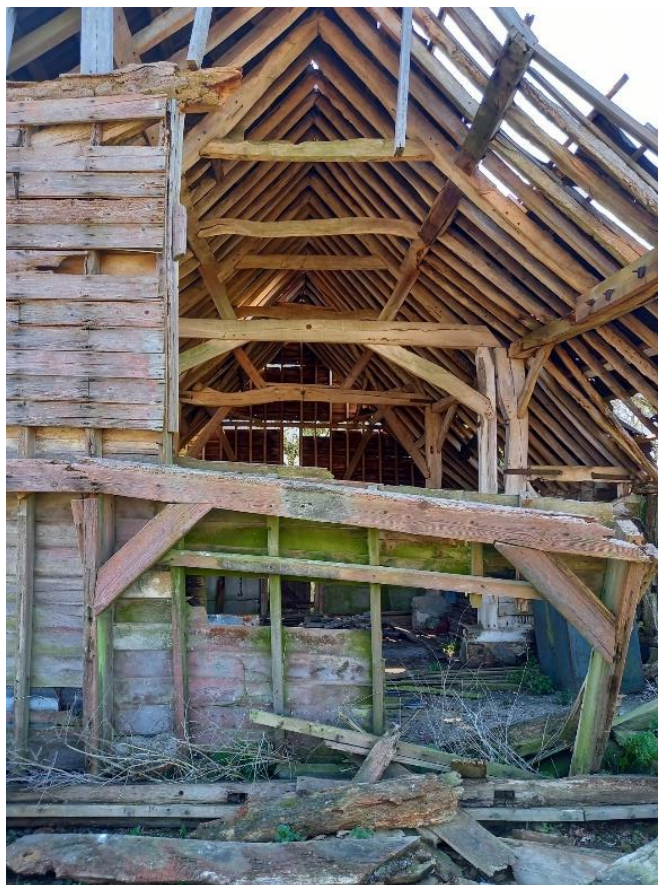
**Description:** Grade II. C17 or earlier timber-framed, weatherboarded with corrugated asbestos roof, all on a brick plinth. Three bays remain of what was an eight-bay barn. Double aisled. One gabled entrance remains in the most northerly bay.

- Prop structure / repair frame with new framing where necessary
- Replace missing roof sheeting / replace rood covering
- Repair / replace weatherboarding
- Record building
- Long-term use needs to be found to ensure full repair and future maintenance

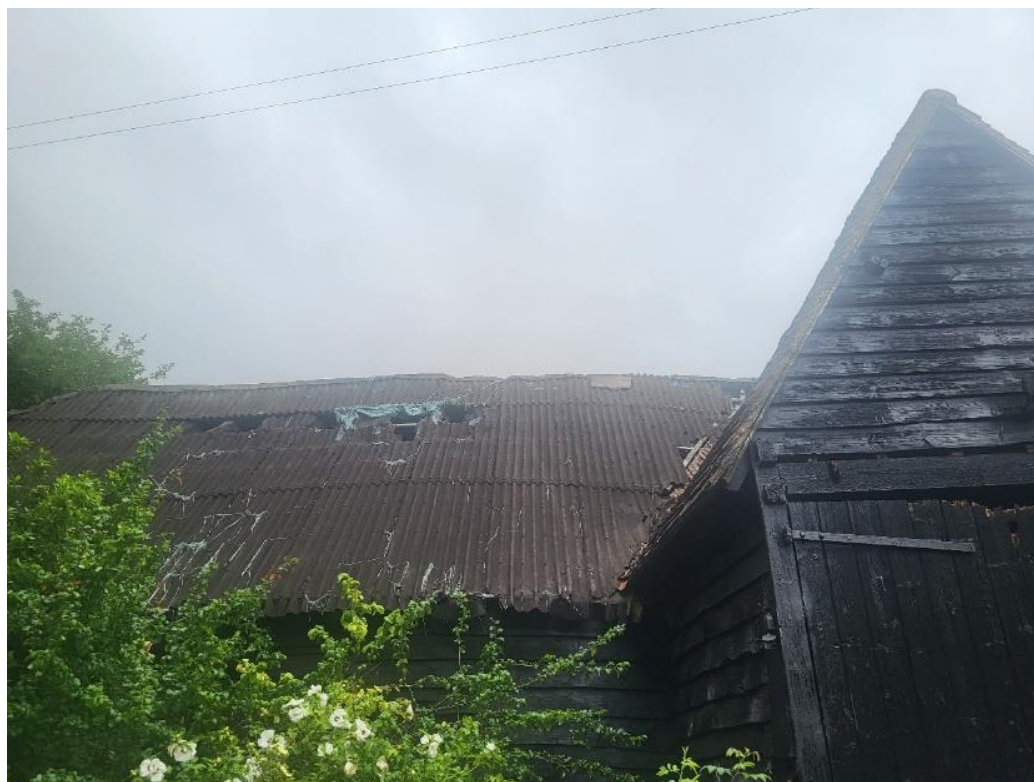
**Description:** Grade II Barn and two stables in one range. Early C17. Timber framed dark weatherboarded. Steep pitched roofs. Barn has old red tiles to gabled front porch but corrugated iron elsewhere (half-hip at South). Short stable at North end of barn also roofed in corrugated iron. Long stable at North thatched with hipped North end. A tall six-bay barn facing East with gabled front porch with double-doors and small winnowing door in rear wall of same bay. Jowled posts with straight braces to cambered tie-beams. Inclined queen-posts to clasped purlin roof. Some re-used timbers. An impressive group of old farm buildings.

**Works required:** The roof covering has holes in it and is not watertight on the main barn and adjacent two storey element. Single-storey stable roof is watertight, but thatch mentioned in description has some years ago been changed to corrugated metal. The timber frame especially in the main barn is in poor condition, showing signs of buckling above plinth/sole plate level, but has been propped internally with scaffolding.

**Latest update:** New addition. Owner to investigate feasibility of the replacing the degraded corrugated roofing with an alternative temporary roof covering as well as exploring feasibility of longer term works to the roof and the frame.

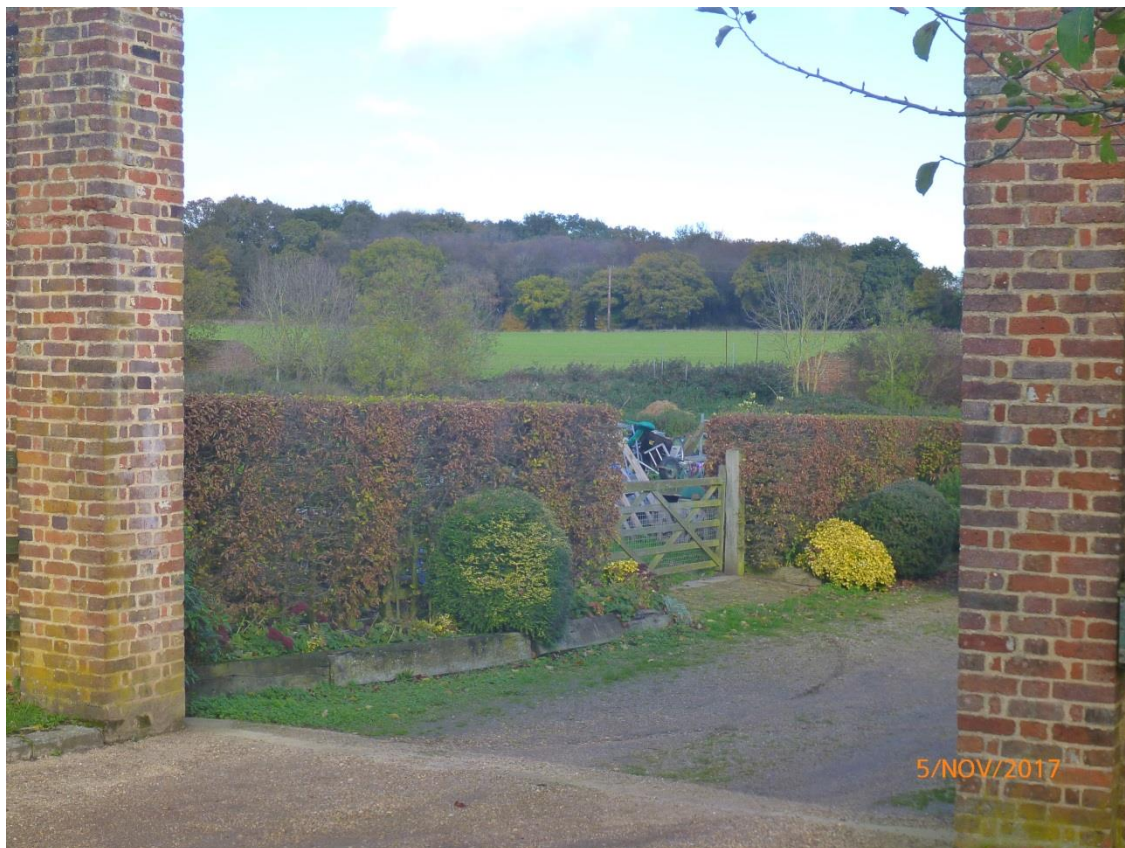
**Description:** Grade II. Former kitchen garden wall dating from about 1785. Part of the garden wall has collapsed. Cottage and the rest of the garden wall are in good condition. Owner advised us that many works had been carried out to other sections of walling and that restoration of this element was a future project.

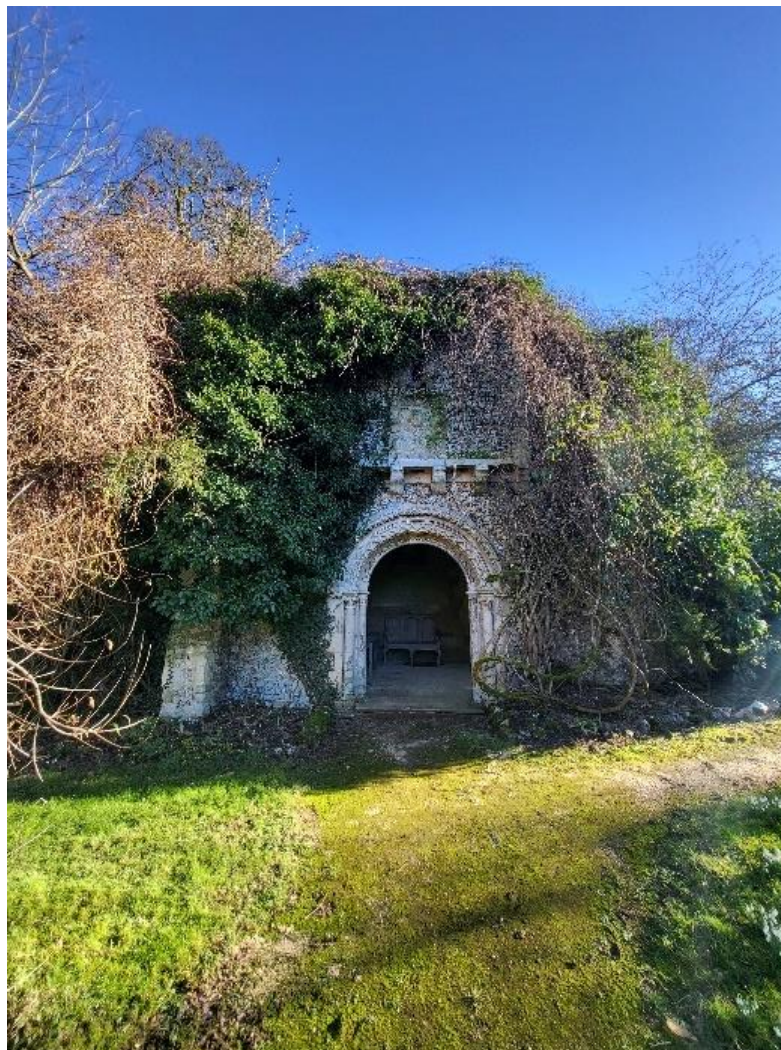
**Description:** Grade II Summerhouse and adjoining curtain wall. Mid-C19th by James Pulham for the Proctor family.

**Works required:** Overall objective – secure consolidation and safety of ruin and prevent ongoing deterioration. Significant split in flint wall needs repairs. Remove vegetation. Obtain specialist advice regarding consolidation and safety.

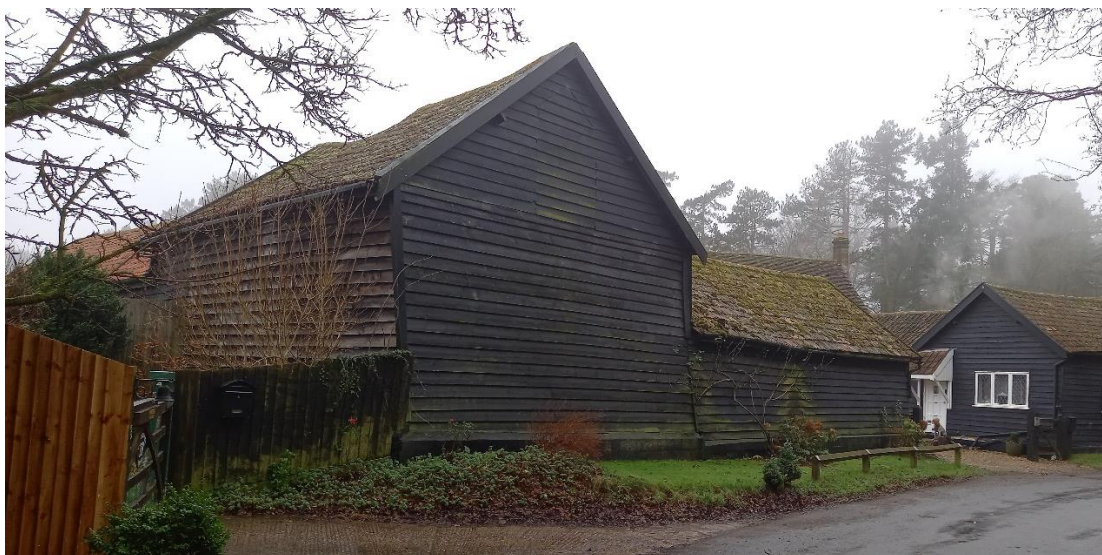
**Description:** Curtilage listed Farm buildings. C18/19th. Post and truss construction. Timber frame on a brick rendered sill, weatherboarding to the exterior. Doorway face into farmyard. Pantile gabled roofs. Three buildings attached to one another, L-shaped next to roadside with a third part attached at the rear. Owned by Cheynes Farmhouse.

**Latest update:** Listed Building Consent granted for repairs to all farm buildings (3/25/0151/LBC). Not yet implemented.

- Repair / replace brick base
- Repair roof
- Repair gutters
- Repair doors
- Repair tie beam and reinstate post and brace to cartshed.

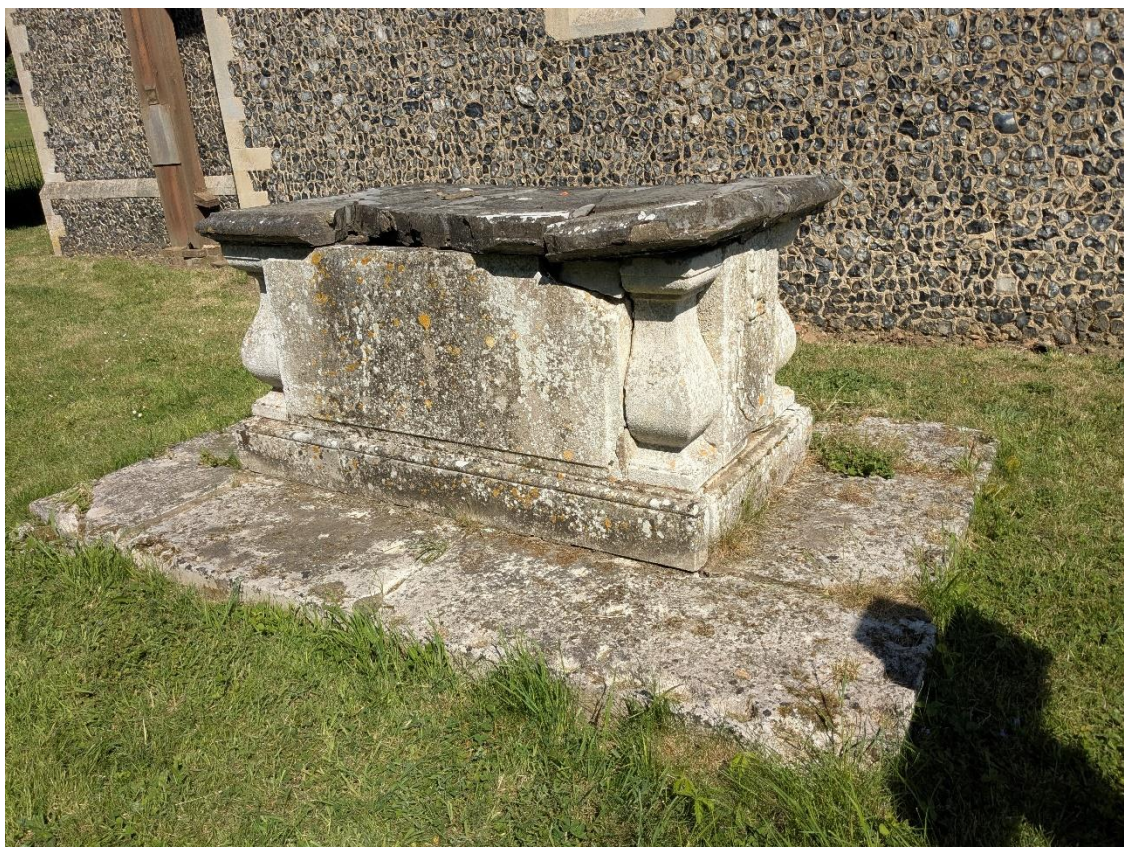
**Description:** Grade II. Tomb. 1789. Stone tomb chest with inset baluster corners and moulded top slab, to William Frampton, Merchant of the City of London.

**Latest update:** Grass and vegetation cleared from the tomb but there is masonry damage and repairs are required.

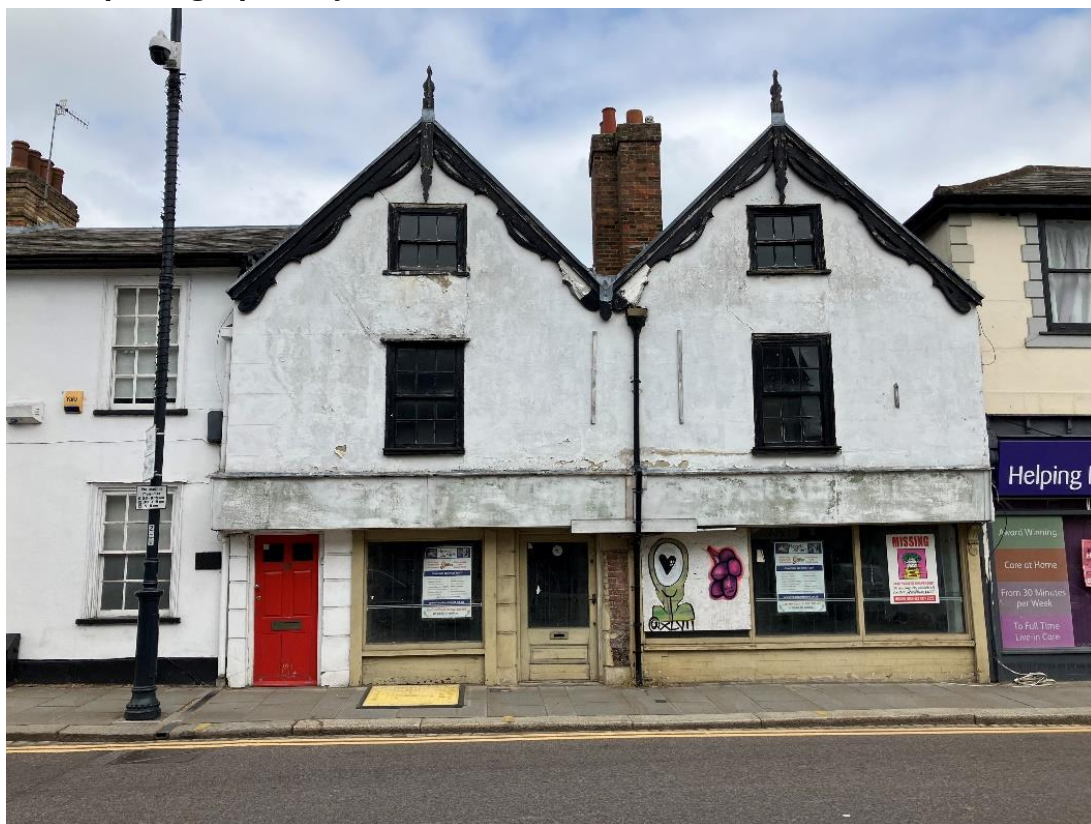
**Description:** Grade II House, now shops and offices, early C17th, altered C19th and extended C20th. Timber-framed and stuccoed, double gabled old tiled roofs, with early C19th Gothick moulded and traceried barge boards and cut pinnacle finials and pendants, facing street, Welsh slated, C19th raised infill between gables at rear. Red brick chimneystack of 2 back-to-back shafts with oversailing band and orange clay pots centre right. Double-depth plan with 2 bay jettied front.

- Assessment of general condition throughout
- General renovation to be habitable
- Repairs to roof and rainwater goods
- Repairs or replacement of shopfront

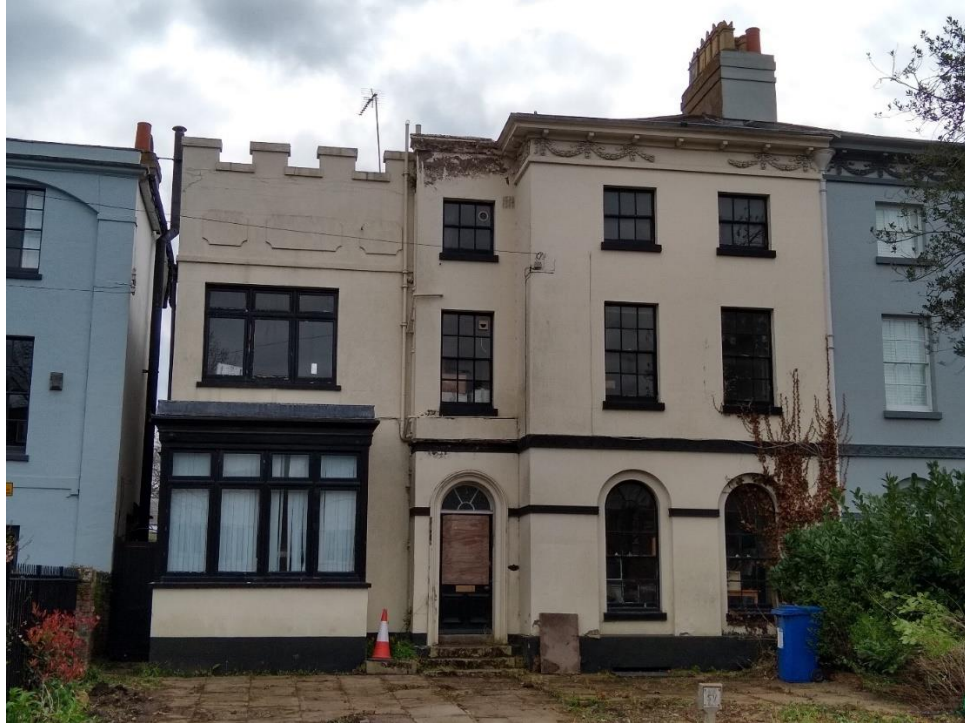
**Description:** Grade II. One of a pair of semi-detached houses. c1825, with C20th alterations and extensions. Stuccoed front below hipped Welsh slated roofs above moulded cornice, with widely spaced modillions and central stuccoed multi-flue chimneystack. 3 storeys, 4-bay front, with recessed single bay 3-storey wings, with later 2-storey extensions left and right with castellated parapets. Second floor has 4 recessed 6-pane sash windows, with band and swag frieze above; first floor has 4 recessed 12-pane sash windows above band with honeysuckle ornament. Ground floor has 4 recessed 15-pane sash windows, with semi-circular heads, set within outer arched recess with projecting impost band, stucco plinth. Entrance doors below semi-circular fanlights. Later wings, early C20, have projecting bay windows on ground floor. This development of semi-detached housing was part of the growth of Hertford along North Road towards the County Hospital during the late 1820s. It was shown as 'North Crescent' on an 1830 map.

- General renovation
- Assessment of rainwater goods and roof
- Assessment of damp / rot throughout
- Repair doors and windows

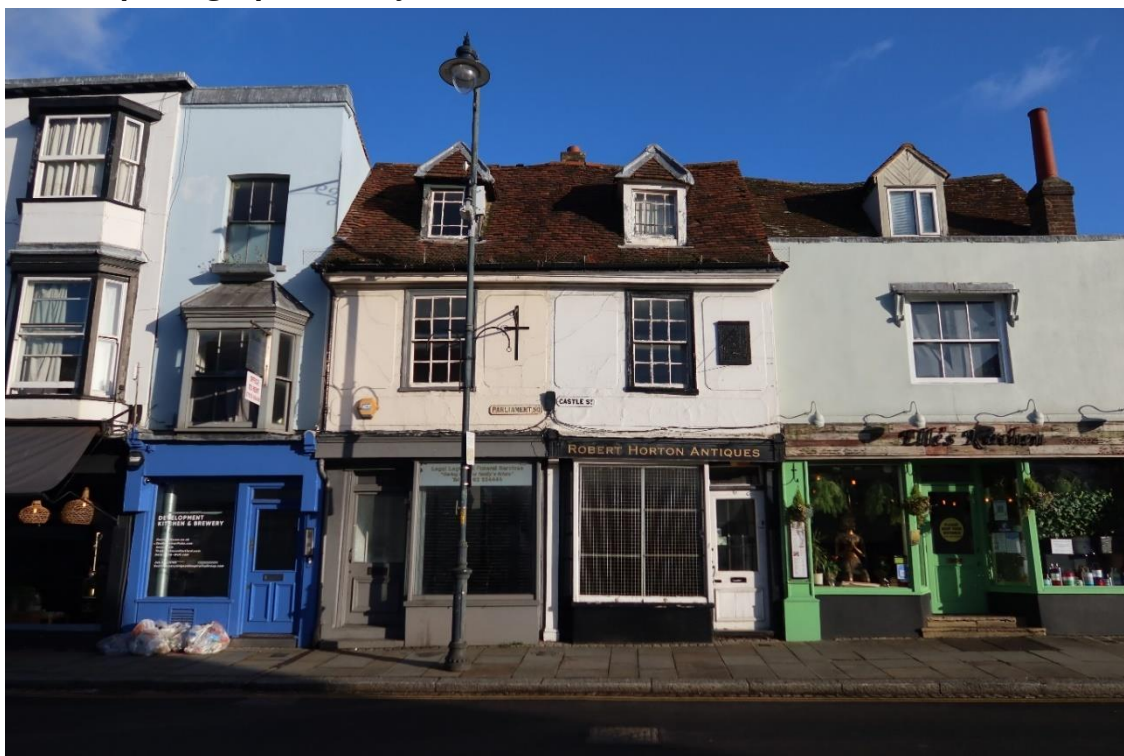
**Description:** Grade II. One building, formerly houses, now shops. C16th, substantially rebuilt early-C18th, extended and altered C19th. Timber-framed, plastered, old tiled roofs with moulded eaves cornice at front. First floor has 2 flush-set 12-pane sash windows with architrave surrounds, with plastered front divided into large, raised panels. Jettied first floor with C19 shopfronts on ground floor below, and fascias on bressummer. Timber framing exposed inside both shops; in No.13 Castle Street downward curved bracing indicates C16th origin of building, which incorporates a lower 2 bay outshut with a pegged rafter roof. No. 25 Parliament Square has a central chamfered beam with tongue stop above ground floor, steep winder stair alongside fireplace and party wall, wide boarded cambered first floor, corner fireplace.

**Latest update:** New addition. A temporary roof has been installed, and permission has been given to carry out full roof repairs but not yet carried out.

- General renovation including to timber-frame.
- Repairs to roof and gutters.
- Repairs to windows.

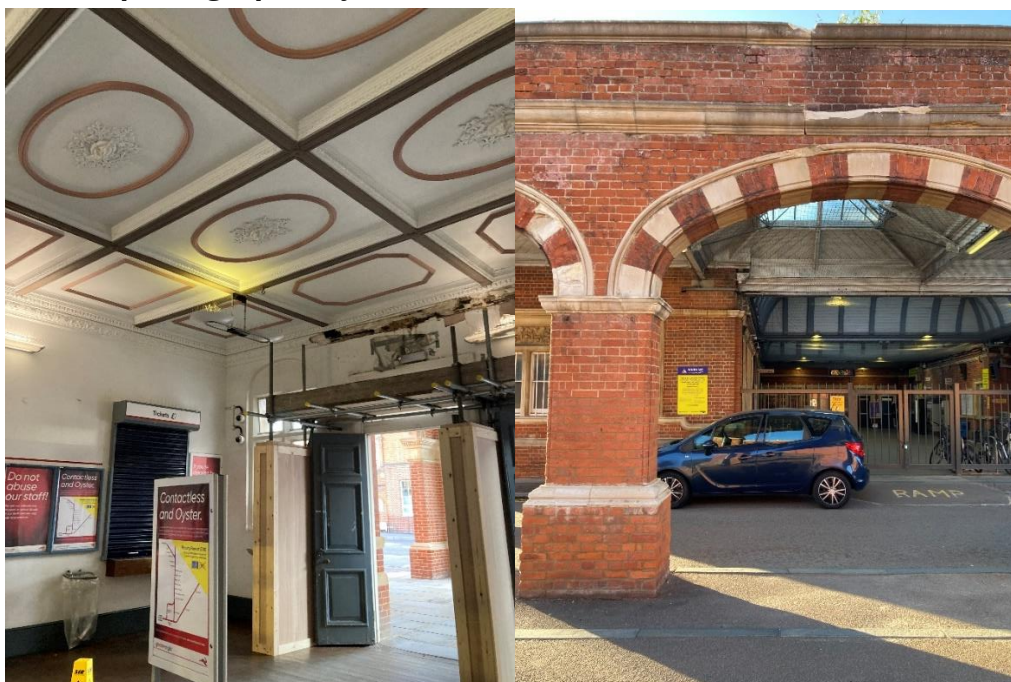
**Description:** Grade II Railway station with terminal booking hall, concourse, porte cochère, platform canopies and screen walls. 1888, with C20 alterations. Built for the Great Eastern Railway. Architect WN Ashbee (d.1919).

**Latest update:** New addition. Schedule of repair works being drawn up by the railway company.

- Addressing water ingress to booking hall roof/ceiling.
- Addressing vegetation at roof level.
- Check general condition of stonework and brickwork and repair where necessary.

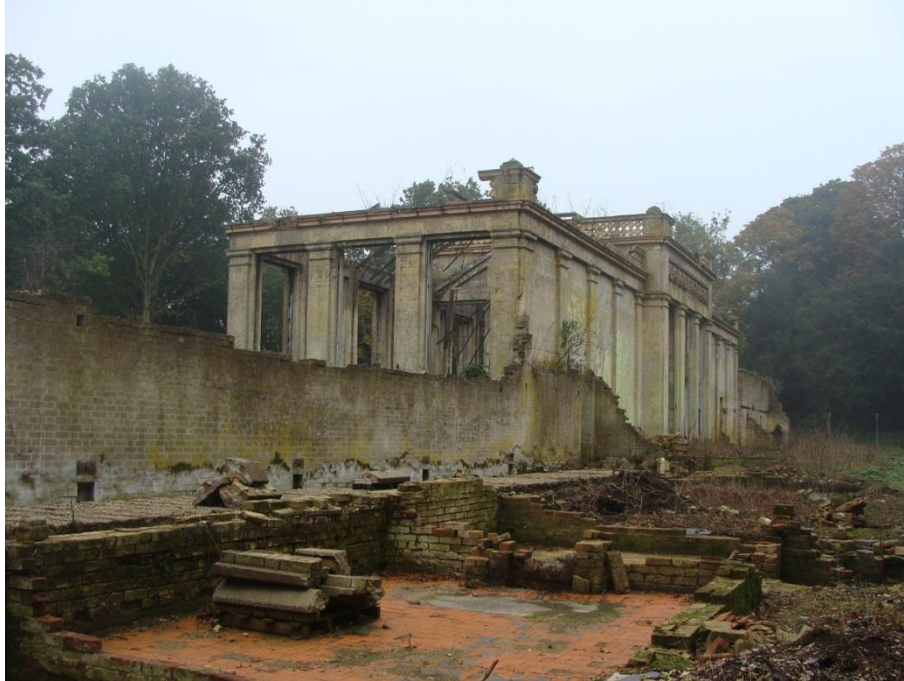
**Description:** Grade II. Mid-C19th former Orangery and Conservatory to Panshanger House for the 7th Earl Cowper in classical style with rich distinctive detailing. Formal gardens once lay south of Orangery leading on to landscaped grounds and Mimram valley laid out by H. Repton, 1799-1801. Panshanger House demolished mid-C20th; footprint still exists adjacent to the Orangery.

**Works required:** A clear vision for the future of this unique building is needed. It should be returned to its original use, or to a use that complements the form of the building. A potential candidate for consideration of an associated enabling development, possibly involving the replacement of Panshanger House. Further strategic discussions needed that work with the Country Park use of the wider site and respect the significance of the designed landscape.

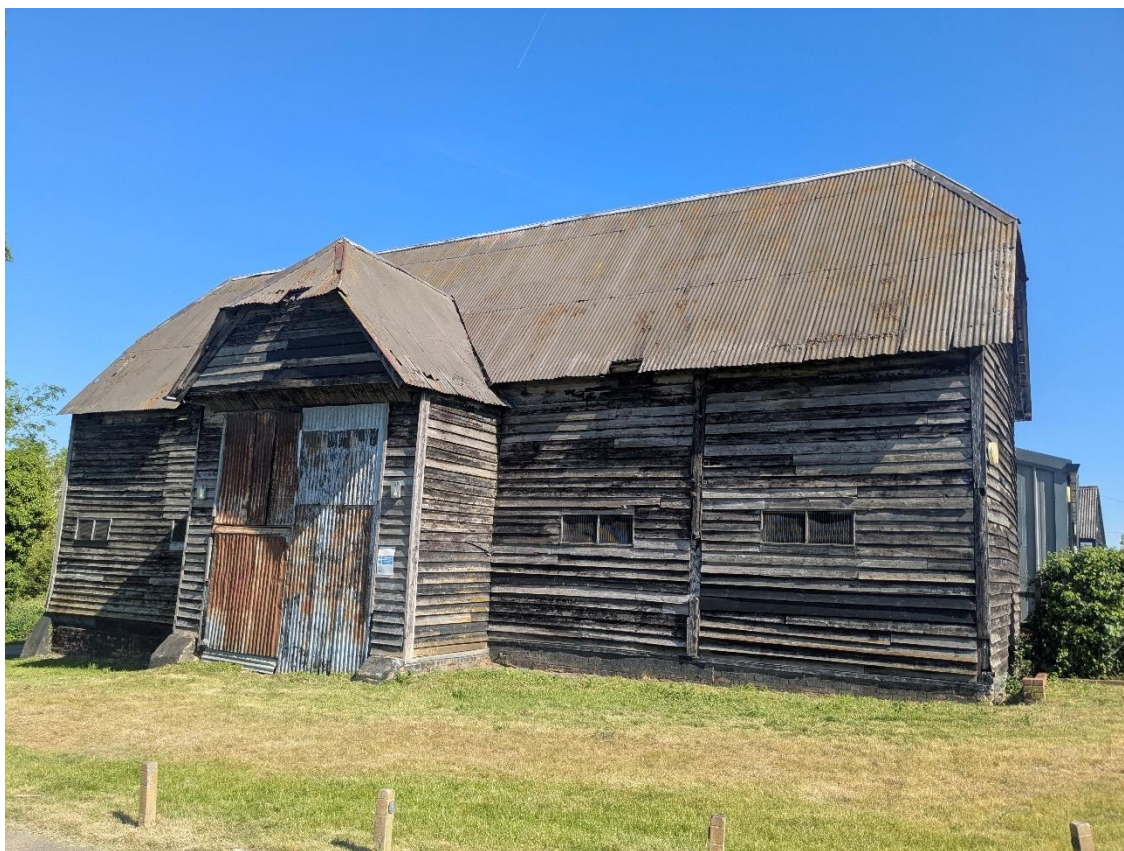
**Description:** Grade II. Barn. C17th. Timber framed on a brick sill, weather-boarded. Steep pitched corrugated roof, half-hipped at ends. Projecting central porch with half-hipped roof and overhanging gable. Double doorway to porch currently without doors. Clasped purlin roof structure with collars and inclined queen struts. Long curved braces from posts to tie beams.

- General renovation
- Assessment of damp / rot throughout
- Assessment to condition of timber frame
- Repair / replace weatherboarding and roof covering
- Repair / replace doors

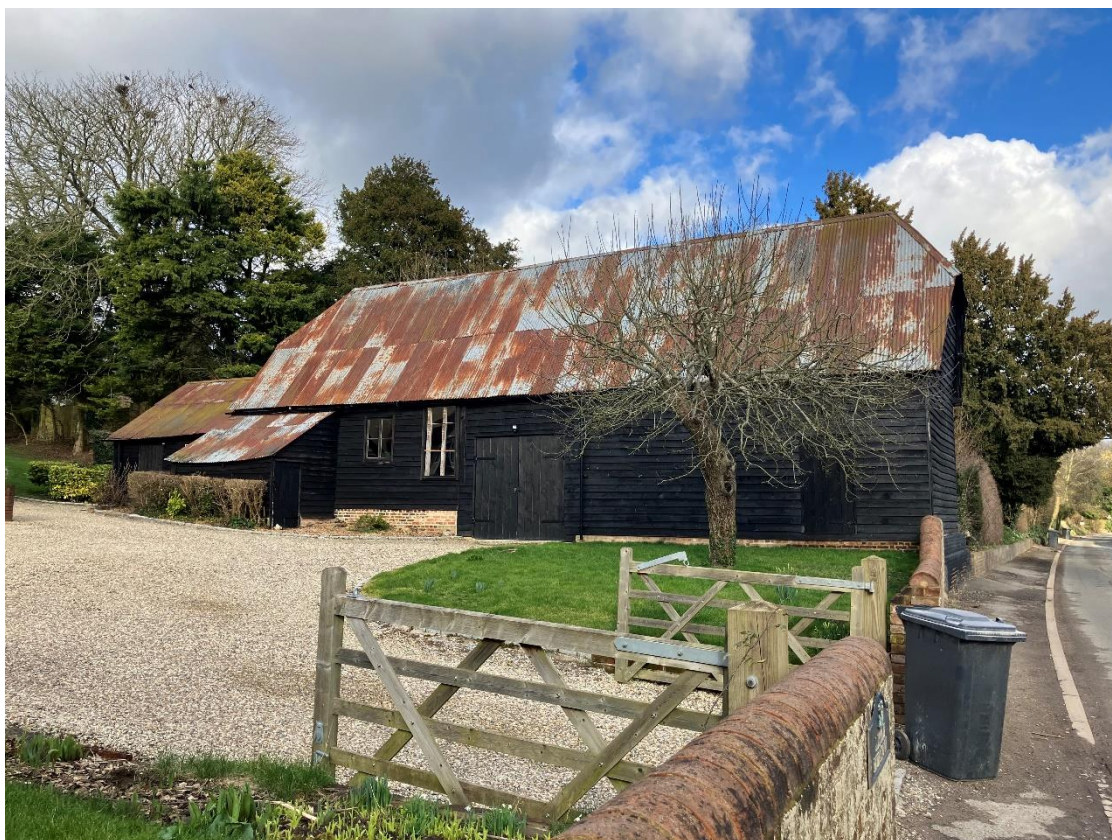
**Description:** Grade II. Barn. C17th. 5-bay. Timber frame on tarred offset brick plinth. Part externally weather-boarded, part corrugated iron walls. Steep half-hipped corrugated iron roof. Central bay rear outshot opposite the central double doors. Jowled posts, long curved braces to tie-beams, clasped purlin roof with thin rafters. Mid height rail staggered with straight tension braces above and below. Face-halved bladed scarf joint in wall plates. Owned by Little Meadow.

**Latest update:** 3/19/0854/LBC granted that does not appear to have been implemented however the lean-to on the southwest elevation has been removed and weatherboarding and doors reinstated on the southwest elevation. The overall condition has improved.

- General renovation
- Assessment of damp / rot to timber frame and roof structure
- Repair / replace weatherboarding including some reinstatement
- Replace roof covering

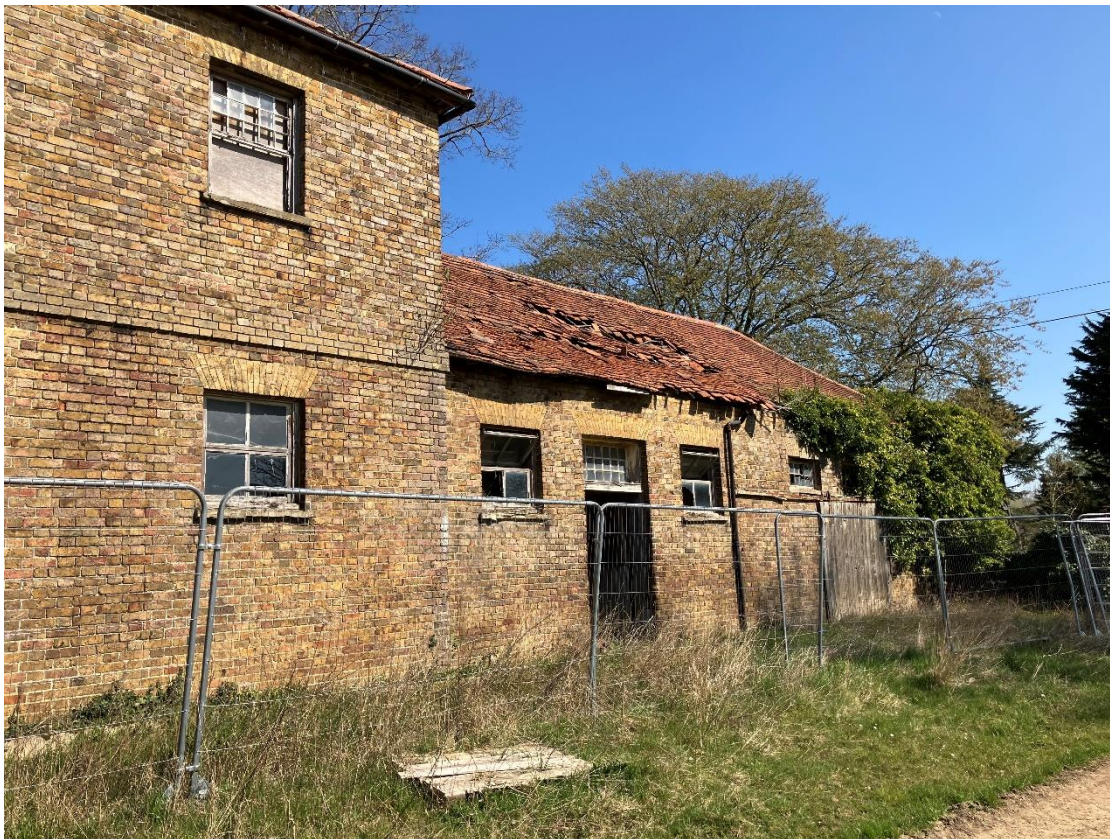
**Description:** Grade II. Stables attached to separately listed central granary and further stables. Early C19th. Brick stable range with hipped red tile roof. Four boarded stable doors with multi-light fanlights under a yellow brick gauged arch. Flanked by small high-set windows, each under a yellow brick gauged arch.

**Latest update:** Further deterioration of roof covering, windows, and sills.

- General renovation, or to be made watertight
- Assessment of damp / rot to roof structure
- Repair / replace roof covering
- Repair / replace doors and windows

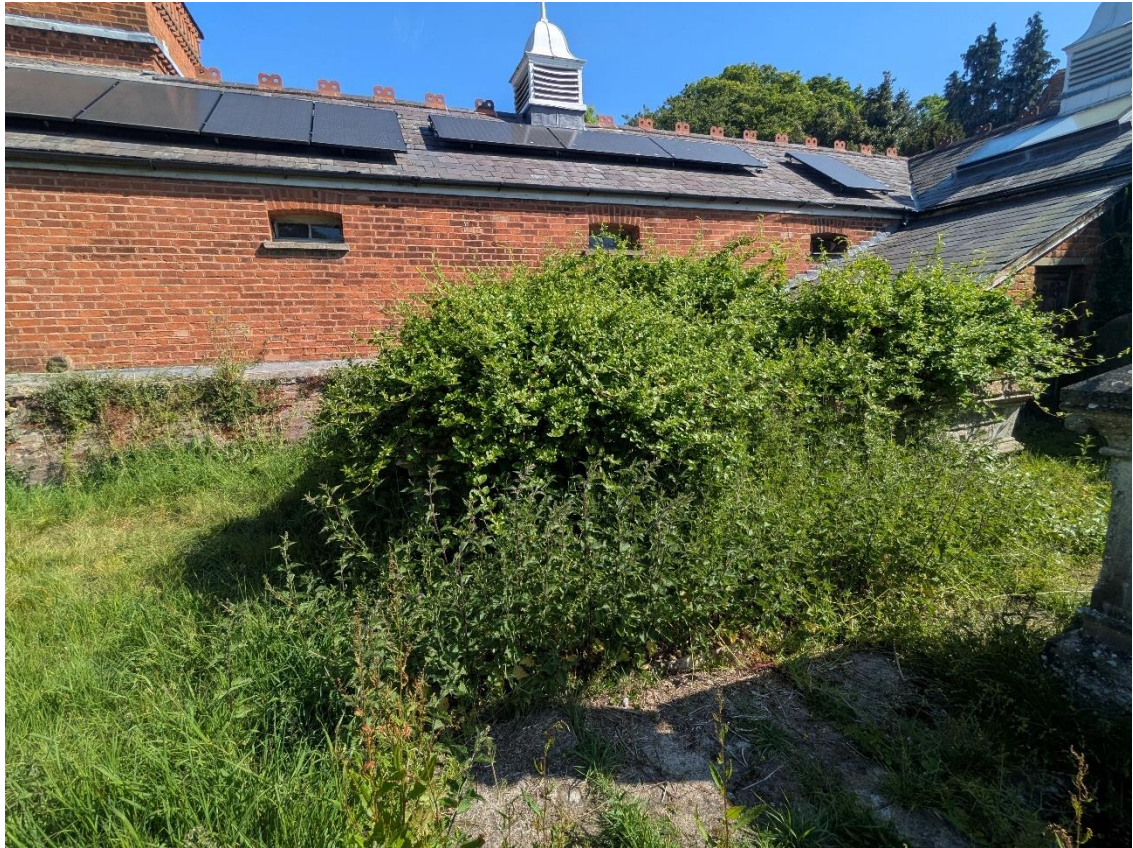
**Description:** Grade II. Monument. 1881. White limestone, hard plaster mouldings to surrounding wall. Rectangular Gothic tomb chest within a stone walled enclosure. Random squared rubble walls, freestone quoins, base topped by a heavy ogee base moulding. Row of five trefoil pierced stones in the middle of long side. Heavy series of plaster capping mouldings. Upper part with foliate recumbent cross carved in high relief. Lombardic lettered inscription to Walter family. Significant vegetative growth needs to be removed.

- Contact Hunsdon Parish Council and the Rector of St Dunstan's Church
- Assess stability and damage by tree stump
- General restoration
- Complete removal of vegetation from the monument
- Long term maintenance to be agreed

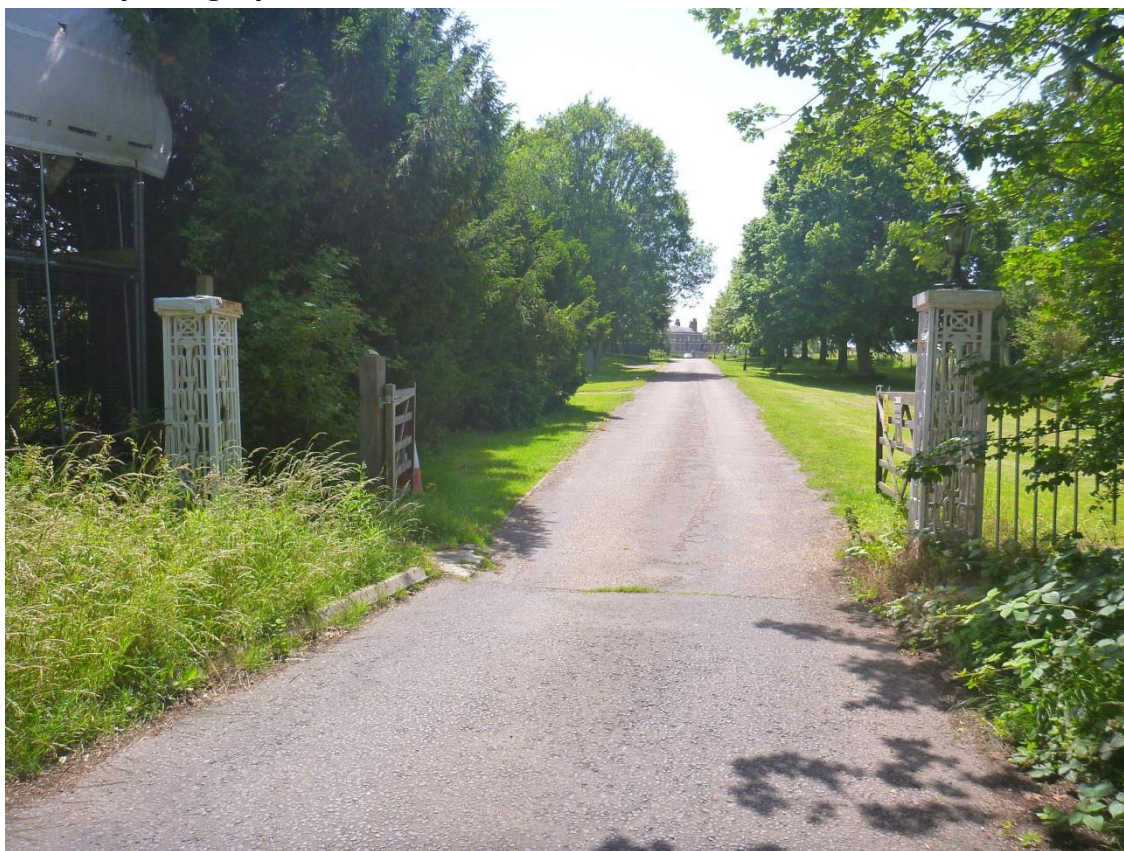
**Description:** Grade II. Gates and gate piers. Early C19th. Neo-classical cast iron gates and piers at entrance to North Drive at Briggens. Tall openwork cast iron piers in the form of tapered square pylons on ball feet, a saltire with superimposed oval at top and bottom, and a stylized anthemion ornament up each face within a margin of rosettes, all topped by deep flat square caps. Similar side railings sweep down to lower terminal piers of cast iron of similar design to the higher piers. Gates have been removed.

- General repairs to surviving piers and side railings
- Repair and reinstatement or replacement of gates and pier
- Replacement of missing railings

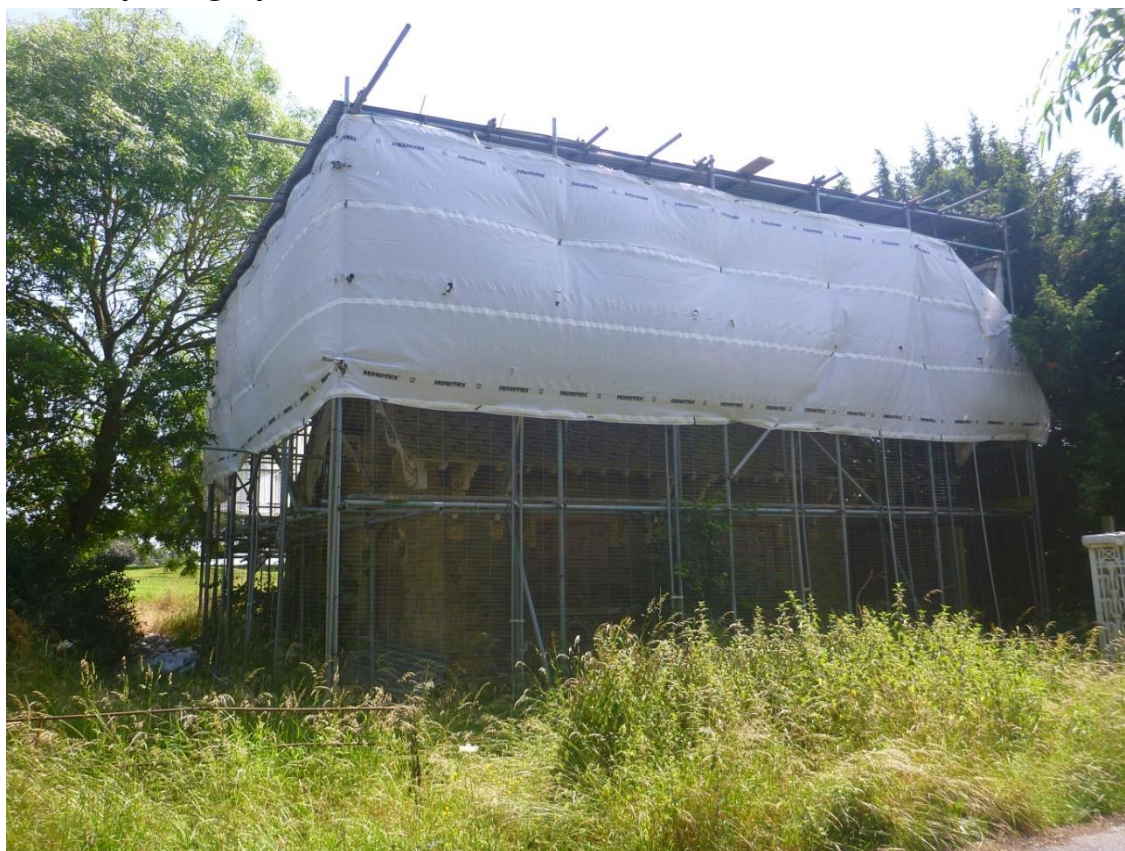
**Description:** Grade II. Lodge. Mid-C19th. Single storey grey brick Tudor style gate house at the entrance to the North Drive. Low pitched gabled roofs of large patent scalloped buff tiles. Stone coat of arms over the door with motto 'Pro Ars et Focis' and a serpentine, pierced wooden bargeboard with finial to the roof overhang. Tall brick central chimney with 2 square shafts. Similar details on lower gabled wing set back to E. (Note: For other lodges at Briggens see Stanstead Abbots parish).

**Latest update:** No change to condition, but the building has been secured and a temporary roof protection installed.

- General renovation to be habitable
- Assessment of damp / rot throughout and condition roof structure
- Longer term repairs to roof and guttering
- Repair or replace windows and doors

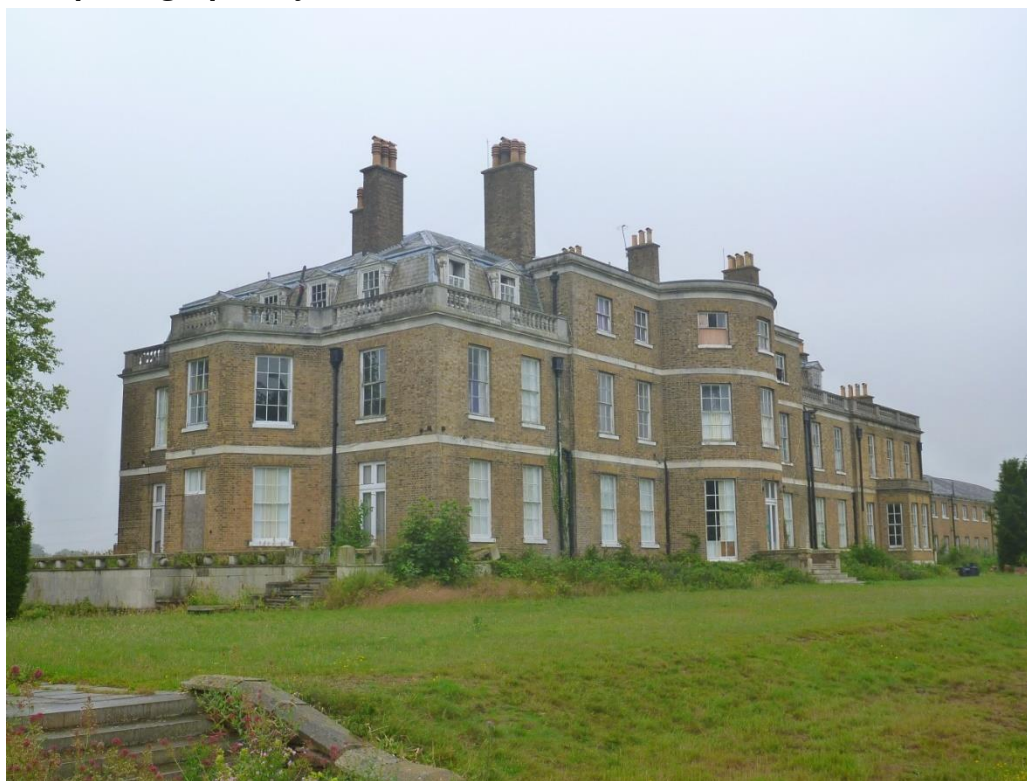
**Description:** Grade II. Country House. Circa 1719 by the mason Christopher Cass (1678-1734) for Robert Chester, a director of South Sea Company: 2-bay N and S blocks and 2nd floor added for Thomas Blackmore probably c1770. N end and W side extensions in 1899: alterations 1908. On hilltop site facing W in a landscaped park designed by Charles Bridgeman in c.1720. Grey brick with stone dressings, hipped slate roof, Portland stone upper terrace on S end overlooking a tank of York stone. 3 storeys above basement, 7 windows front. Balustrade of low square piers with stone rails between supported on stone balls.

**Latest update:** No change to overall condition, but the house has been secured, and some localised temporary works to address water ingress have been carried out.

- General renovation to be habitable
- Assessment of damp / rot throughout
- Assessment to condition roof structure
- Repairs to roof and guttering
- Repair / replace windows and doors

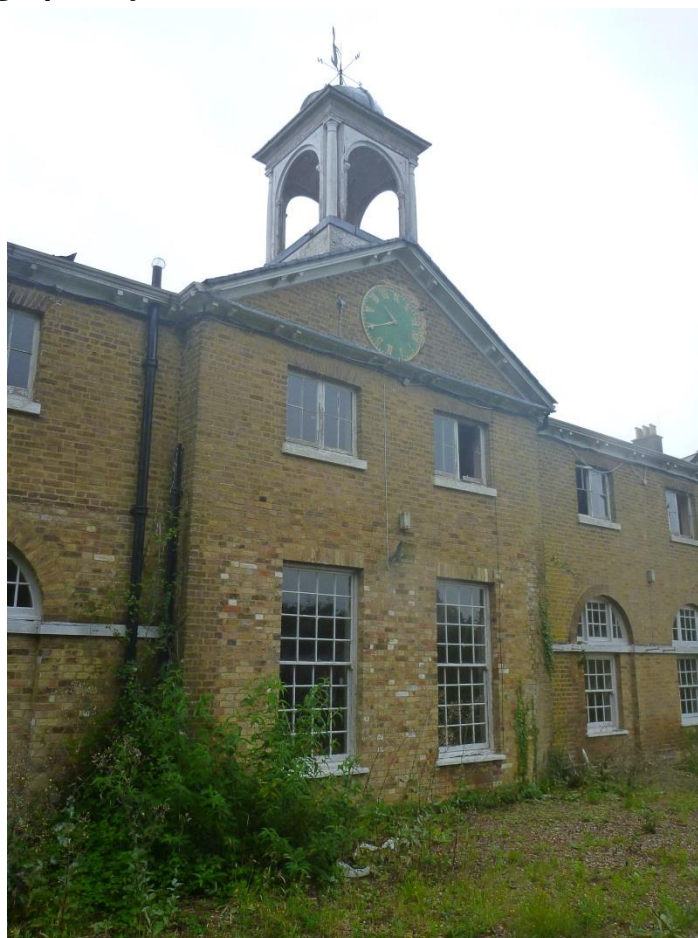
**Description:** Grade II. Stable block. C18, probably 1770 for the Blackmore family. 2 storeys. Wooden cornice with paired brackets. Rectangular block with 2-window central projection on W with triangular pediment and clockface in tympanum. White wooden square cupola over, topped by low dome and windvane with a fox. Round-headed openings in each face, dentilled cornice and Tuscan columns recessed at each corner. Bell said to be cracked. Recessed sash windows with glazing bars. Front arches now blocked and large sash windows inserted.

- General renovation to be habitable
- Assessment of damp / rot throughout
- Assessment to condition roof structure
- Repairs to roof and guttering
- Repair / replace windows and doors

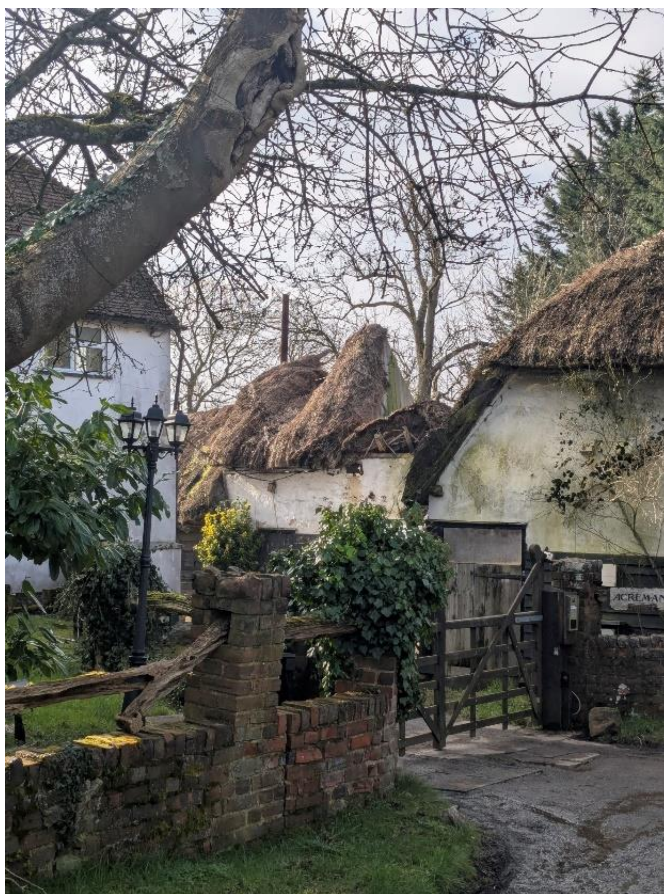
**Description:** Grade II. Farm buildings. Later C17th. L-shaped range, thatched, timber framed, on roadside. T-plan barn with longer part N-S and projection on W. Lower stables extend to E along roadside and at S end. Red brick bases in English bond, plastered walls with weather-boarded aprons to all. Barn has ventilation holes under eaves, closed by battens. Wind-vane with stork. Steep thatched roofs half-hipped at ends. All doors open to yard on SE.

**Latest update:** Rapidly deteriorating, at risk of total loss. A vehicle strike in 2021 has caused extensive damage to the range on the roadside. Building has partially collapsed. Other range also in disrepair and roof has collapsed.

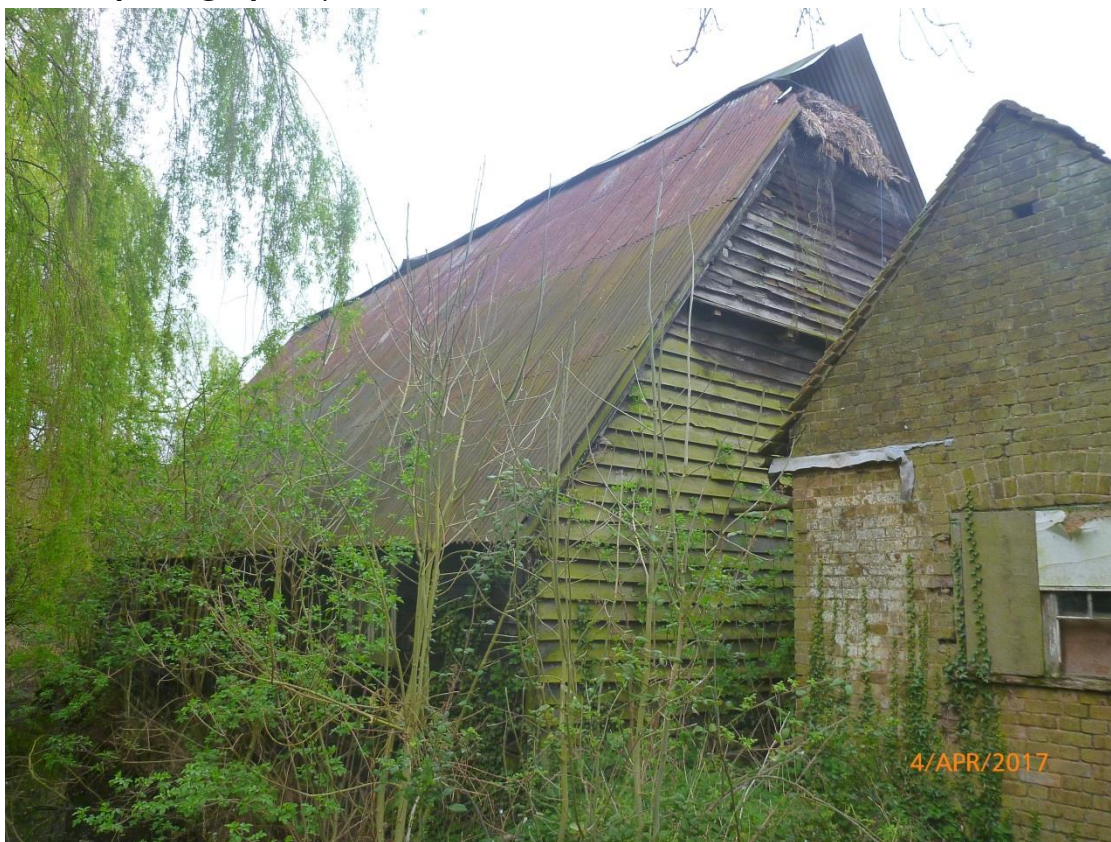
**Description:** Grade II. Aisled barn. C17th or earlier. 4-bay. Timber framed on a red brick sill, external weatherboarding. Steep gabled roof thatched with red tiled valleys to thatched gabled porch in second bay from E. Rear slope now covered in corrugated iron. Shouldered jowled posts, curved braces to tie beams and arcade plates. Thin clasped purlin roof with curved wind braces and lap jointed collars. Arcade plate scarfed over entrance with face halved and bladed scarf. Wall plates have edge-halved scarf joints with bridled butts. Owned by The Old Farmhouse.

- General renovation
- Assessment of damp / rot to timber frame and roof structure
- Repair / replace weatherboarding
- Repair / replace thatched roof
- Repair / replace doors and windows

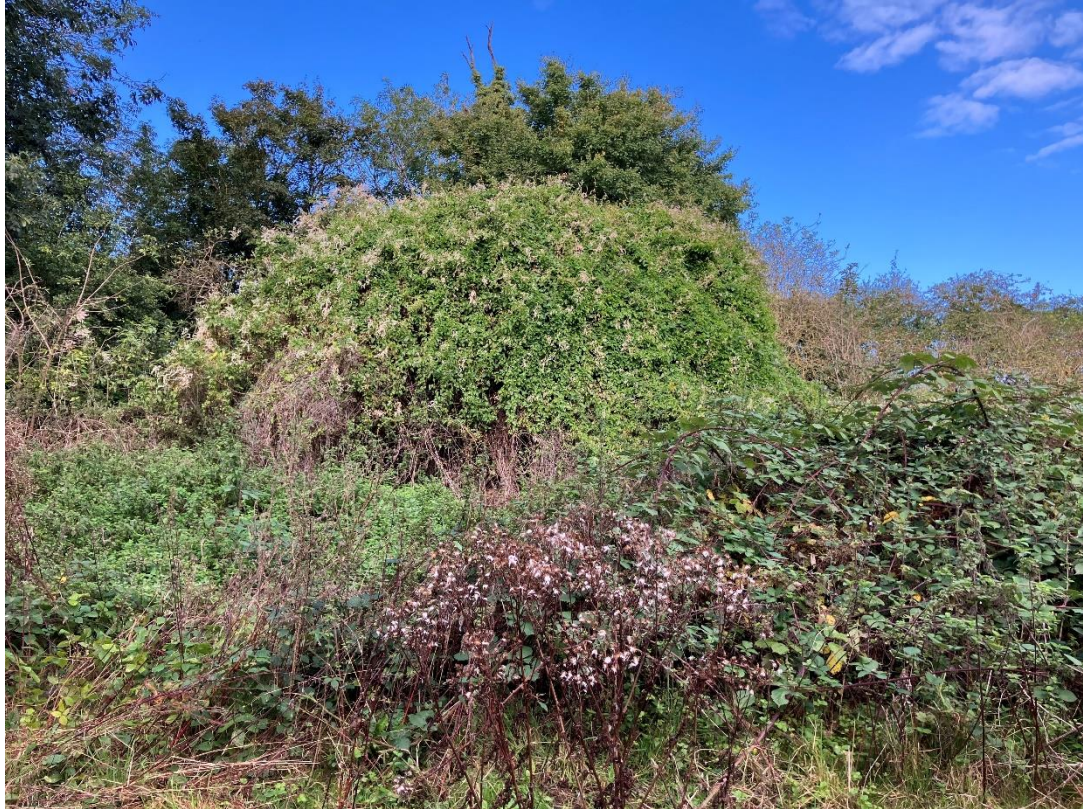
**Description:** Grade II Windmill tower. Upper part destroyed by fire in 1981. Mid-C18th. Formerly a tall 2 storeys red brick octagonal tower. In use up to 1930s. Used to represent a striking industrial monument of considerable historic and technological interest. Now only a stump remains.
