# EAST HERTS COUNCIL HERITAGE AT RISK REGISTER

Updated October 2025

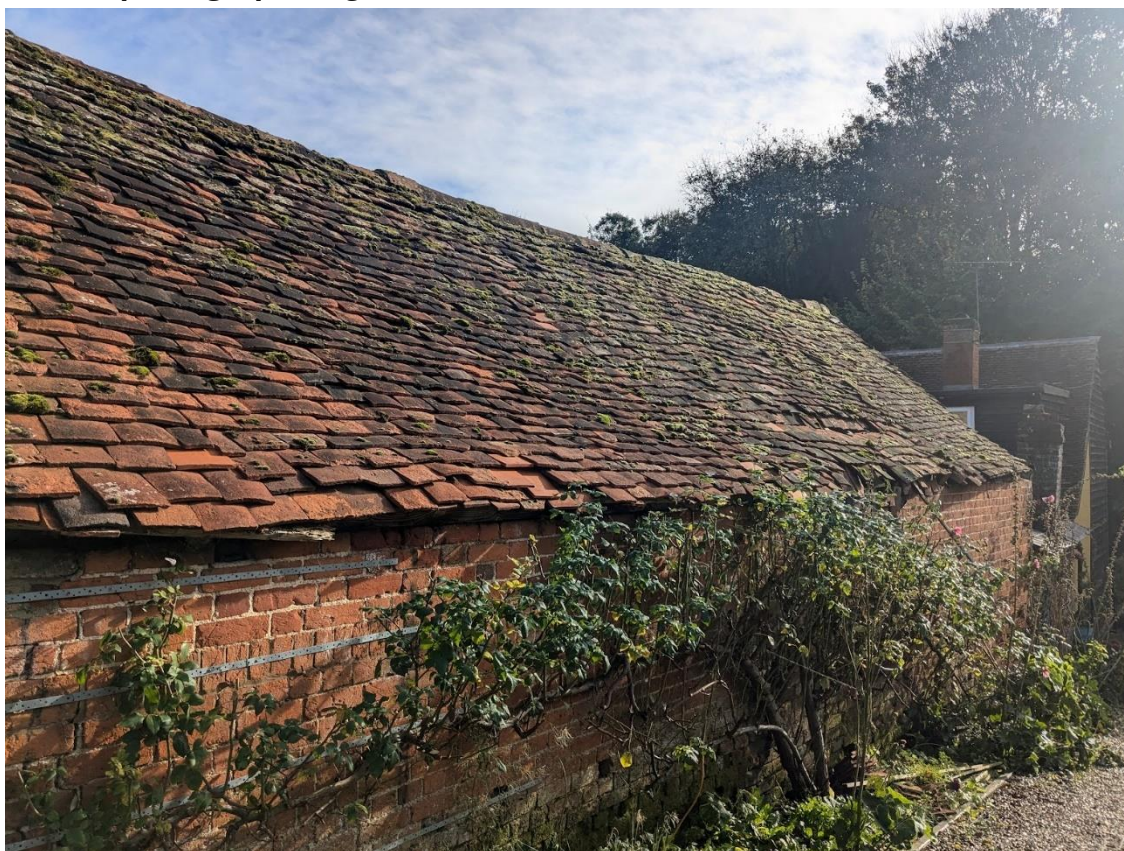
**Description:** Curtilage listed barn to the rear of main dwelling, running parallel. Red brick with clay tiles above. Evidence of prior uses including a brick chimney stack.

- Assessment of structural integrity of existing roof structure and overall structure.
- Reinstatement of tiles to replace temporary roof.

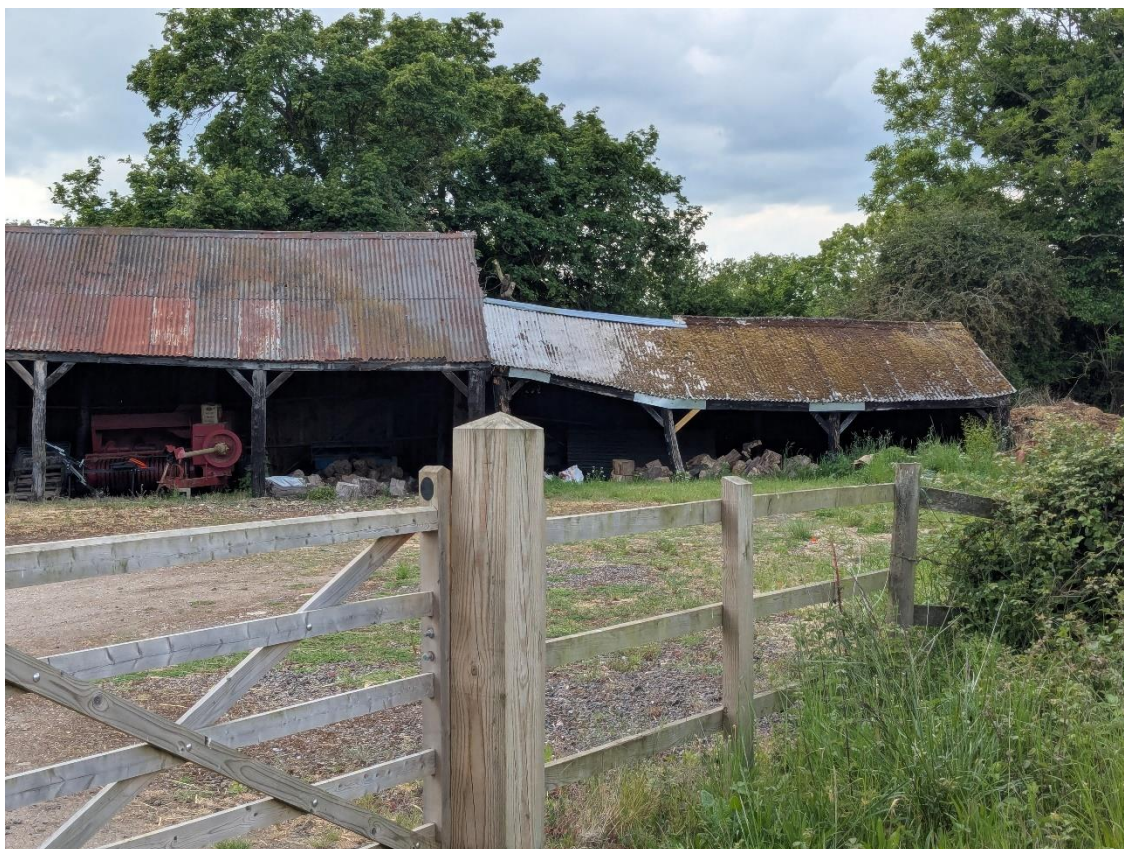
**Description:** Curtilage listed Farm buildings. C18th to C19th. Two 3-bay cart-sheds. Post and truss construction. Timber frame on a brick sill with external weatherboarding. Corrugated iron gable ended roofs. Open sided into farmyard.

**Latest update:** Condition is deteriorating.

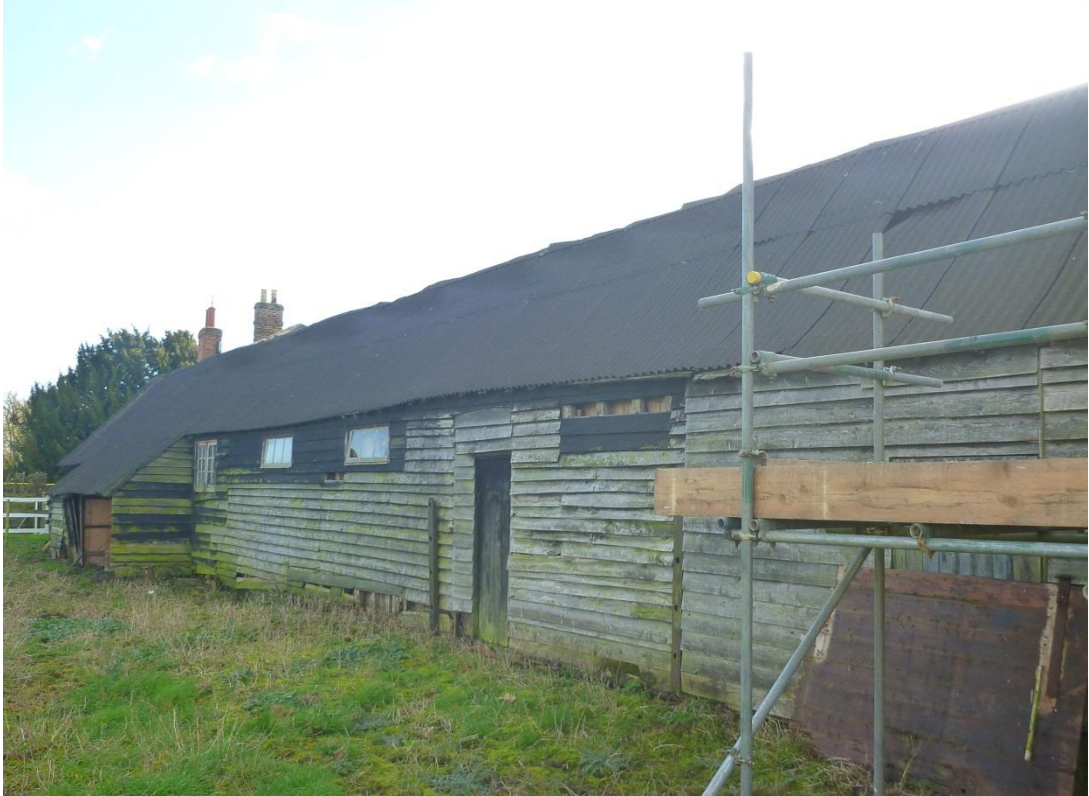
**Description:** Grade II C19th timber-framed and weather-boarded with corrugated iron roof. All elements in poor condition; roof appears to leak in places; some weatherboarding missing. Used for accommodation of 100 Shire horses in late-C19th when owner of this time had a Hackney carriage enterprise.

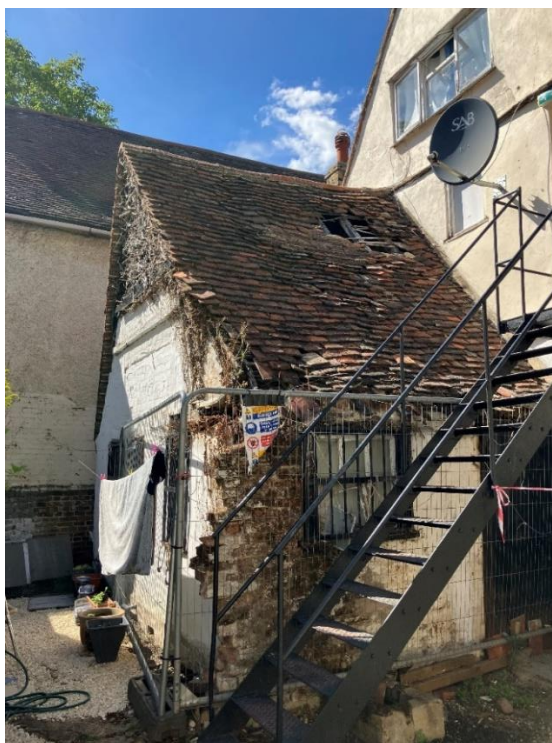
**Description:** Grade II. Former inn range, now shop with flats above. C17, altered C19 and C20. Timber-framed, stucco faced, old tiled roof with large gable end to street. Timber framed rear two storey and single storey outshoots. Access to the upper floors is now from an external metal staircase. The moulded flat hood above the central door to the east elevation has been lost and the late-C17<sup>th</sup> century internal staircase may no longer survive. The roof to the single storey outshoot has partially collapsed, external materials are either failing, deteriorating, or absent.
