Water Lane Hall Bishops Stortford

Condition Reports

East Herts District Council

60739177
WLH-ACM-XX-XX-RP-SE-001

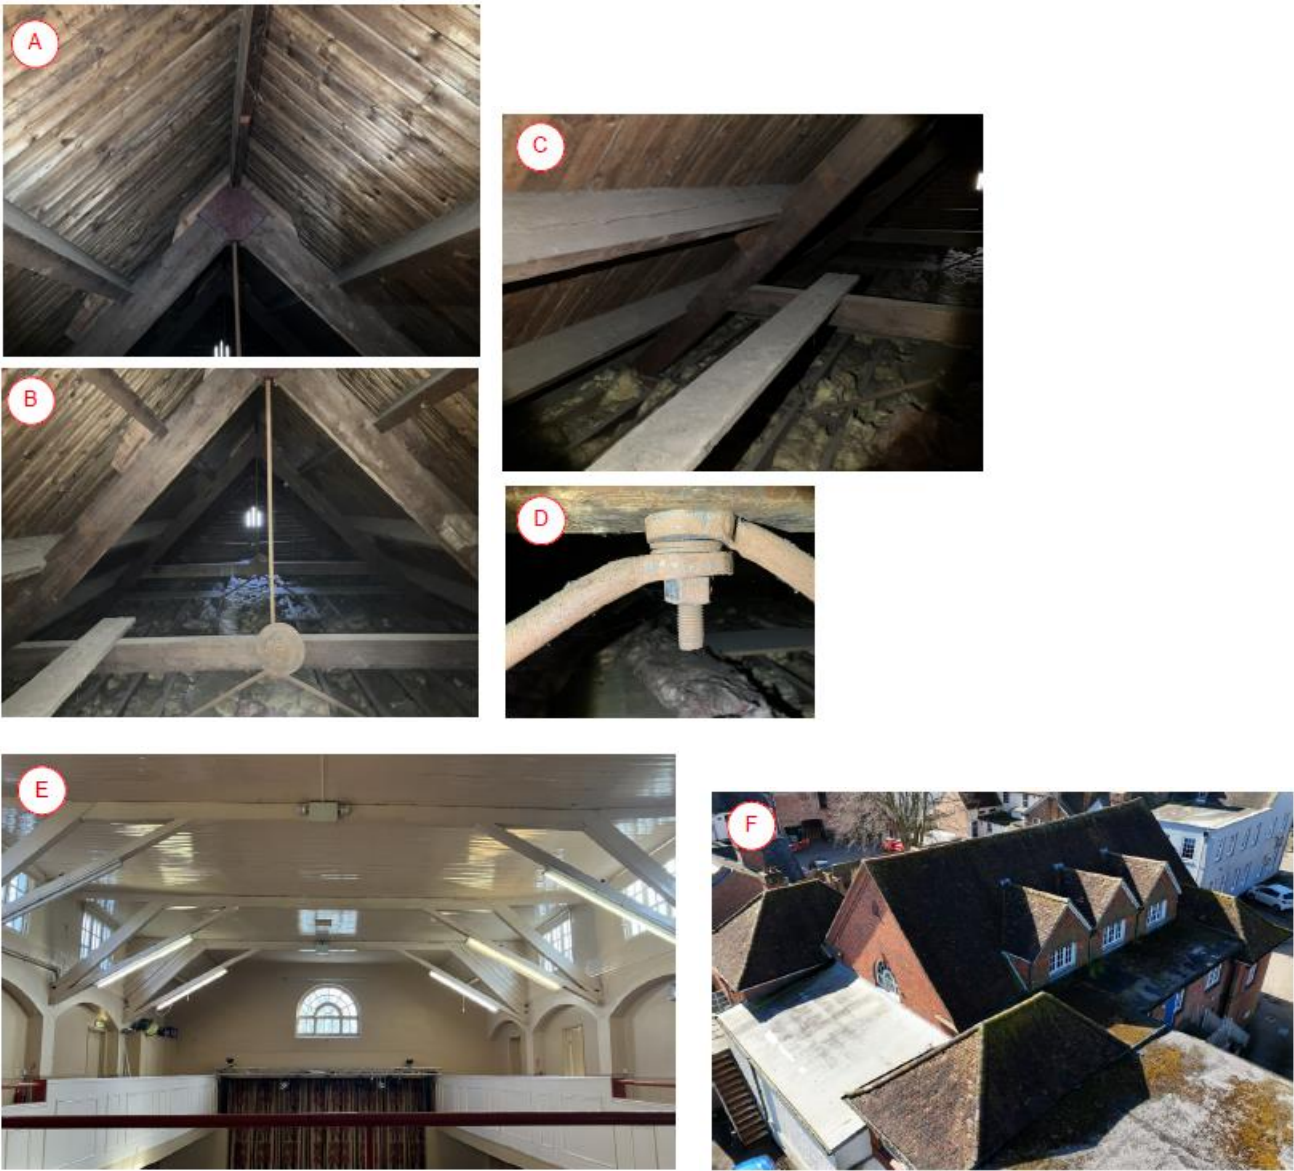
Figure 4 – A typical section through the hall roof structure with key to photographs (AECOM)

Although not all parts of the main hall roof structure were fully visible, the primary timber construction appeared sound with no evident signs of decay or significant movement. The direct cause(s) of the widespread cracking to the side walls of the hall where the roof trusses are supported is not fully understood without further investigation. Roof spread from the roof trusses imparting lateral load onto the walls is possible due to the geometry of the trusses whose feet are not tied by a horizontal chord (as shown in Figure 4).

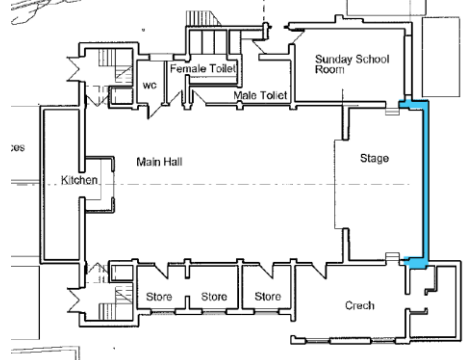
(3a) Photo EX-6	<u>Family room (modern extension over car park entrance) on east elevation</u> i) General water related damage to brickwork, including around windows	i) Blocked roof guttering and downpipes (refer to accompanying building surveying report for further advice).	Refer to accompanying building surveying report for any further advice.	Refer to accompanying building surveying report for any further advice.	Progressive ongoing water ingress and damage to the internal structure and fabric leading to further deterioration / decay compromising the structural safety through loss of fabric.	B/C
(3b) Photo EX-6	<u>Ground floor (Sunday school / meeting room)</u> i) General cracking and spalling to painted rendered wall below and around window, with severe water saturation and staining at junction with the ground.	i) Blocked roof guttering and downpipes (refer to accompanying building surveying report for further advice). ii) There are evident problems with the below ground drainage in the car park area. Reports of bad smells from foul drainage has been reported in the warmer months in this area. It understood that the hardstanding at the rear elevation once housed an external toilet building (since removed and covered with a raised paved hardstanding). The height of the raised paving	Allow for permanent removal of the raised paved hardstandings, and inspection of the downpipe. Locally remove the render coverings to promote drying. Inspect the render material which may be a hard cementitious mix.	Cement renders are known to promote dampness within solid masonry as rainwater which passes the render becomes trapped within the wall structure. This usually leads to the decay of the masonry itself along with the mortar, the internal finishes and leads to decay of the timbers bearing into or, in close contact with the walls. It is recommended that when a major	Progressive ongoing water ingress and damage to the internal structure and fabric leading to further deterioration / decay compromising the structural safety through loss of fabric.	B/C

Ref: [DP1]	Visible Symptom of Distress	Possible Cause(s)	Further Investigation Required	Principles of Repair (subject to Further Investigation)	Likely Consequence of Inaction	Repair Priority
		bridges above the level of the damp proof course, which has allowed to penetrate the wall. iii) Defects exacerbated by the lack of vapour permeability of the cement-based render and their inability to deal with the normal movement and breathability of a solid masonry wall.	Refer to accompanying building surveying report for any further advice.	scheme of refurbishment is undertaken, the cement render be removed, the walls consolidated with an imminently hydraulic lime mortar and then finished with a suitably designed lime render. This will be less prone to cracking and begin to allow the walls to dry through evaporation. Refer to accompanying building surveying report for further advice.		
(3c) Photo EX-7	<u>Rear and side elevations of hall stage (single-storey rear extension)</u> i) General cracking and spalling to painted rendered wall below external wall chamfer with severe water staining at junction with the ground. ii) At high level (accessed from the rear external steel staircase), the south facing wall to the stage has cracked render. iii) External metal staircase – The finish to the steel staircases is corroding, causing deterioration of the paint finish.	See above comments for Sunday school / meeting room.	See above comments	See above comments. Subsidence of the stage rear wall is not evident. However given the significant subsidence movement to the adjoining workshop building, provide provisional sum allowance for underpinning for the extent shown below (all as highlighted in blue).

iii) Clean and repaint staircase	Progressive ongoing water ingress and damage to the internal structure and fabric leading to further deterioration / decay compromising the structural safety through loss of fabric.	B/C

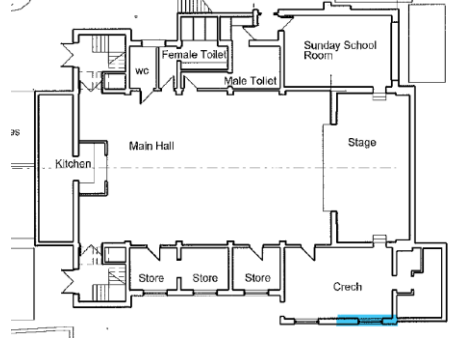
Ref: [DP1]	Visible Symptom of Distress	Possible Cause(s)	Further Investigation Required	Principles of Repair (subject to Further Investigation)	Likely Consequence of Inaction	Repair Priority
(5b) Photo EX-12	<p><u>Side (south) elevation of office at first floor and creche under at ground floor</u></p> <p>Staggered diagonal cracking in the brickwork walls generally between the lower and upper-level windows. The pier to the right-hand corner adjoining the single-storey workshop has evidently dropped.</p> <p>The concrete gulley below the location of wall cracking is cracked. The gulley is also blocked, as evidenced during the survey during heavy rainfall.</p>	<p>i) The symptoms of distress suggest that the cause is ground related, which may be subsidence due to faulty drains and / or the action of tree roots.</p> <p>ii) Open cracks in the façade allow water to penetrate into the wall core which exacerbates further deterioration due to damp and mechanical actions such as freeze/thaw. Other agents of decay include faulty rainwater goods, roof leaks, water splashing, latent defects i.e. missing DPC, and deficiencies in the brickwork/mortar which need to be investigated further to enable appropriate repairs to be specified.</p>	<p>i) Investigate below ground drainage (see above for details)</p> <p>ii) Establish ground movement monitoring to check for progressive subsidence.</p> <p>iii) Carry out trial pitting of the foundations. Expose the existing foundations for structural inspection.</p> <p>iv) Refer to table section relating to defects to the internal face of the wall.</p> <p>v) Investigate for damp penetration and retained moisture in the masonry. Determine the quantity of moisture in the masonry masses and its source(s).</p>	<p>sacrificial mortar that allows moisture to drain from the joints rather than the brickwork.</p> <p>i) If subsidence is the cause of the movement the foundations in the location of the subsidence will likely require underpinning for the extent shown (all as highlighted in blue).</p>

<p>ii) Repair of the vertical masonry cracks based on an underpinning scheme would comprise of brick stitching using stainless steel bars inserted into the bed joints (such as Helifix), specified by the structural engineer.</p> <p>iii) Once the condition of the below ground drainage has been confirmed, allow for replacement of all the external gulleys on the south elevation (4No) and their connections to the drainage network.</p>	<p>Subsidence-based movement may be ongoing. Inaction may result in further deterioration of the structure.</p> <p>Durability is essential for the continued structural health of the building and fabric. Openings in the external envelope allow water to penetrate and initiate decay.</p>	B/C

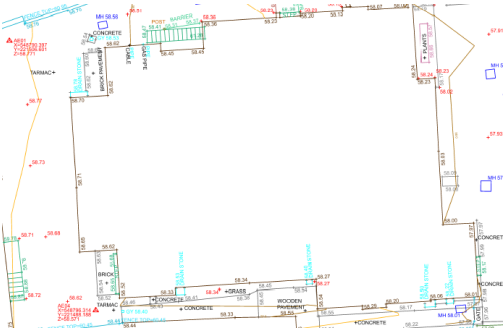
<p>Extract from topographical survey (AECOM 2025)</p>

7.0	Internal – Hall roof structure below the ceiling (Read the following in conjunction the accompanying drawing ref: ACM-SK-HF-250321 001_WaterLane_Truss, the photographs and the hall ceiling spot level survey in the appendix.					
(7a) Photos H INT 1 - 4	<p>i) Assessment of vertical deflection of the bottom chord of the roof trusses below the hall ceiling.</p>

<p>Extract from measured survey of hall (for truss identification)</p>	<p>i) The report of structural inspection of the hall building by RCA Structures dated October 2016 refers, <i>'We could see that the roof trusses have deflected under the load of the existing roof. This is causing the joints to open [in the] timber sections and is creating a lateral load to be applied to the external walls. Extensive repair works will be required to repair the trusses and ensure that they are structurally sound.'</i></p> <p>In their report RCA Structures advised they did not enter the hall roof space to inspect the roof structure. AECOM carried out a partial inspection of the roof space during the March 2025 surveys and undertook spot level surveys of the hall ceiling structure to observe the truss deflections. The results of the spot level survey are included in the Appendix, and the overall range in measured defection of the bottom truss chord is summarised as follows (in millimetres):</p> <p>TRUSS 1 (West): 16mm downward shape between outer knee braces. TRUSS 2: 25mm upward shape between outer knee braces. TRUSS 3: 22mm upward shape between outer knee braces. TRUSS 4 (East): (0mm) flat bottom truss chord between outer knee braces.</p> <p>Based on the above results, it is evident that the four principal roof trusses have not deflected significantly under load from the roof (and attic floor).</p> <p>The hall ceiling construction is comprised of gloss paint coated close boarding which is secret nailed/screwed to the ceiling support timber structure. It is evident there is a general undulating profile in the surface of the ceiling, which can trick the observer into thinking the structural frame is distorting.</p>	<p>The general condition of the hall ceiling fixings to the attic floor structure is not known.</p> <p>It is recommended that investigations are made (using scaffolding or a mobile elevated working platform (MEWP) to carry out spot checks by locally removing ceiling boards, in conjunction with touching distance inspections from within the attic space. Given the limited walkways in the roof, a planned safe means of access is needed to carry out this work.</p>	<p>Repairs to the ceiling may be needed if the close boarding is becoming detached. Make allowance for access to fully survey and enhance the fixings between the boarding and ceiling joists.</p>	<p>Given the water ingress in the hall via the roof coverings, it is prudent to carry out the survey work in the next 12 months so that an action plan can be made for the repairs.</p>	B

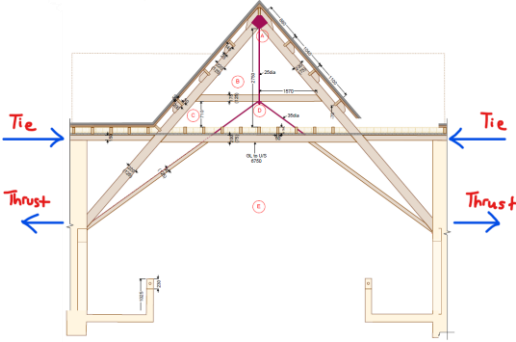
(7b)	<p>ii) Assessment of verticality (i.e. plumbness) of the external walls to the hall at truss supports.</p> <p>Roof spread can occur with this type of roof structure when the principal rafters are not adequately tied, causing them to open in a scissor-like pattern. The first signs of roof spread are often cracks, bulging, or leaning at the head of the masonry, causing bowed walls.</p> <p>Previous structural modifications have been made to several truss feet, using bolted steel plates/shoes, which were probably installed in response to water damage to the truss bearings.</p>	<p>As noted in Section 2, the principal roof structure to the hall is a hybrid timber scissor truss incorporating steel tension rods, timber knee braces and a horizontal timber chord (tie) member (see extract below from the truss section drawing). Generally, compared to conventional closed triangular roof trusses, scissor trusses can apply horizontal loading (or thrust) at the supports which needs to be resisted by the bearings. The truss arrangement at Water Lane Hall incorporates a horizontal chord which acts as a tie to resist the horizontal load. However, the knee braces meet the walls below the level of the bottom chord, so there may be some residual load thrust onto the external walls to the hall (see drawing extract below). Some resistance to lateral thrust is resisted by the two-storey side additions to the hall on the north and south elevations (i.e. the storerooms to the south, and the offices and WCs to the north.</p>	<p>It is recommended that structural investigations be made (using scaffolding or a mobile elevated working platform (MEWP) to carry out spot checks of all trusses, notably TRUSS 3 in the hall. Assessing the timber joints to the truss to check if they have opened due to roof spread or other reasons.</p>	<p>Structural repairs may needed to the roof truss if the touching distance inspections reveal that the timber components such as the knee brace have moved over time, allowing load to push against the external wall.</p> <p>Make allowance for access to fully survey and enhance the fixings top TRUSS 3 below the hall ceiling.</p>	<p>Given the age of the building and the history of water ingress in the hall via the roof coverings, it is prudent to carry out the survey work in the next 12 months so that an action plan can be made for any repairs.</p>	B

Ref: [DP1]	Visible Symptom of Distress	Possible Cause(s)	Further Investigation Required	Principles of Repair (subject to Further Investigation)	Likely Consequence of Inaction	Repair Priority
		<p>Based on this, digital verticality checks have been carried out to assess the verticality of the hall walls between the gallery (first) floor and the head of the dormer roof (truss bottom chord).</p>

<p>The results of the wall verticality survey are included in the Appendix, and summarised as follows.</p> <p>The offsets in millimetres are the measured out-of-plumbness of the internal wall. The offsets are taken from the face of the wall finish, therefore there may be inaccuracies due to irregularities in the wall construction:</p> <p>South wall at TRUSS 1 = 37mm South wall at TRUSS 2 = 14mm South wall at TRUSS 3 = 63mm South wall at TRUSS 4 = 22mm</p> <p>North wall at TRUSS 1 = 8mm North wall at TRUSS 2 = 16mm North wall at TRUSS 3 = 58mm North wall at TRUSS 4 = 6mm</p> <p>Walls that are either built out-of-plumb or move out-of-plumb in service can become potentially unstable when the centre of gravity of the wall moves beyond $t/6$ where t = the <i>structural</i> thickness of the wall. At Water Lane Hall we have assumed a thickness of 330mm for the external walls at the level where the roof knee brace intersects the wall. The results show that the verticality of wall locations supporting roof trusses 1, 2, 3 & 4 are all safely within acceptable verticality recommendations for walls based on a limit-of-lean of $t/3$ (110mm). The wall at Truss 3 appears to show higher horizontal displacements (as highlighted in red) with an average value of 60mm. Whilst 60mm still falls well within width $t/3$ (110mm), the movement may be one of the reasons for the brickwork wall cracking seen internally within the hall (see table section 8b).</p>

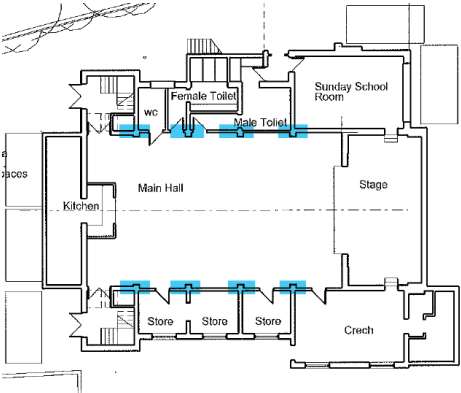
(8b) Photos GAL-1 - 19	<p>ii) <u>Gallery walls (cracking)</u></p> <p>There is widespread and sporadic plaster cracking to the perimeter walls around the hall at all truss / wall interfaces and around and under the dormer windows between the trusses. Some of the cracking located around the hall windows and gable ends is severe. This is shown in the photographs in Appendix A.</p> <p>The age of the defects is not known, however wall cracking is recorded in the 2002 and 2008 condition reports by Swarder & Sons, and the 2016 structural report by RCA Associates.</p> <p>Some of the cracks appear to coincide with wall cracking in the external brickwork face. It is not known if associated cracking continues internally to ground floor level due to mush of the wall surfaces being concealed behind wooden boarded dado panels.</p>	<p>Given there are evident ground movement related defects around parts of the Water Lane Hall building(s), damage from subsidence cannot be discounted until appropriate factual site data is obtained through various investigations.</p> <p>Other causes for the cracking could be structural movement of the roof, which is discussed above (in table sections 7a and 7b), water penetration, condensation and thermal effects. Earlier reports suggest that the wall construction to the dormer roofs is a type of clinker concrete. Clinker is a by-product from the coal industry, and it is known to deteriorate when in prolonged contact with water.</p>	<p>i) Investigate drains (see external observations for further details)</p> <p>ii) Physical checks to check if the plaster cracks continue through into the wall structure. This is particularly important in the masonry arched walls below the hall windows on the north and south elevations. Open up plaster to the arches to check extent of damage to masonry.</p> <p>iii) Establish movement monitoring to check for progressive subsidence (see external observations for further details).</p> <p>iv) Carry out trial pitting of the foundations. Expose the existing foundations for structural inspection. Open up the dormer walls to determine their construction, in conjunction with the other investigations.</p> <p>v) Refer to table section relating to defects to the external face of the walls.</p>	<p>i) If subsidence is the cause of the movement the foundations in the location of the subsidence will likely require ground improvement or underpinning for the extent shown below highlighted in blue in the region of the 6No loadbearing masonry piers.</p>

<p>ii) Repair of the masonry cracks based on an underpinning scheme would comprise of brick stitching using stainless steel bars inserted into the bed joints (such as Helifix), specified by the structural engineer. Repairing the internal cracking to the plaster would benefit reinforcement of the new plaster interface with existing.</p> <p>If the masonry arches are found to be defective, additional reinforcement to repair the brick arches may be able to adopt a Helifix solution (subject to</p>	<p>If it is active subsidence, it will continue causing further cracks, water ingress and loss of stability affecting the safety of the building.</p>	B/C

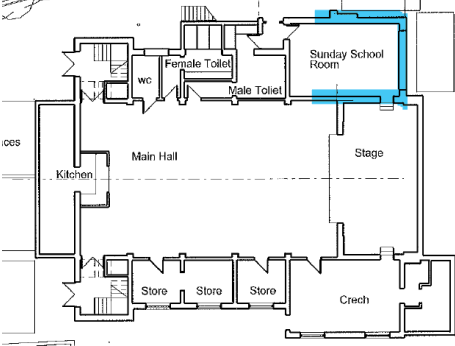
<p>The ceiling above the church parlour room has a raised collar roof arrangement. There are visible signs of water penetration due to water staining, spalling and cracking on the ceiling and walls. There are also signs of roof spread and possible distortion of the roof/ceiling towards the rear wall facing the car park. This is evidenced by stretch mark patterns of cracking in the ceiling.</p> <p>The parlour room floor is live and bouncy under the heel-drop test, and the vibration causes the internal door to rattle. The floor is also noticeably rolling towards the rear wall.</p>	<p>Given there are evident ground movement related defects around parts of the Water Lane Hall building(s), particularly at the east (car park) side, damage from subsidence cannot be discounted until appropriate factual site data is obtained through various investigations.</p> <p>Other likely causes for the cracking and movement of the roof is water penetration, condensation and thermal effects.</p>	<p>i) Investigate drains (see external observations for further details)</p> <p>ii) Physical checks to check if the plaster cracks continue through into the wall structure.</p> <p>iii) Establish movement monitoring to check for progressive subsidence (see external observations for further details).</p> <p>iv) Carry out trial pitting of the foundations. Expose the existing foundations for structural inspection.</p> <p>v) Refer to table section relating to defects to the external face of the walls.</p>	<p>i) If subsidence is the cause of the movement the foundations in the location of the subsidence will likely require underpinning for the extent shown below highlighted in blue, with transition underpinning along the flanking walls as shown.</p>

<p>ii) Repair of the masonry cracks based on an underpinning scheme would comprise of brick stitching using stainless steel bars inserted into the bed joints (such as Helifix), specified by the structural engineer. Repairing the internal cracking to the plaster would benefit</p>	<p>If it is active subsidence, it will continue causing further cracks, water ingress and loss of stability affecting the safety of the building.</p> <p>Durability is essential for the continued structural health of the building and fabric. Openings in the external envelope allow water to penetrate and initiate decay.</p>	B/C

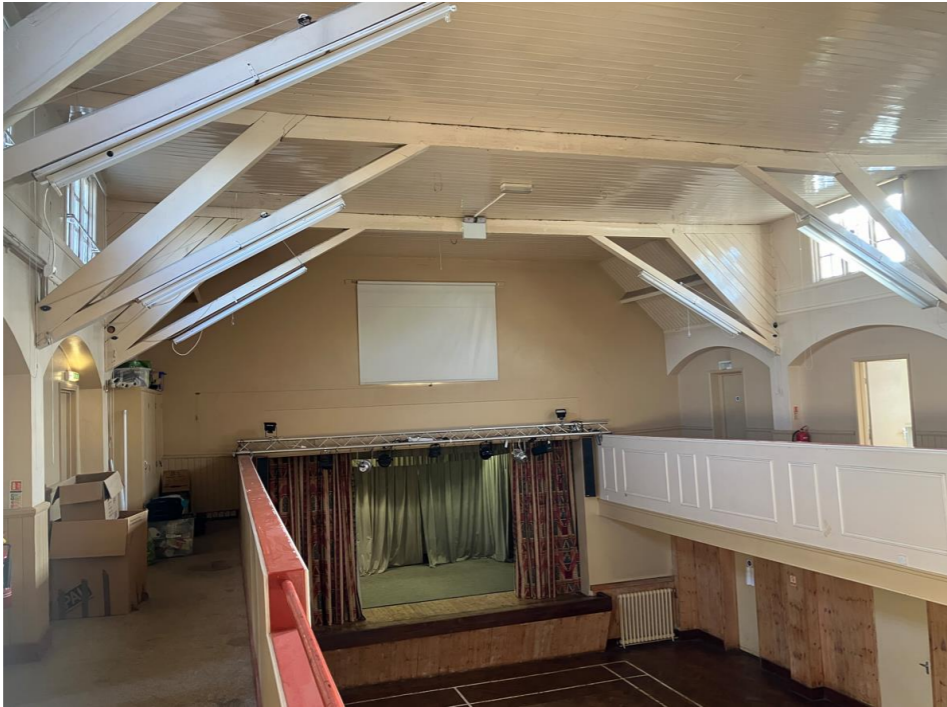
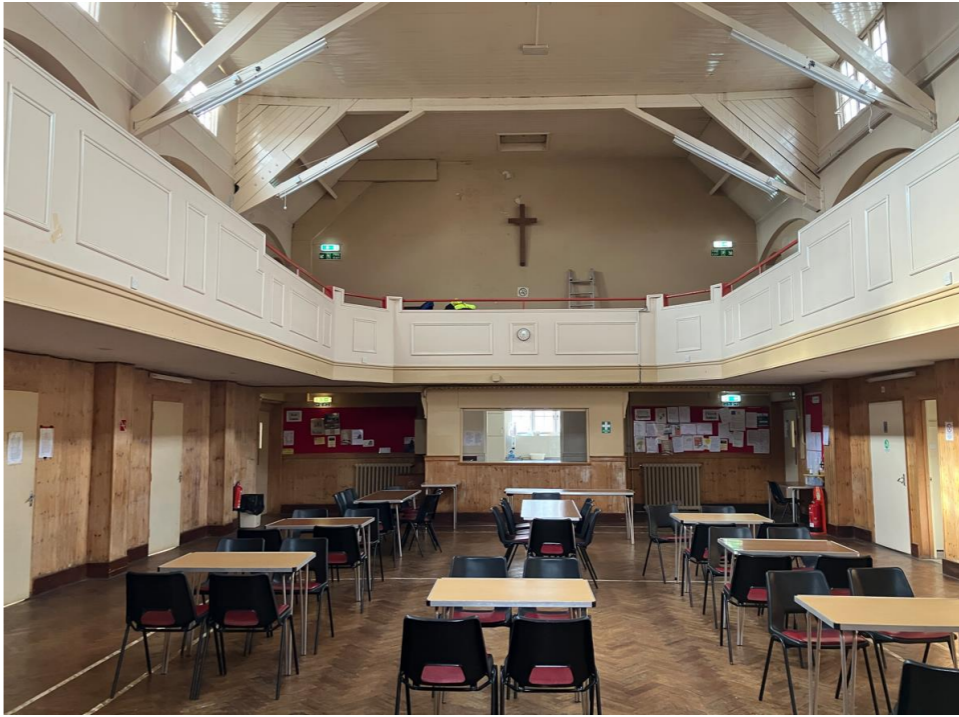
H INT 1	Interior of hall from gallery, viewed to the east	H INT 2	Interior of hall from ground floor, viewed to the west

H INT 3	Interior of hall from ground floor, viewed to the west	H INT 4	Interior of hall from gallery, viewed to the west
