# EAST HERTS COUNCIL HERITAGE AT RISK REGISTER

Updated October 2025

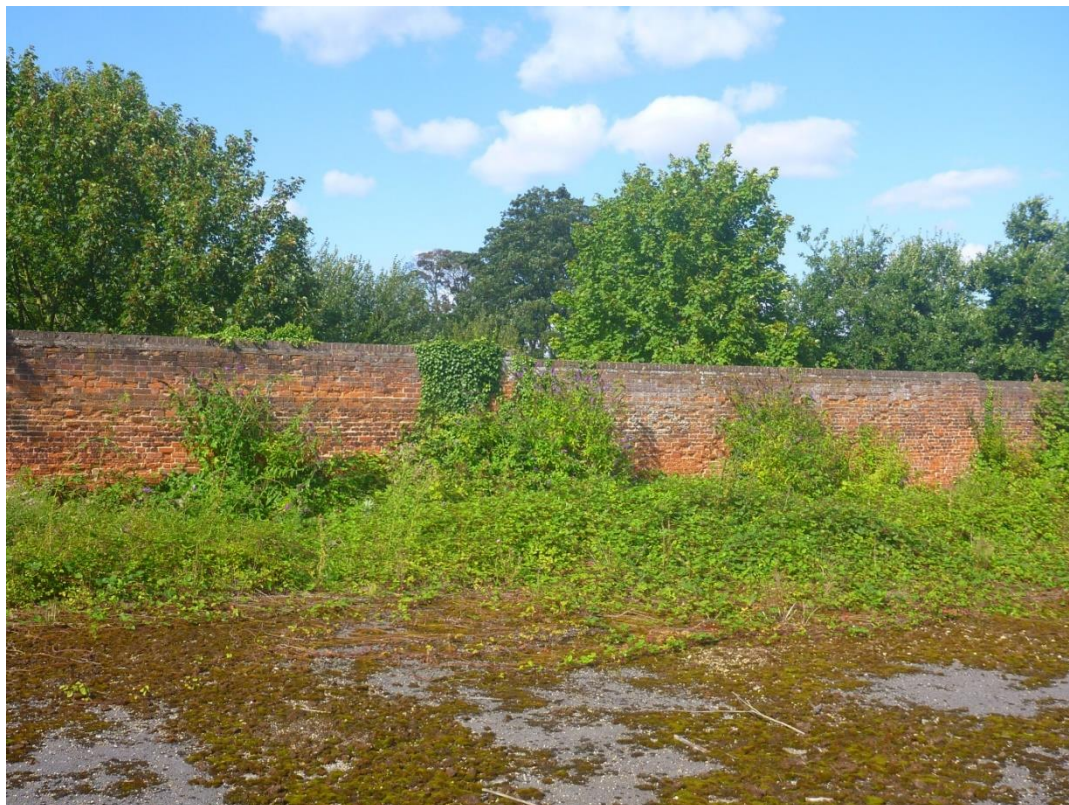
**Heritage Asset Number:** 1269020

**Description:** Grade II. Two walled gardens. Former Kitchen Garden Walls for Balls Park. Early C18, with C19 and C20 alterations and repairs. Red brick laid to Flemish bond, with Portland stone copings and finials to piers. Lean-to glasshouse to east section of north wall in north garden.

**Works required:** To restore the walled garden and architectural detailing as described in listing description following removal of vegetation.

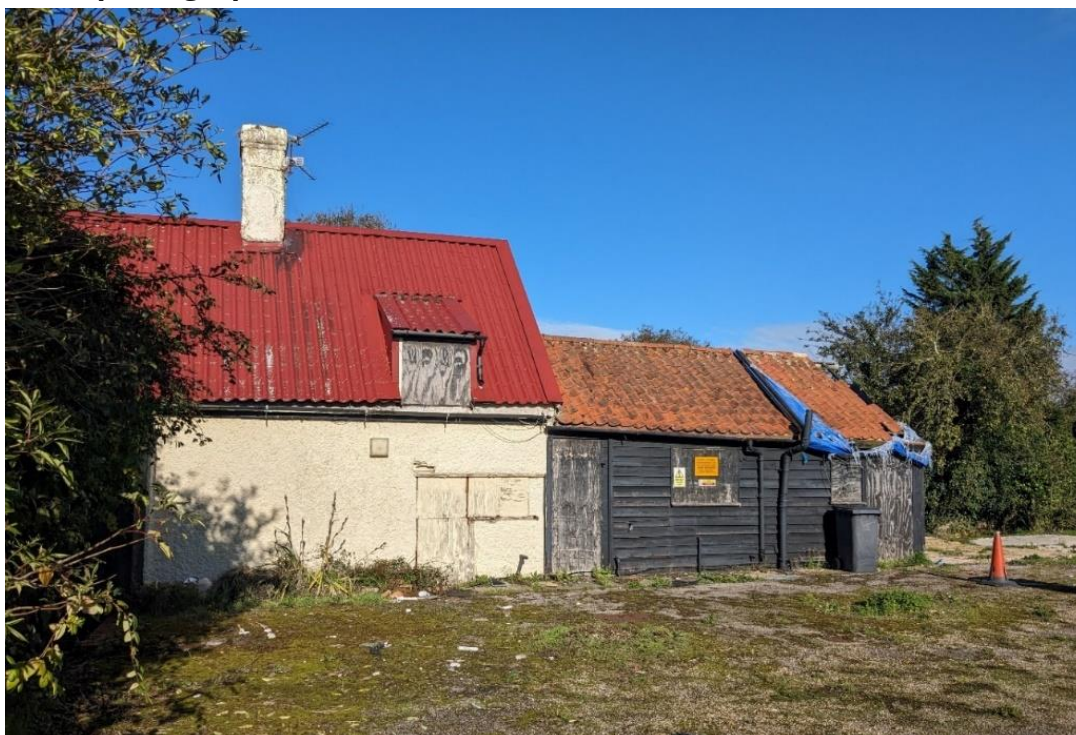
**Heritage Asset Number:** 1102230

**Description:** Grade II House, now a public house. C17 or earlier, N wing C19 and extended to rear in early C20. Timber frame roughcast with steep pitched roof now of black corrugated iron. A 3-unit, central chimney plan house of one and a half storeys facing S. Central chimney roughcast, a third from E end. 2 lean-to dormer windows at eaves with small-paned wooden 2-light flush casements. Plank door and 2-light casement linked under a dripboard to E part. Lower single-storey long weatherboarded outbuilding with red pantile roof extends to E. W end to road has 2-light casement window in gable over pilastered window and door surround on left. Roughcast N wing has old red tile roof and gable chimney. Half glazed panelled door with casement windows, one with gothic pointed heads to top lights.

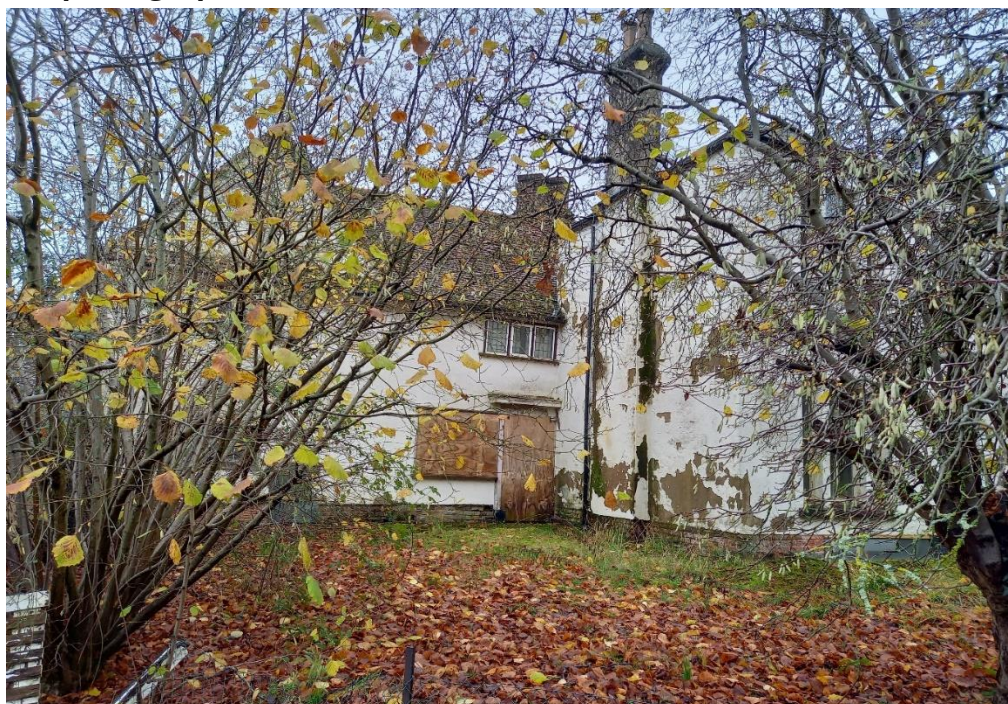
**Heritage Asset Number:** 1347850

**Description:** Grade II. C17 or earlier, late C19 front wing. 2 storey timber frame plastered house under steep old tiled gabled roof. Front wing 2 storey brick rendered under hipped slate roof. Main range has low 1st floor windows suggesting that it is possibly C16 or earlier with C17 floor and chimney stack inserted in hall. A massive chimney with stumpy diagonal shafts rises through rear slope of roof near middle of range. 3 light wood mullioned windows with rectangular leaded panes and iron casement. Single storey C18 timber-framed gabled rear storage wing on S. Weatherboarded and pantiled. Some scalloped slating, metal ridges, and square finial.

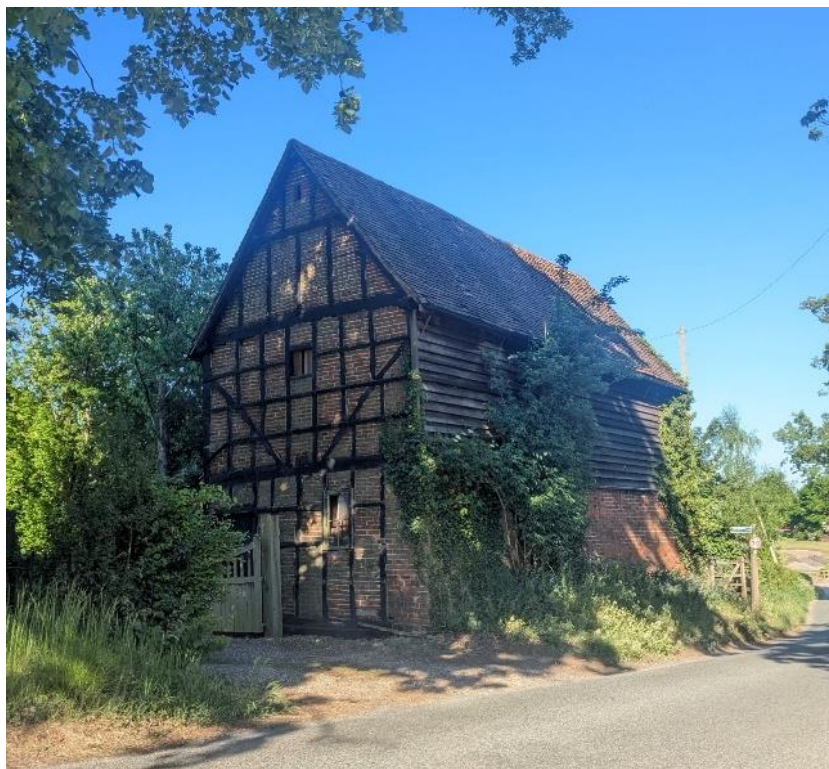
**Heritage Asset Number:** 1055846

**Description:** Grade II. Former stables with hay loft, now workshop and storage. Late C17 / early C18. Exposed timber frame with red brick, largely infill. Some weather-boarding. Steeply pitched tiled roof. 3 bays. Left gable end exposed small panel framing of thin scantling, mid rail with upper tension braces, cambered tie beam, struts to collar clasp purlins. Ground floor plank door and small pane casement. First floor 2 light window with a diagonal mullion. Right gable-end all boarded. Rear catslide roof over a boarded and rendered lean-to. Central double doors with ground floor boarding. First floor 2 loft doors, exposed framing with a tension brace, 2 light window with a diagonal mullion. Owned by the Old Rectory.

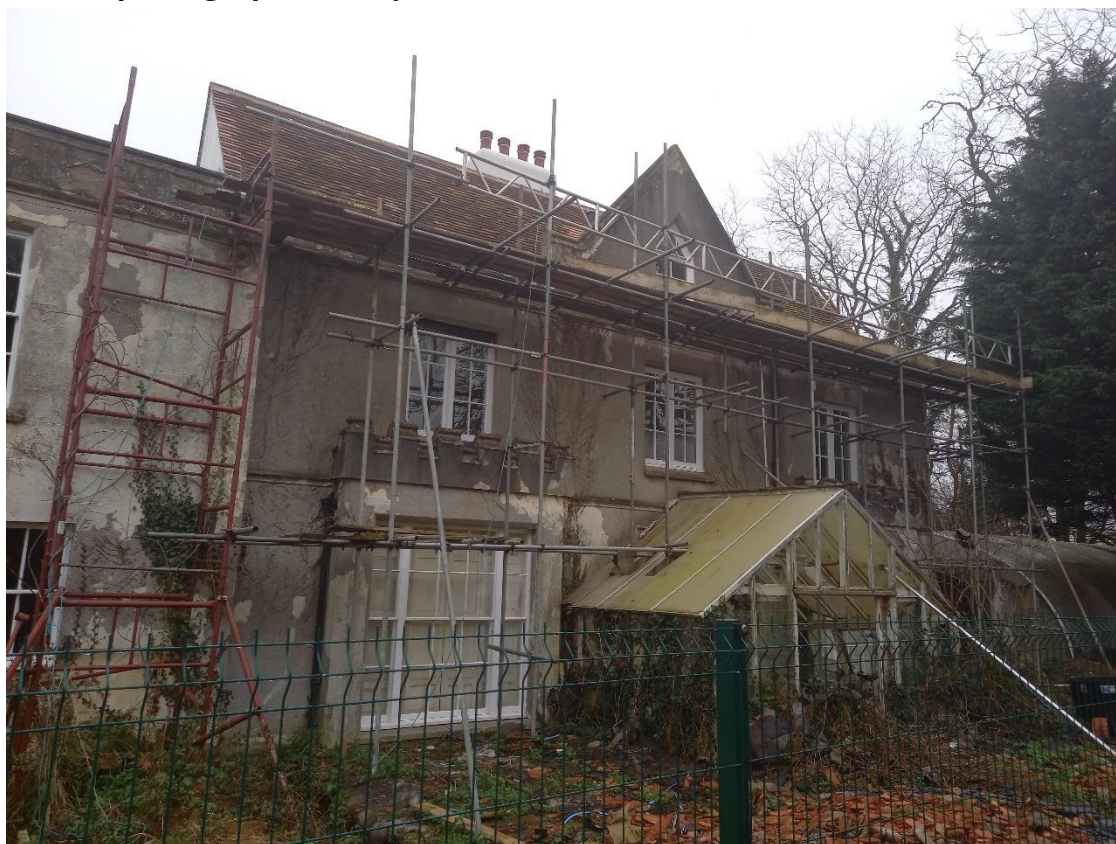
**Heritage Asset Number:** 1089152

**Description:** Grade II. Late C17th Farmhouse, re-fronted 1840-50 in Gothic Style. Largely brick built, now covered by stucco, with red tile roofs. A large L-shaped house of 2-storeys, attics, and cellar, facing south. Later low extensions.

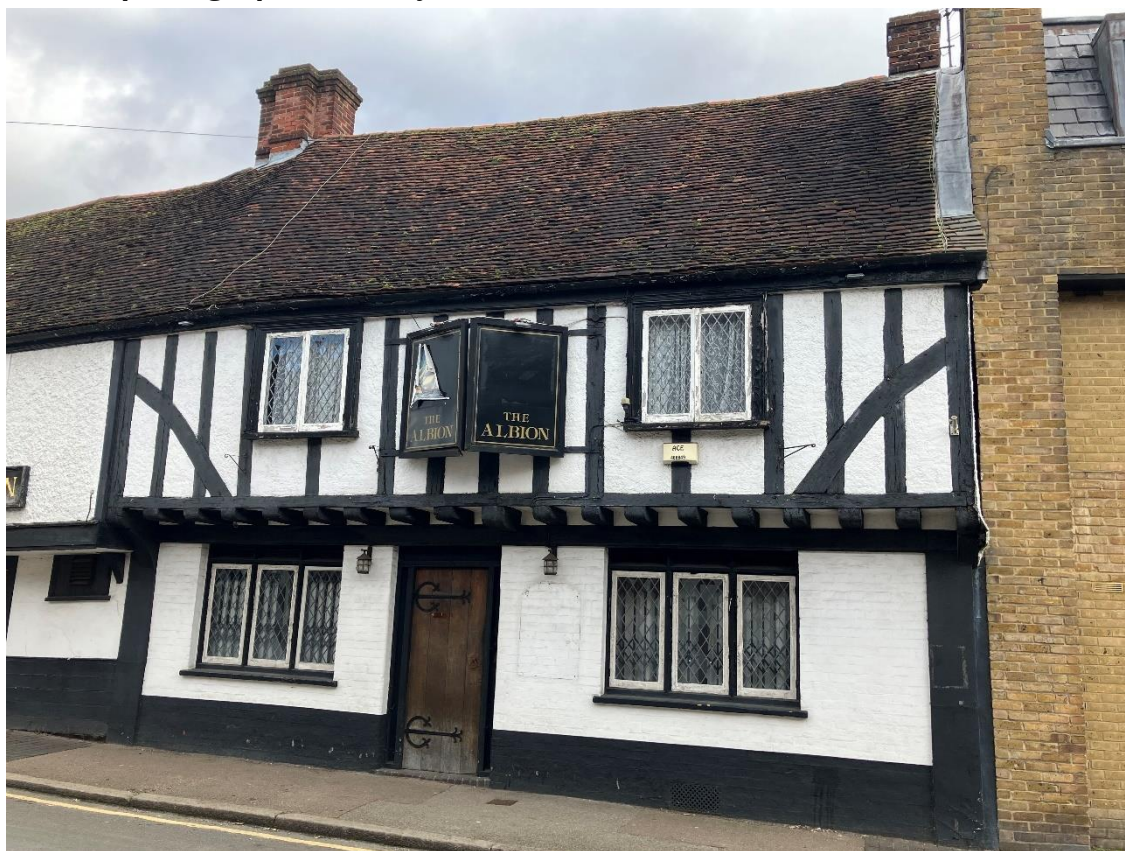
**Heritage Asset Number:** 1222116

**Description:** Grade II listed building, built as a house, later a public house with living accommodation above, currently unoccupied. Dates from C15th, altered C17th, and early-C20th.

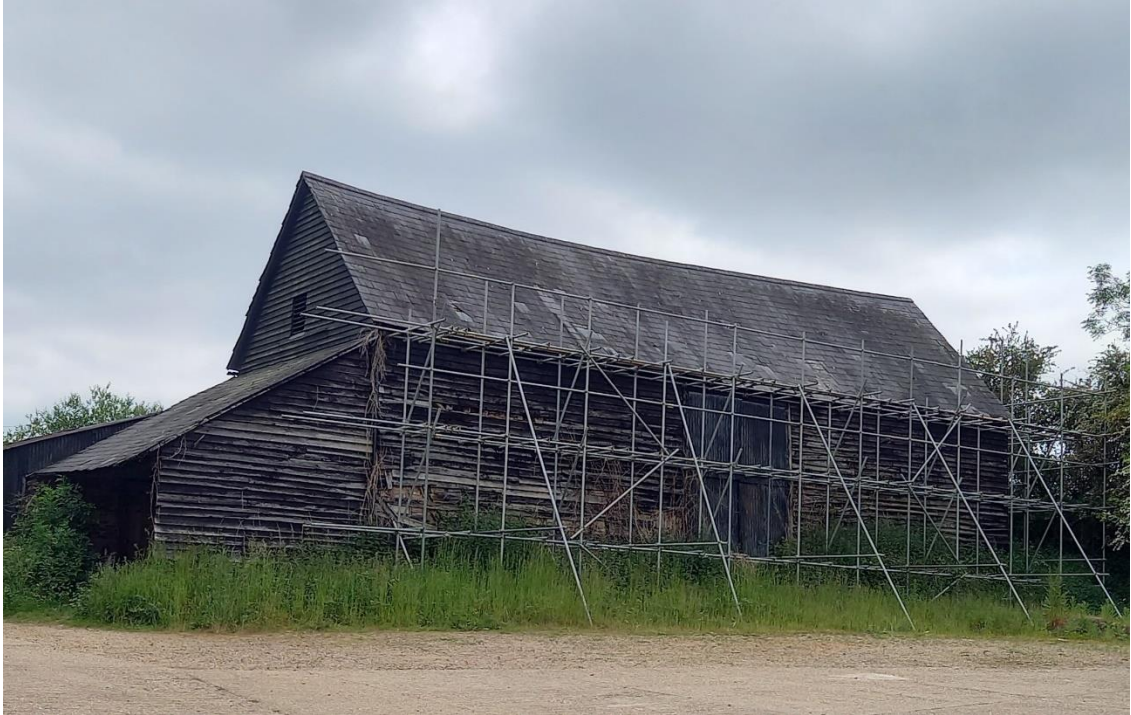
**Heritage Asset Number:** 1204940

**Description:** Grade II early-C18th 5-bay barn, re-roofed in early-C19th. Timber frame weatherboarded on tarred red brick sill wall in English-bond. Steep roof now slated. Lean-to at north (lower) end. Interior has long curved braces to heavy tie-beams and boarded walls. The West Barn is a 5-bay box-framed timber threshing barn cut into the sloping ground to the south with a brick plinth and pitched slate roof. Brick threshing floor with compacted earth to the north and south. The doors – which are stored within the building – are a later replacement.

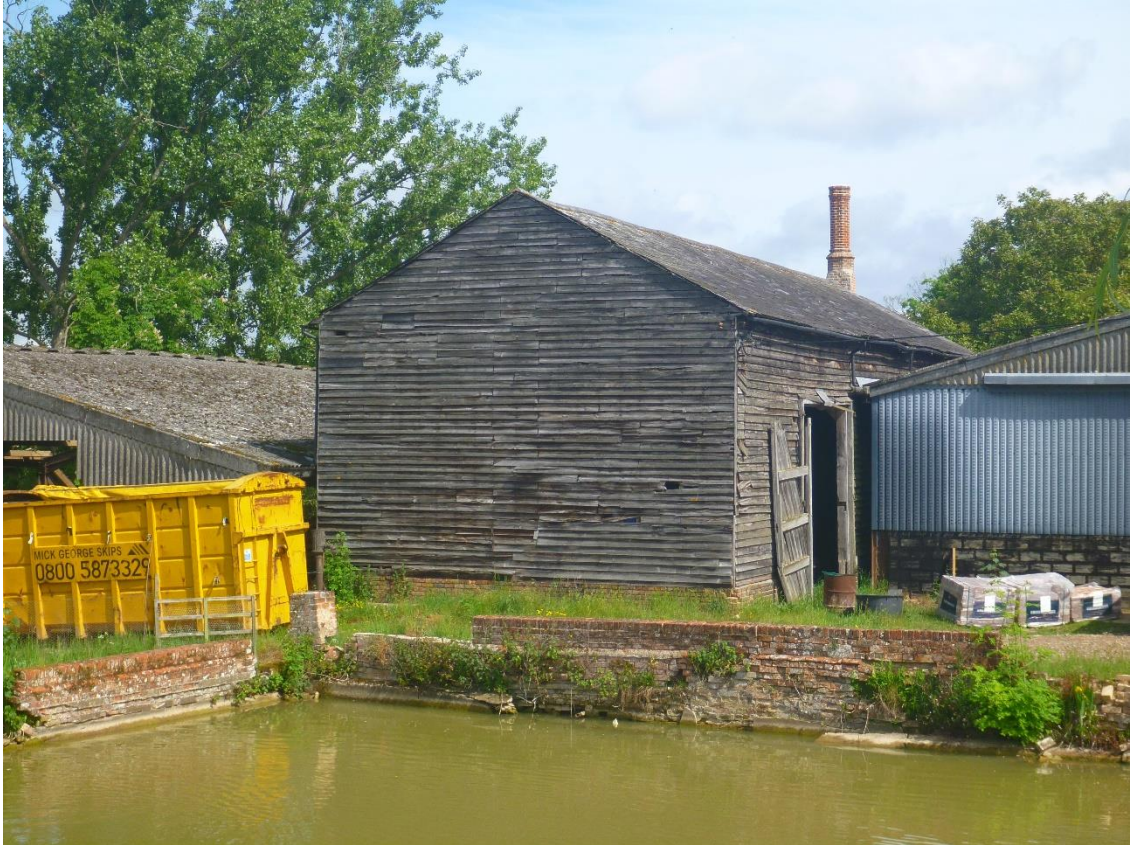
**Heritage Asset Number:** 1102246

**Description:** Grade II. Early-C19th barn. A tall un-aisled 6-bay barn facing E with 2 pairs of double doors. Un-jowled posts with long curved braces to tie-beams of king-post roof. Assortment of C19th and early-C20th curtilage barns and structures around the yard in very poor condition.

**Works required:** Overall objective to restore barns and improve yard by implementing consent and planning permission.

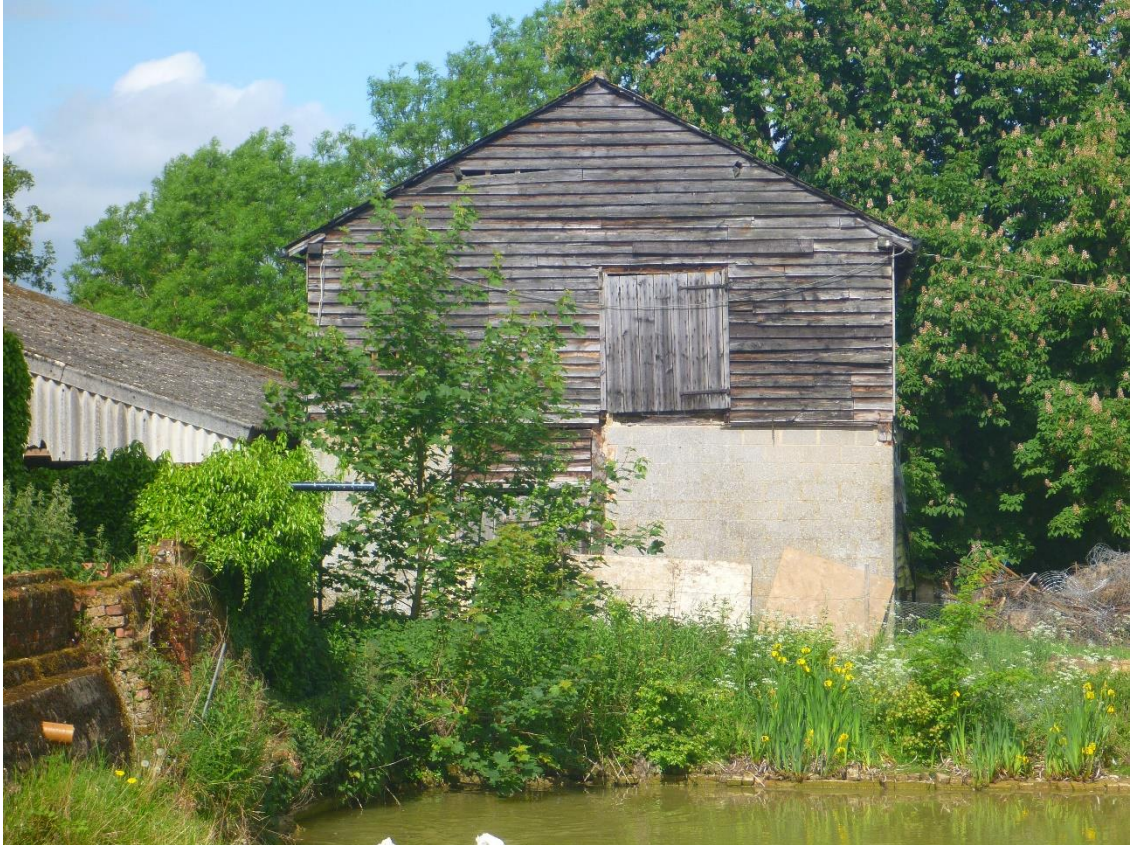
**Heritage Asset Number:** 1102245

**Description:** Grade II. Early-C18th barn. An unusually wide-span 7-bay tall un-aisled barn facing N. Opposed double doors in middle bay. Un-jowled posts and long curved braces to tie-beams. Mid-height rails tennoned in-line. Single purlin to each slope of queen-struts and collar roof. Undulating roof indicates present unstable condition; inadequate base showing some signs of movement; areas of weather-boarding missing. Other curtilage structures within yard also in very poor condition.

**Works required:** Overall objective to restore barn by implementing consent and planning permission.
